# Nofs Garments Ltd

Plot no. 01/04, Road no. 01, Doyal Housing Ltd., Bosila, Mohammadpur, Dhaka-1207.

14 August 2022

# Building Information

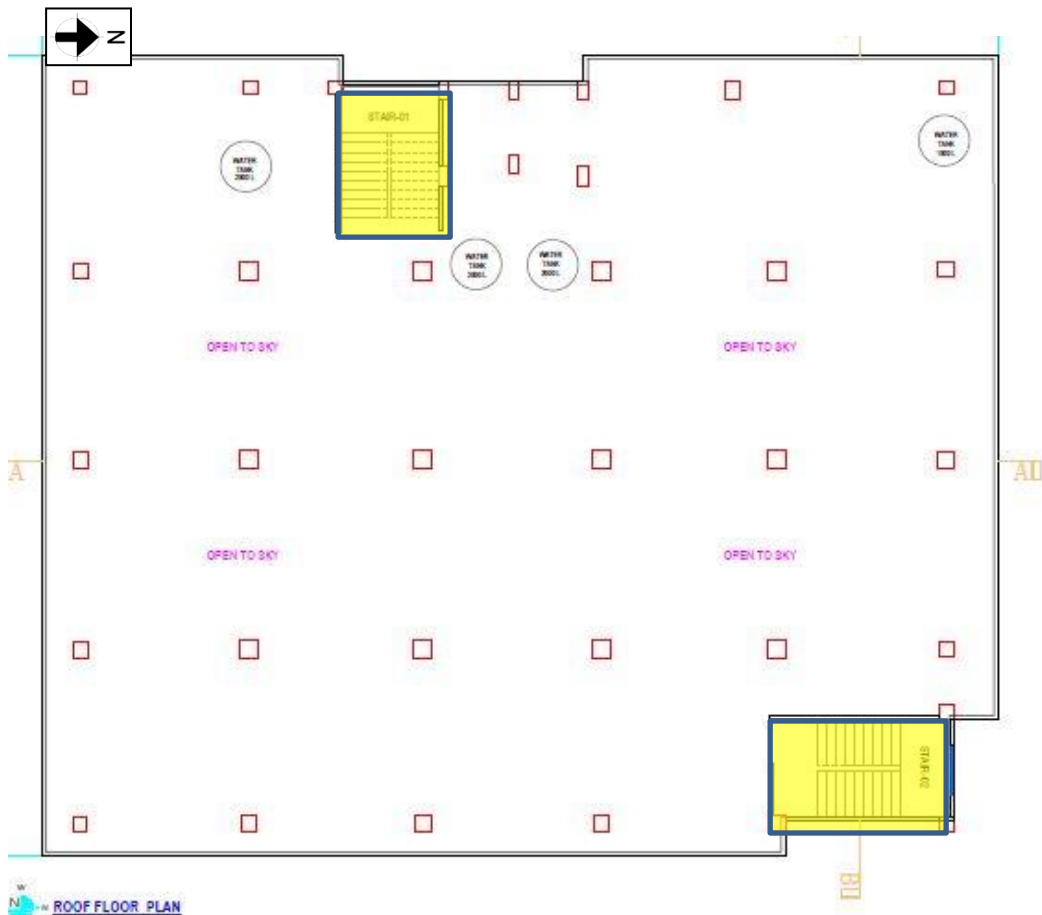
Stair locations

Apparently inadequate connection

At stair roof, rafters were observed as inadequately anchored with brick wall which were appeared to be inadequate for uplift forces. Building engineer is required to check the connection adequacy for uplift forces as part of EA.

Item No.	Observation	Recommended Action Plan	Recommended Timeline
06	Apparently inadequate connection (Main Building)	As part of EA, building engineer is required to check the connection adequacy of stair roof for uplift forces.	6-weeks
07	Apparently inadequate connection (Main Building)	Implement remediation work where required.	6-months
08	Water ponding on roof slab (Main Building)	Factory is required to improve roof drainage system with adequate slope.	6-weeks
09	Exposed reinforcement left at roof level (Main Building)	Factory is required to provide rust proof paint on exposed reinforcement to protect from corrosion.	6-weeks
