# Knit Valley Fashions Limited

Kalma, Dairy Farm, Savar, Dhaka.

01 August 2022

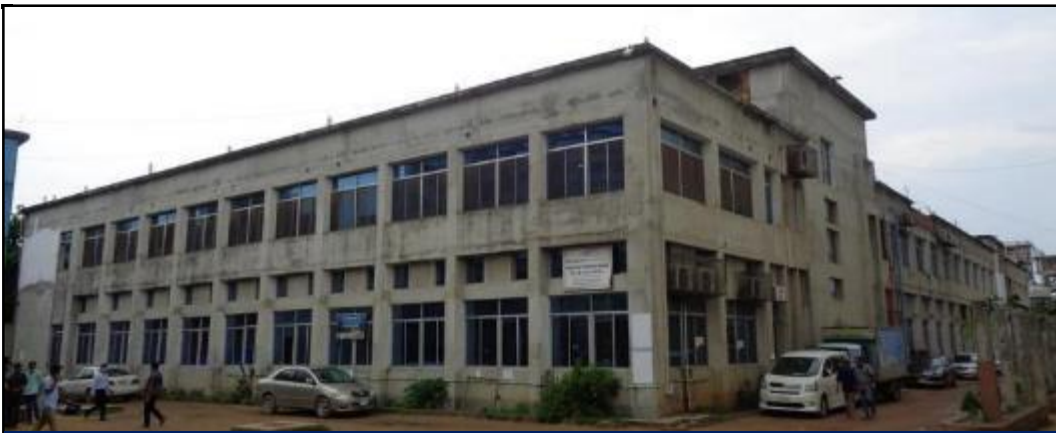
Production Building

**Design report not available**

As per BNBC, every building or structure designed shall have its design documents prepared in accordance with the provision of Section 1.9.1. The design document shall include a design report, and a set of structural drawings, which shall be prepared in compliance with section 1.9.1.1 and section 1.9.1.2 as per BNBC. At the time of inspection, the design report was not available which is required to be prepared in compliance with section 1.9.1.1 and section 1.9.1.2 (part-6, BNBC).

| Item No. | Observation | Recommended Action Plan | Recommended Timeline |
|---|---|---|---|
| 02 | Design report not available. (Production Building) | Implement the recommendation of the design report. | 6-months |
