# Famkam Fashion Ltd.

Shirir Chala, Bagher Bazer, Gagipur Shadar, Gazipur

28<sup>th</sup> July 2022 & 03<sup>rd</sup> August 2022

# Executive Summary

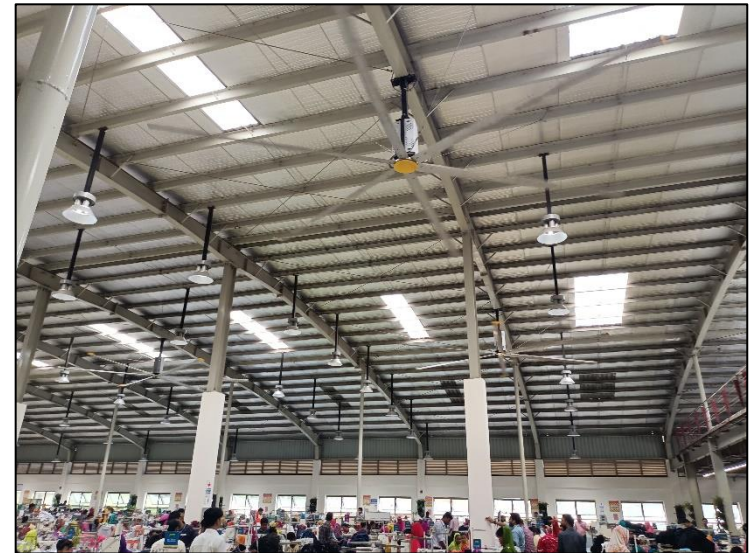
Steel roof shed - Lateral load transfer media missing at roof level

Lateral load transfer media (compression strut) along the ridge and eave is missing. The building engineer to check the lateral load path and review the stability of the structure accordingly.
