KSS Knit Composite Ltd. (Extension Buildings)

Boherar Chala, Sreepur, Maowna
(24.200929, 90.401977)
29 May 2022

Observations

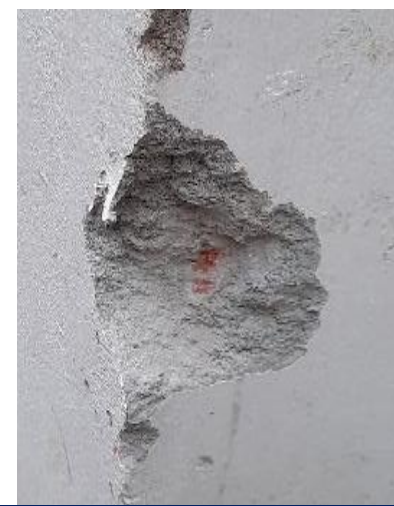
Brick aggregate concrete

Columns are stressed above normal design limit

Cursory calculation indicates that the working stress of ground floor column exceeds the normal design limits considering the minimum concrete strength of brick chips aggregate & prepared live load plan of 3 kPa. A Detail Engineering Assessment is required to carry out by the Building Engineer.

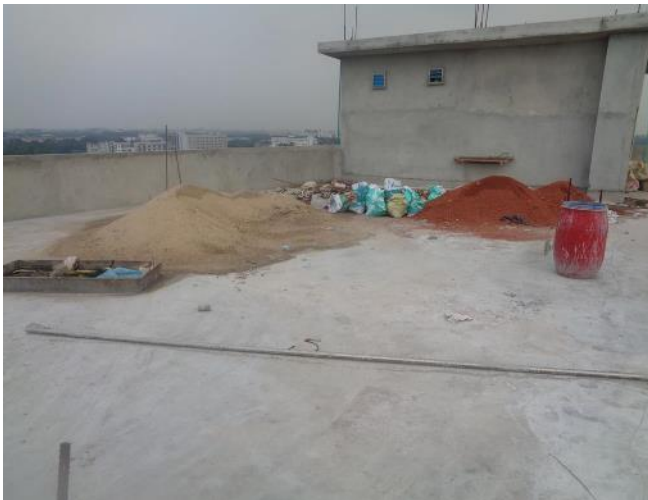
Standing water on the roof observed due to lack of proper sloping and drainage system. Exposed rebar also found on the roof as well as construction debris not removed from roof (although construction work is completed).

Construction debris on roof

Building Engineer is required to provide proper slope on roof and to developed drainage system to avoid water clogging in future as well as to remove excess exposed rebar & construction debris from the roof.

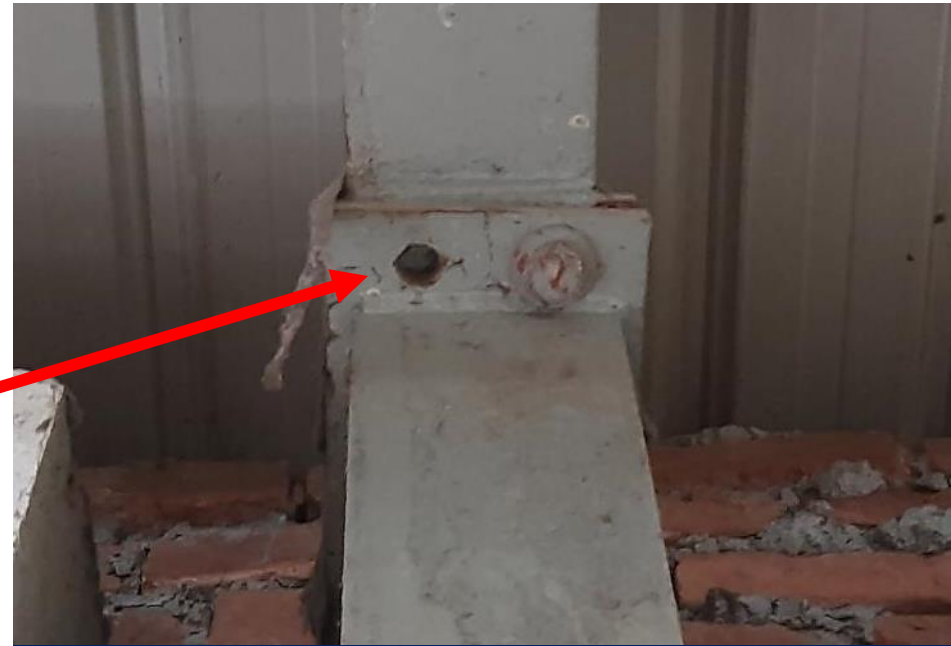
Missing bolt in steel column
and rafter joint

Building is required to install the missing bolt of the
steel structure.
