# Impress Newtex Composite Textiles Ltd. (Extension)

Gorai Industrial Area, Mirzapur, Tangail  
(24.089497, 90.171619)  
7 November 2021

# Observations

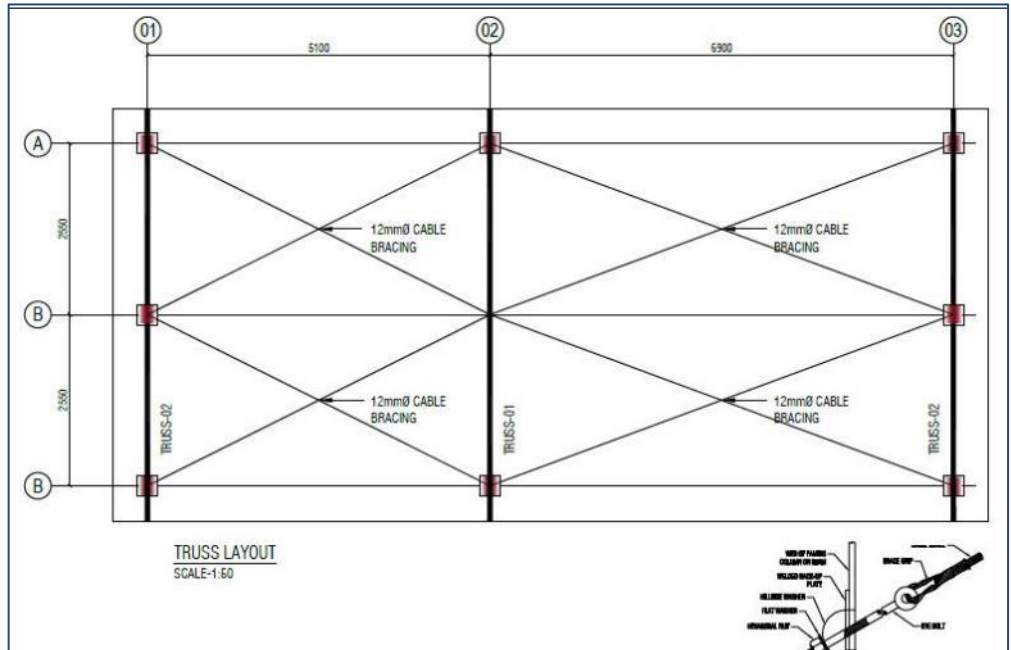
Bracings on as-built drawing

No bracings were found in as-built condition. Apparently non-engineered connection were found. Building engineer is required to check the lateral stability and connection adequacy of the structure for uplift forces.
