# Cotton Club (BD) Ltd. (Extension)

Jarun (South), Kashimpur, Gazipur, Bangladesh.

19 & 31 October 2021

# Observations

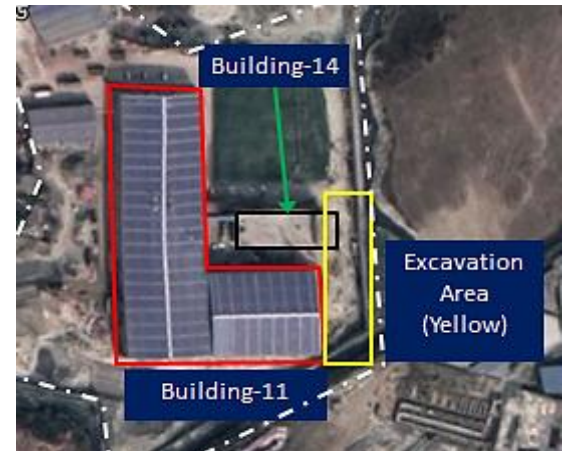
Building-11, foundation exposed due soil excavation

Soil excavation for the construction of a new building was found adjacent to Building-11 and Building-14. Because of that excavation, the soil under the shallow foundation of the steel stair adjacent to Building-14 has been moved away and the steel stair is now overhanging, supported by some steel props that have the potential to collapse at any time. The ground-bearing slab at EGL level, and one landing of the RC stair of Building-14 that connects to the mezzanine floor was found demolished. The upper floors' RC slab still lacks a railing and safety briary, potentially posing a fall hazard. The factory need to take following immediate actions.

1. The operation of Building-14 and the construction of a new building must be ceased immediately. Ensure that the steel stair is properly cordoned off to restrict access.

3. Stop all excavation work for the construction of the new building immediately. All existing and adjoining structures must be protected from any damage due to construction operations.

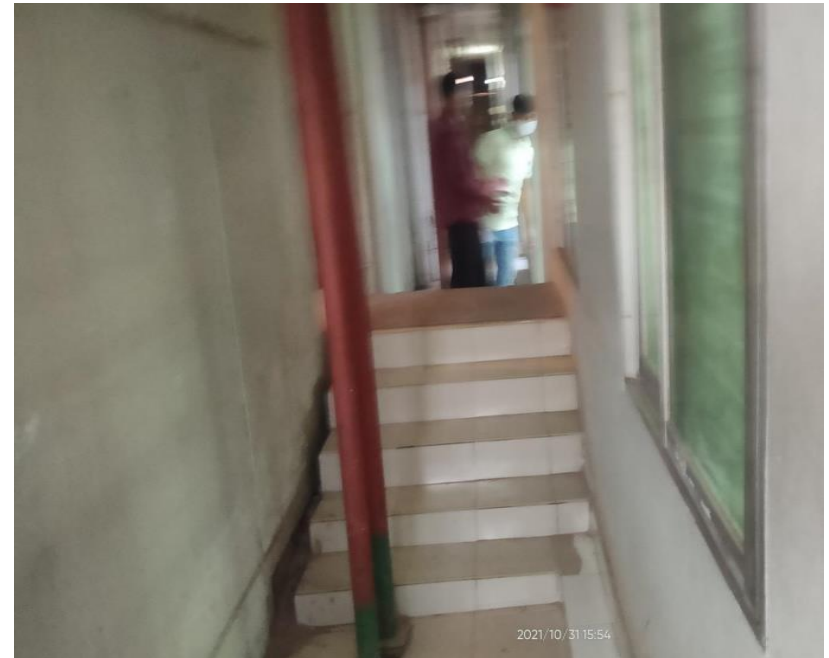
600 mm floor build-up on 1.5 m cantilever slab  
not shown in drawing.

Factory engineer is required to survey the whole structure and update as-built drawings as per actual site condition and check the cantilever slab adequacy.

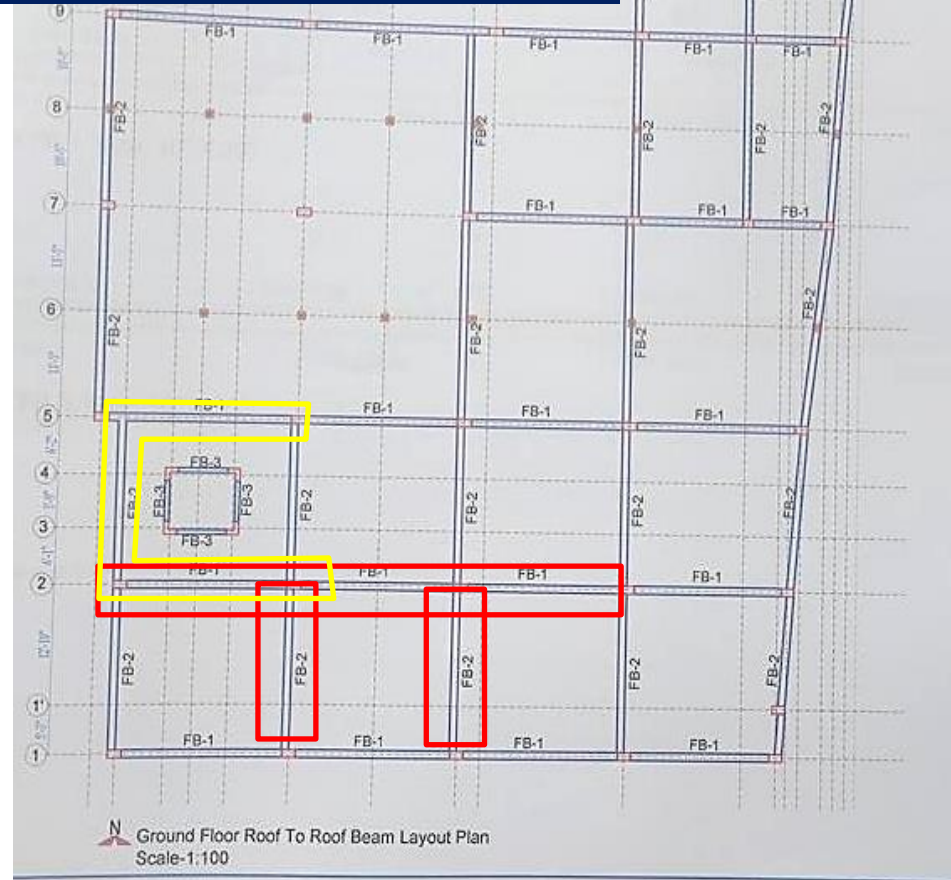
Typical beam layout plan

Floor beam was missing on 1st floor roof (red marked) and stair top room (yellow marked). Also, slab thickness was measured 150 mm instead of 125 mm. The building to survey the structure and update the as-built structural drawings accordingly.

Beam missing on 1st floor roof

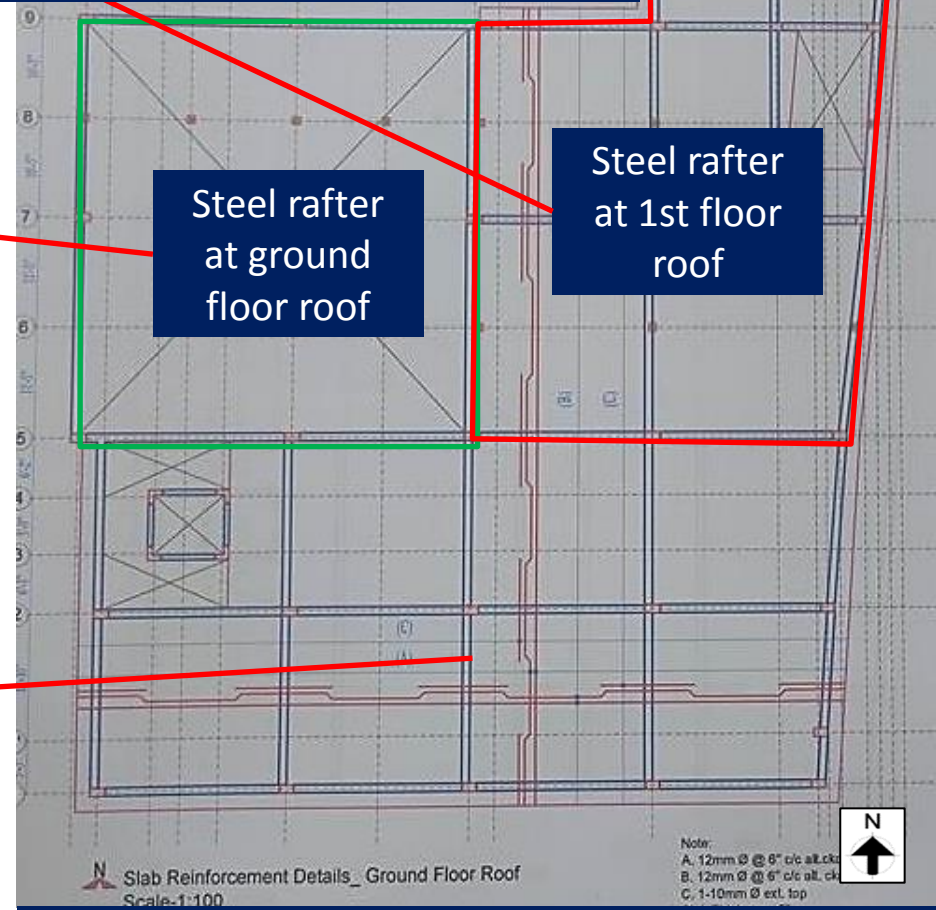
1st floor slab outline and rebar detail

The building is irregular in shape and structural arrangement. There are different structural systems in same floor level. The building engineer to verify the lateral load path and check structural integrity.

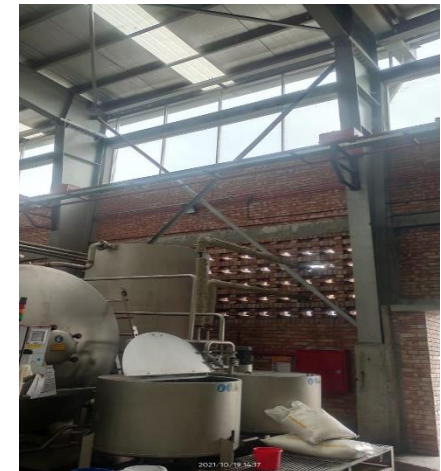
Typical cross-bracing

Half cross-bracing instead full

Vertical bracing location did not matched with as-built drawings. Some bracings found onsite which were not shown in drawing in grid i-H, K-L, A-B any many others locations. Some bracings were missing on-site as per drawings location. Some cross bracings were found in half length of column where full length was shown in drawings. The building engineer to prepare as-built drawings.

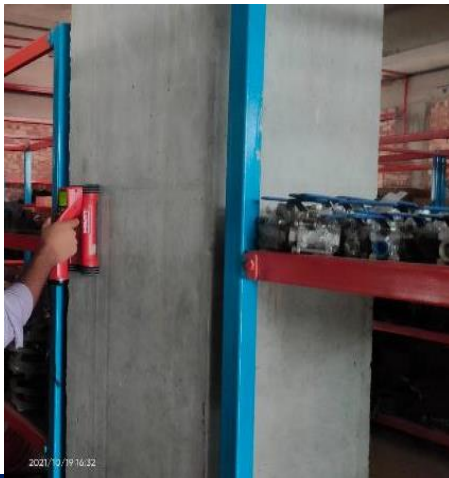
B-9: Ferro scanning

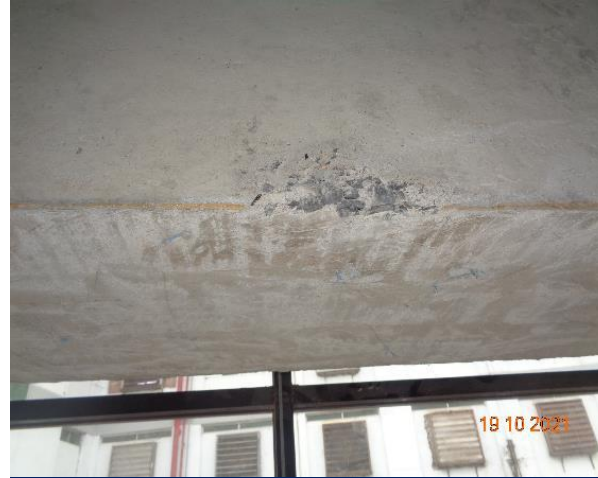
B-9: Stone aggregate on column and floor

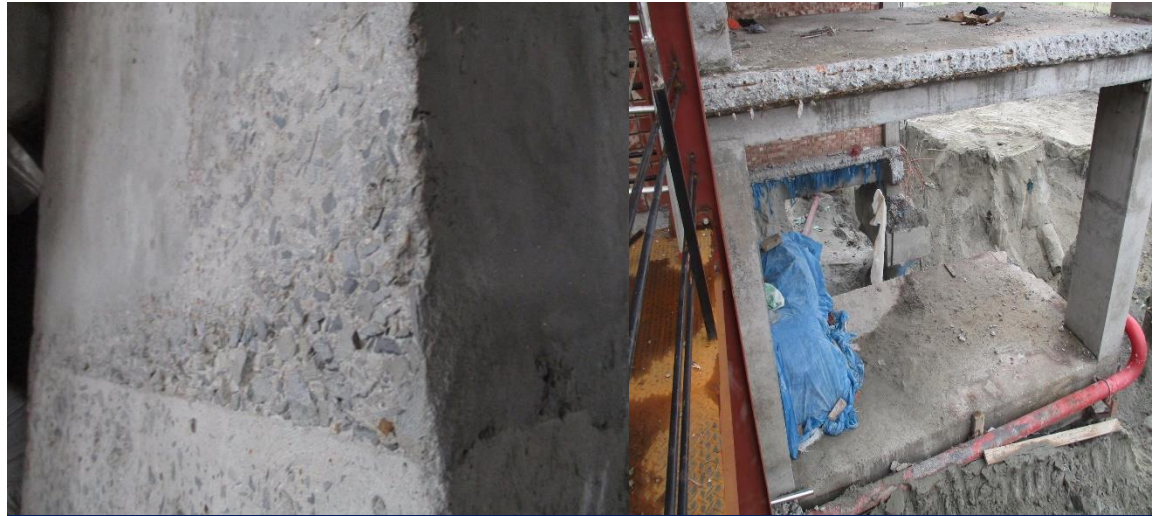
B-14: Stone aggregate on column and slab

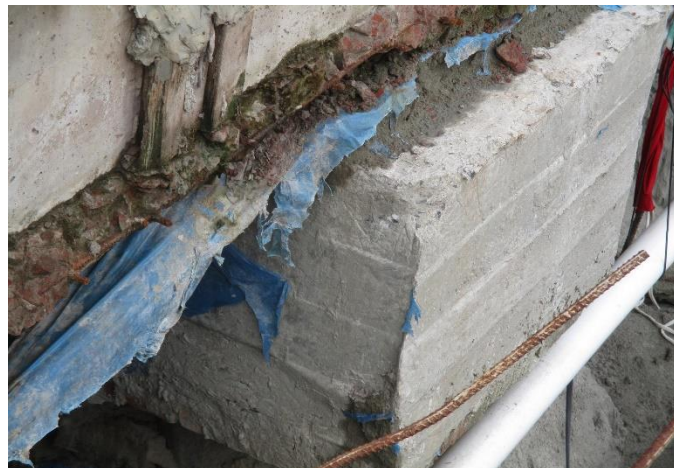
B-11: Stone aggregate on foundation
