Karooni Fashions Ltd.

Ratanpur, Shafipur, Kaliakoir, Gazipur

5 October 2021

1. KFL Building(B+G+7)

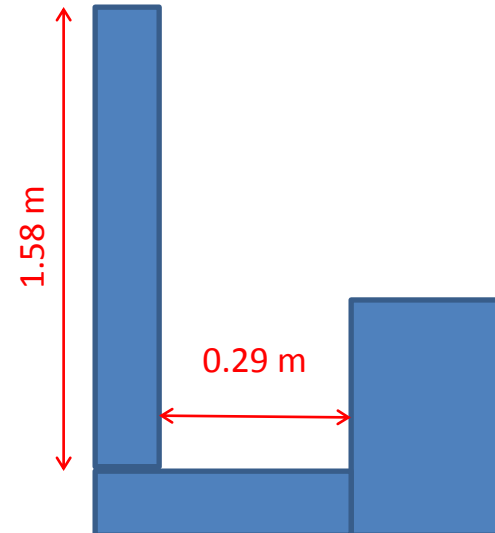
Free standing wall observed on the beam bottom cantilever slab.

The RC parapet wall is resting on the beam bottom cantilever slab. The factory is required to provide parapet wall to the eastern part of the roof. The building engineer is required to check the lateral stability of the parapet walls and check the capacity of below cantilever slabs.
