# KC Lingerie Ltd. (Unit-2)

57/1, Water Works Road, Godnail, Narayangong 1400.

23<sup>th</sup> February 2021

# Building Information

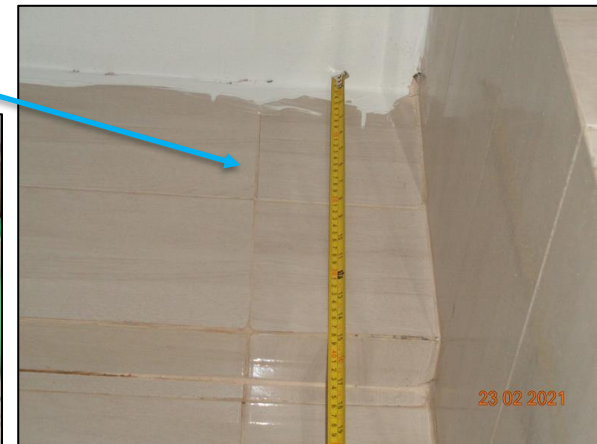
Sectional details of FB-15 and FB-08

The d/s of floor beam FB-15 was found 375 mm instead of 412.5 mm.

Factory engineer is required to survey the whole structure and update the as-built drawing as per on-site condition.
