# Shad Fashion Ltd. (New Building)

Gorat, Ashulia, Savar, Dhaka  
(23.944135, 90.302859)  
22<sup>nd</sup> December 2020.

# Building Information

1. New Building. (G+2)

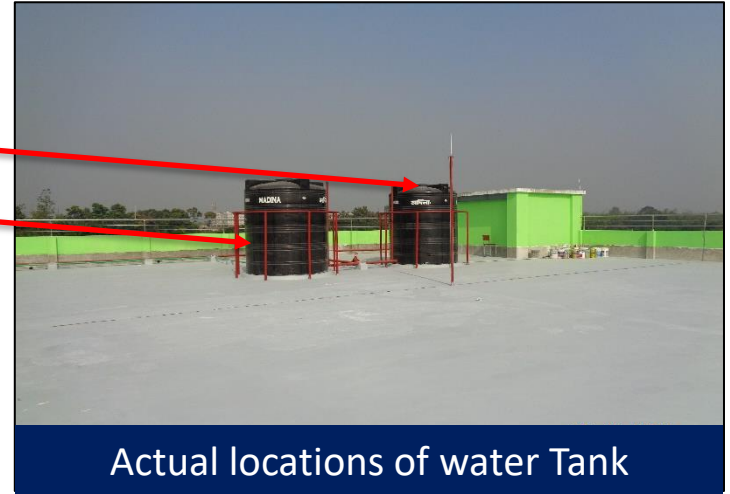
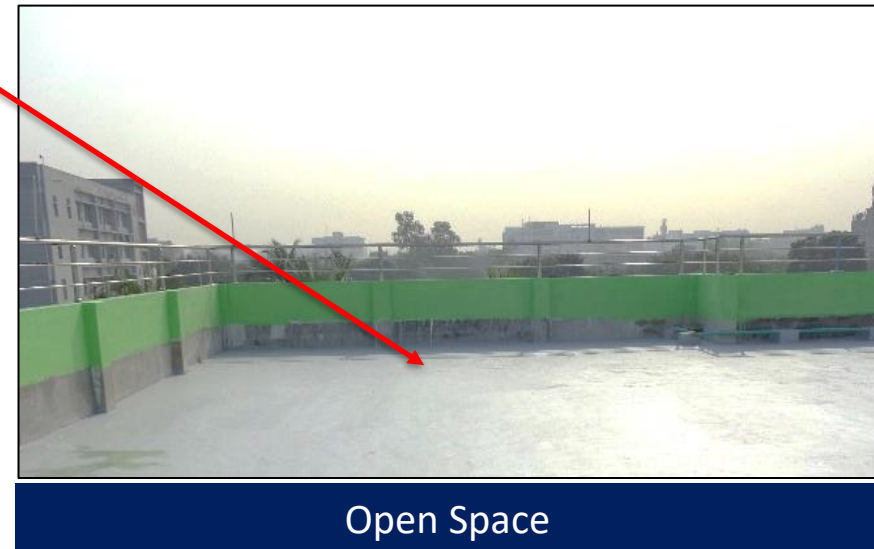
There are 2 water tanks on roof top whose allowable capacity is 4000-liter. But 4 nos. 4000-liter water tanks have been shown in as-built drawing & also water tank position has not matched with as-built drawing. Moreover, 6 nos. of toilets has shown in as-built drawing, but that area is open to sky on site.

Factory engineer is required to survey the hole structures and prepare accurate as built drawings.
