# Ahsan Apparels Ltd.

M S Tower-2, Siddhirgonj, Narayanganj.

25<sup>th</sup> January 2021

# Building Information

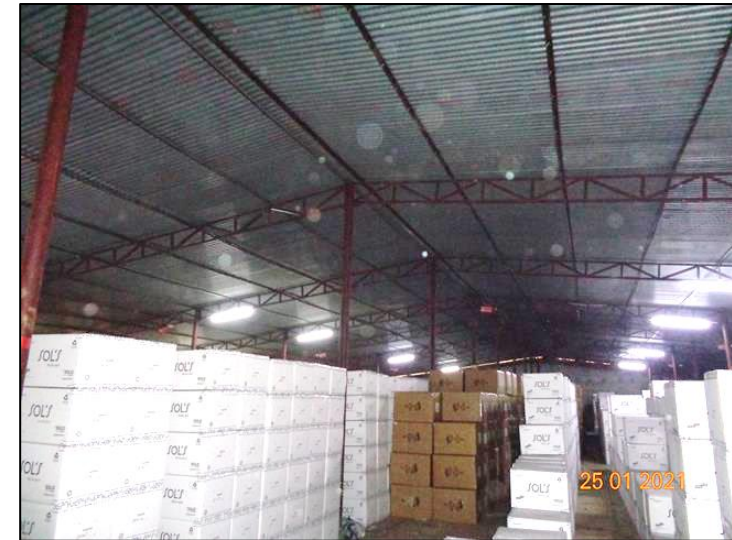
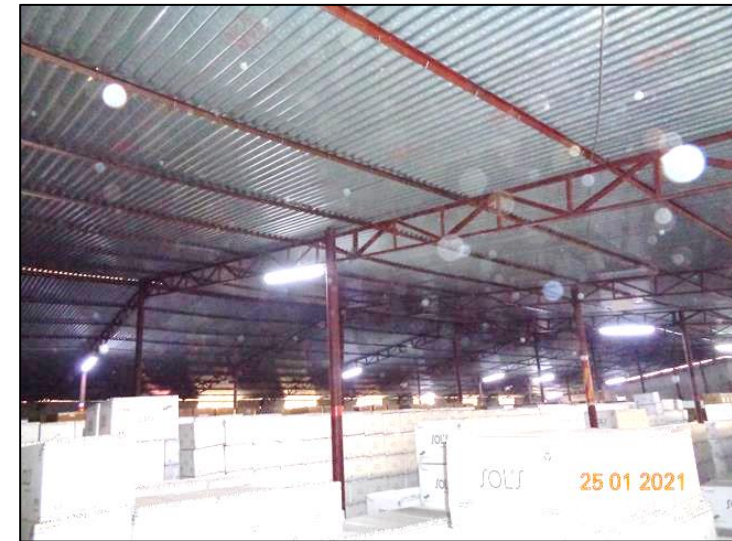
There were no credible as-built drawings and documents to review for the steel shed.

Factory engineer is required to survey the structures and prepare as-built drawings that are in compliance with section 1.9.1.2 as per BNBC.
