Unisense Apparels Ltd (Extension)

Beraider Chala, Sreepur, Gazipur
(24.20003, 90.42065)

26th January 2021

Observations

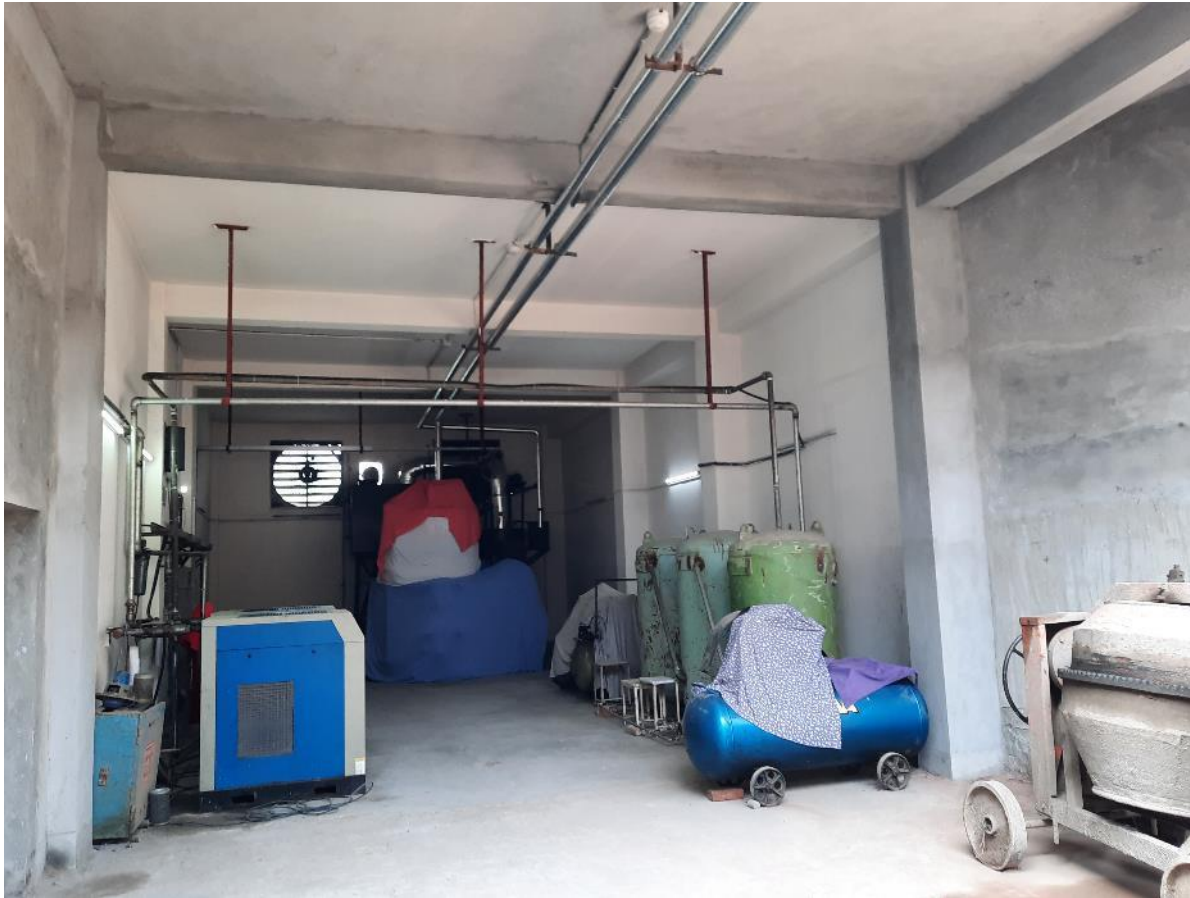
As-built drawings not available onsite

No as-built drawings were available onsite. Building engineer is required to prepare as-built drawings.
