Sultana Sweaters Limited

Ahakhalia, Hazir Bazar, Mollik Bari, Bhaluka, Mymensingh, Bangladesh.

02 & 16 February 2021

Observations

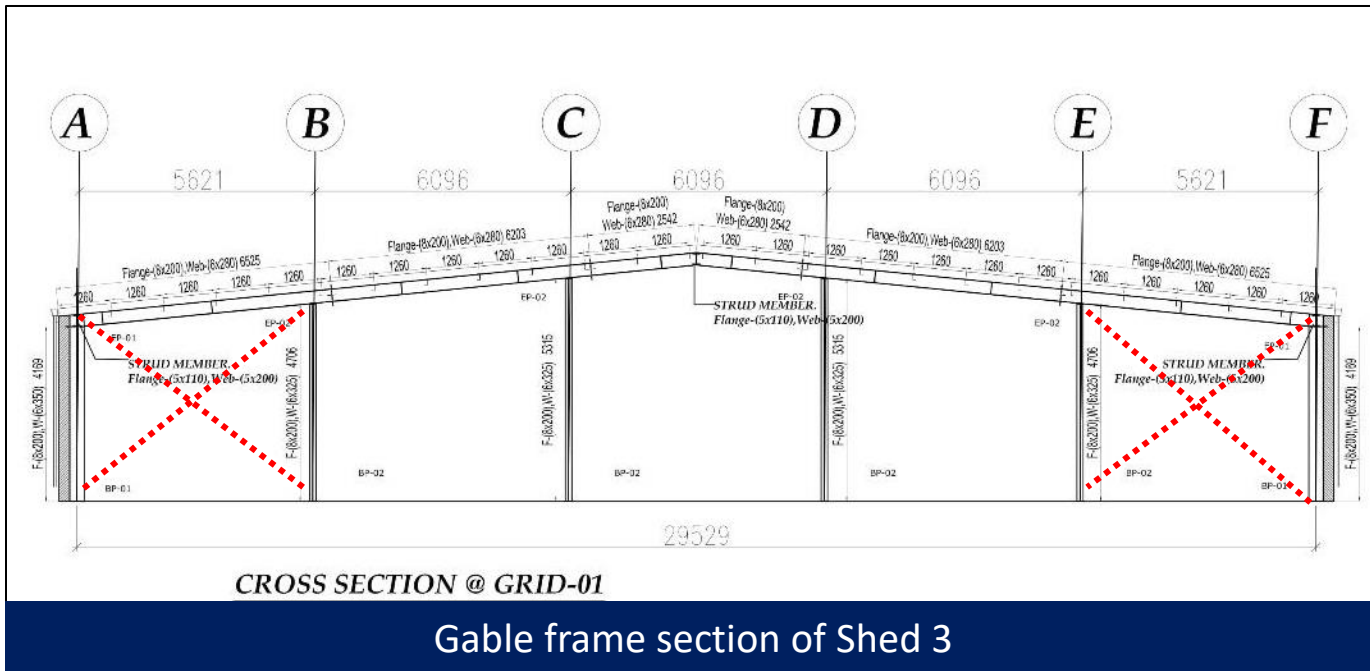
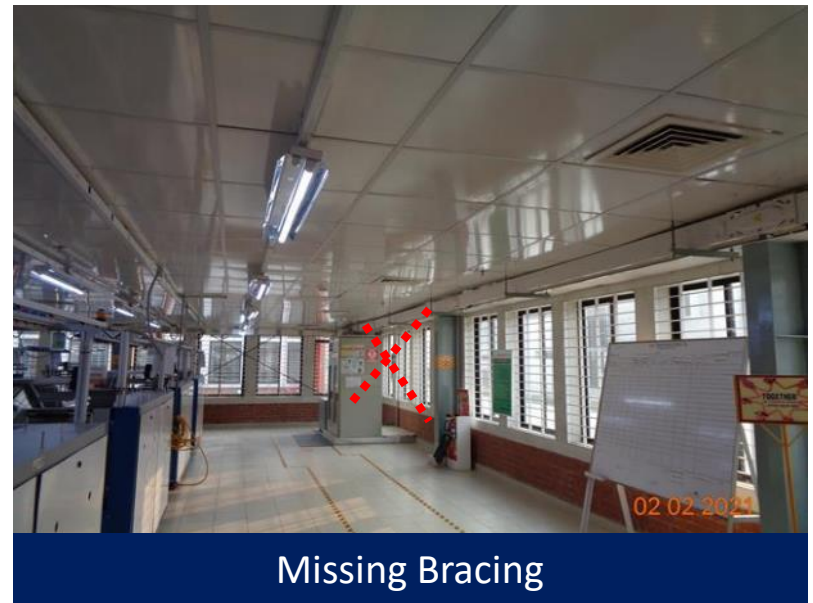
Missing Bracing

| Item No. | Observation | Recommended Action Plan | Recommended Timeline |
|---|--|---|---|
| 05 | Missing bracing at several locations. (Shed 1,3,4, Substation 1 & 2) | Building engineer is required to re-install all the missing bracing as per the design specifications. | 6-weeks |

| Item No. | Observation | Recommended Action Plan | Recommended Timeline |
|---|---|---|---|
| 06 | Missing bracing at several locations. (Shed 1,3,4, Substation 1 & 2) | Building engineer is required to check the lateral stability of the sheds. | 6-weeks |
| 07 | Missing bracing at several locations. (Shed 1,3,4, Substation 1 & 2) | Complete implementation of any remedial works deemed necessary by the Design Report. | 6-months |

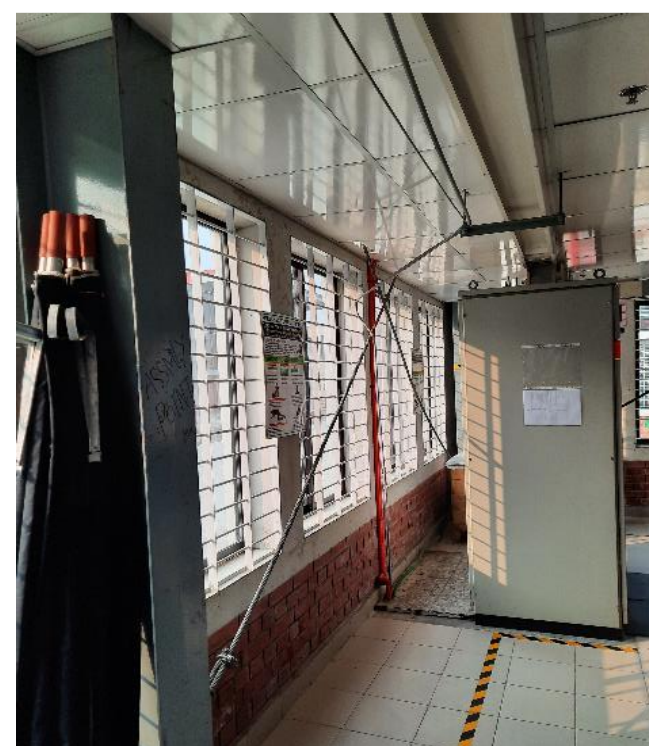
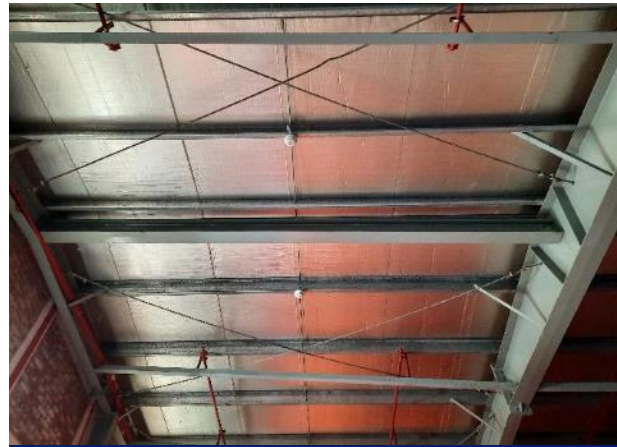
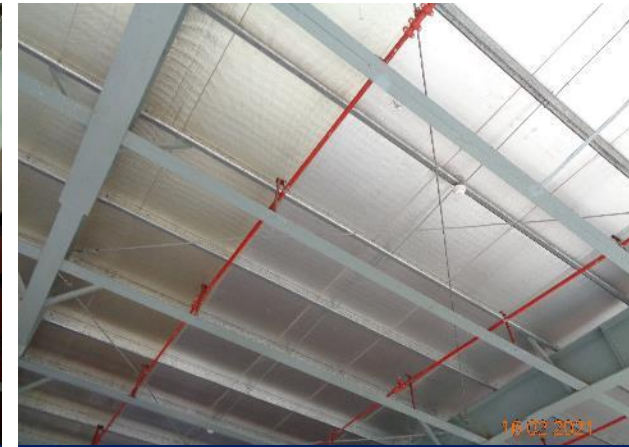
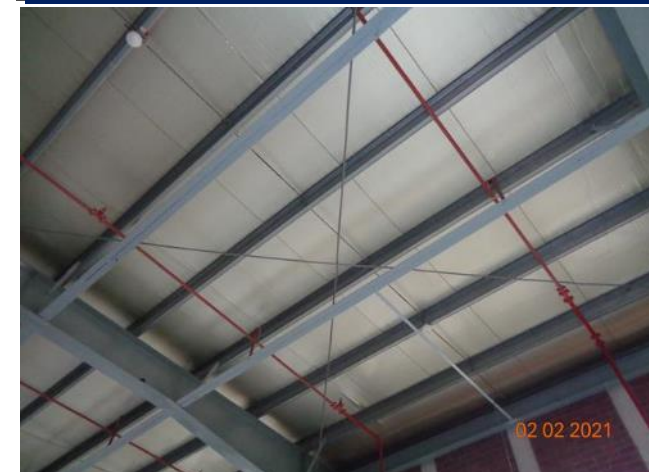
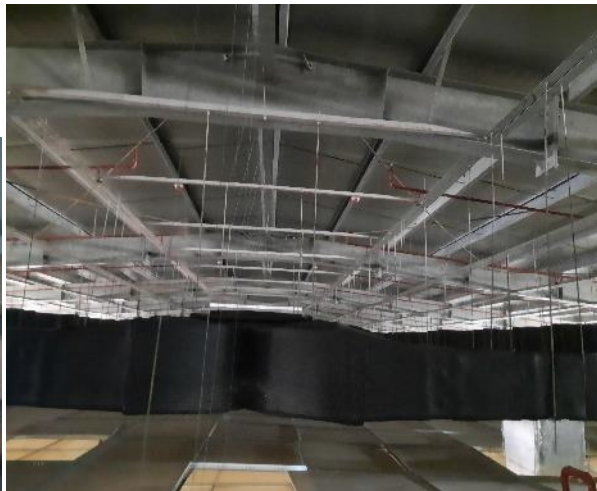
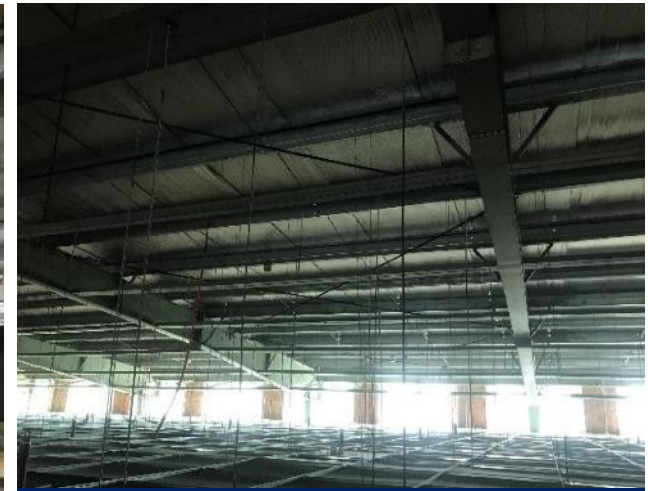
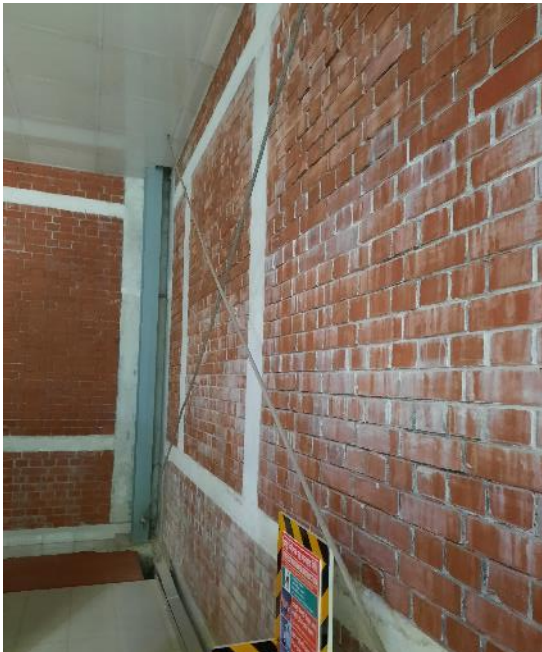
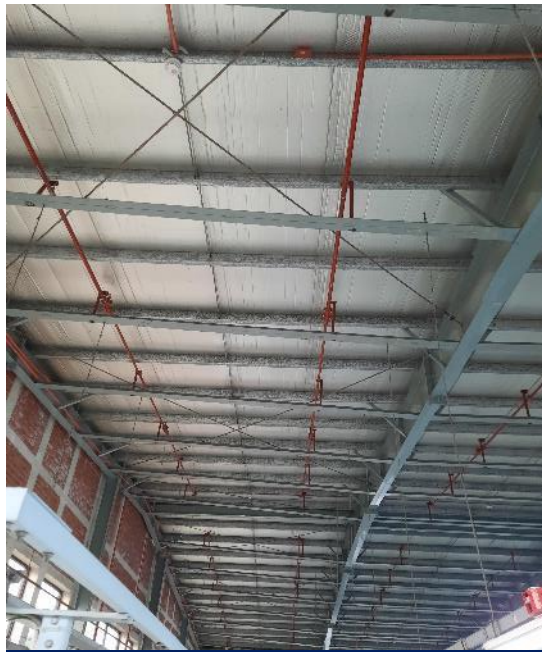
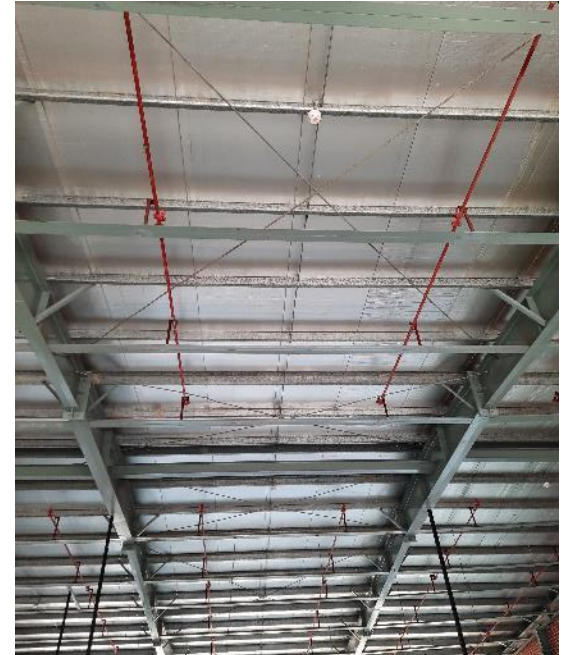
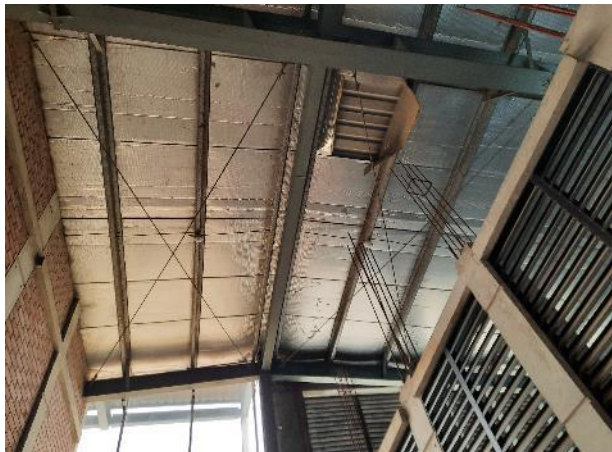
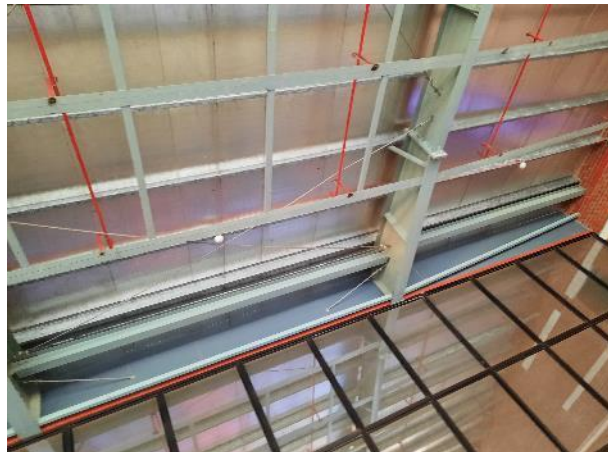
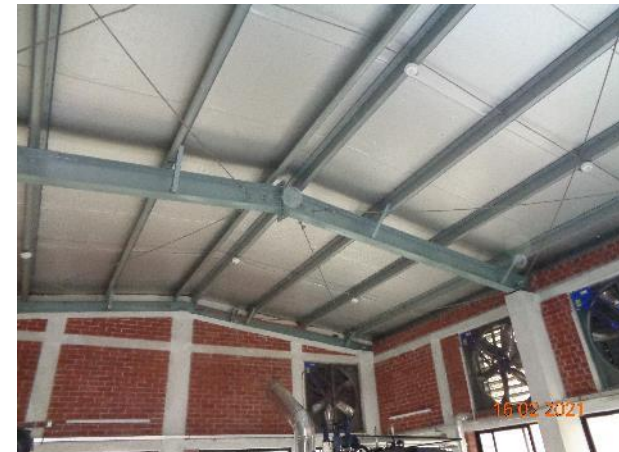
Loose cable bracing

| Item No. | Observation | Recommended Action Plan | Recommended Timeline |
|---|--|---|---|
| 04 | Loose cable bracing. (All Sheds) | Building engineers required to tighten all the loose bracings. | 6-weeks |
