Hamid Tex Fashion Ltd.

203, Habirbari, Seed Store Bazar, Bhaluka, Mymensingh-2240, Bangladesh
(24.339661, 90.375837)

17th June 2021

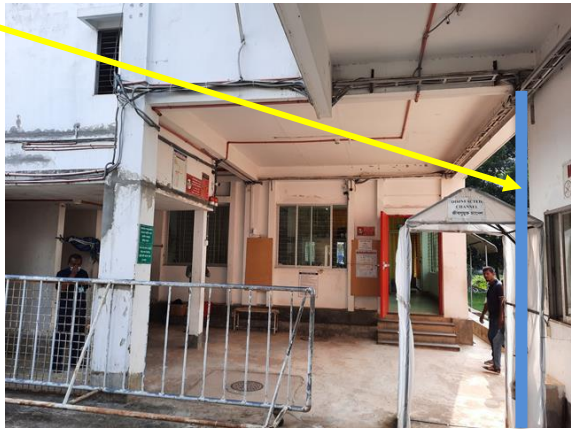
The building is geometrically irregular shaped. Due to lateral forces the building might be affected for torsional irregularity. Building engineer is required to check the torsional effect of the building due to lateral forces.
