# INITIAL FIRE SAFETY INSPECTION REPORT

**Four Design (Pvt.) Ltd**

**RSC ID: 24109**

**Date: 08-Feb-2021**

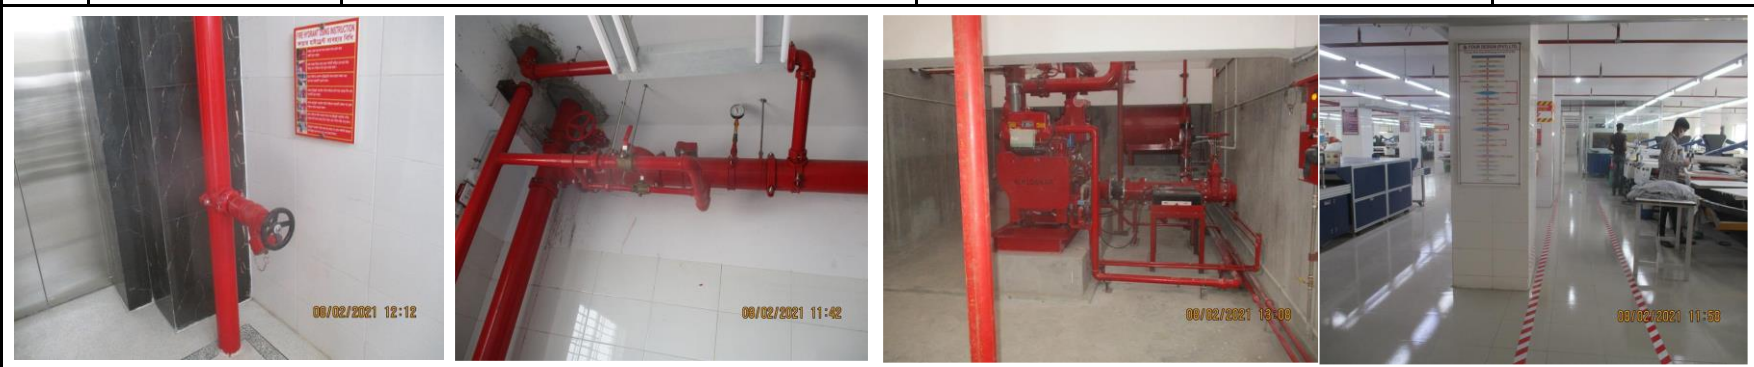
F-16	Fire Protection System(Standpipe)	The Sprinkler and Standpipe System requires detailed review to confirm compliance with NFPA 13, 14 and ACCORD standards. Fire Pump NFPA-20.	Submit design to RSC for review and modify installation if required. Installation of Standpipe system should be in accordance with ACCORD standard and NFPA 14, 20, 22 and 24.	Design within 2 months, Install within 4 months (If modification required)
------	-----------------------------------	---	--	--
