Hamza Clothing Ltd.

Bangabandhu Road, Tongabari, Ashulia

26th August & 7th September 2021

Observations

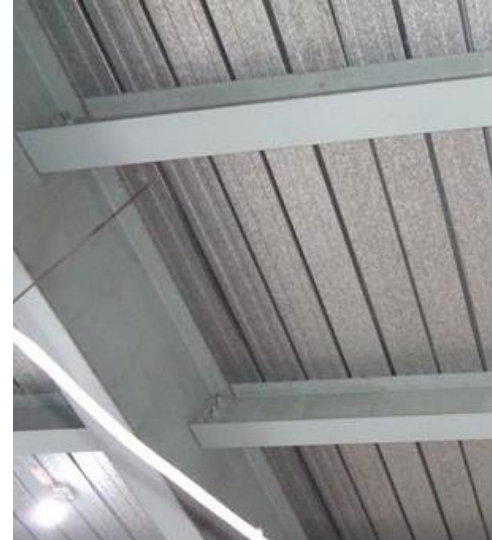
Connection of sub-beam with Main Beam

DEA documents need to be reviewed by RSC

Factory performed DEA and as per recommendation of DEA, factory completed the retrofitting works. In DEA report connection adequacy has not been provided for any type of connection. Factory engineer is required to provide the connection adequacy check for all types of connections in DEA report which is required to be reviewed by RSC.

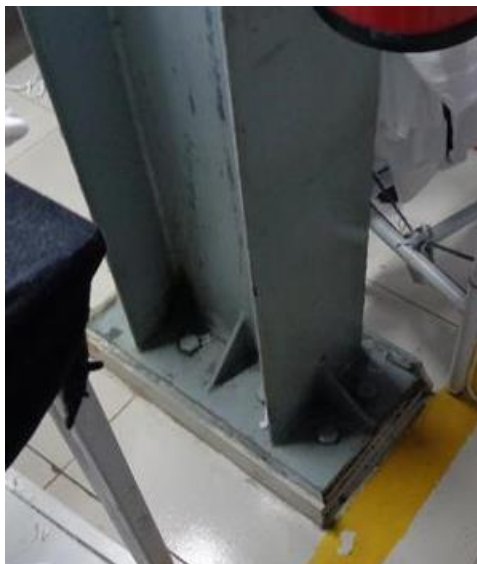
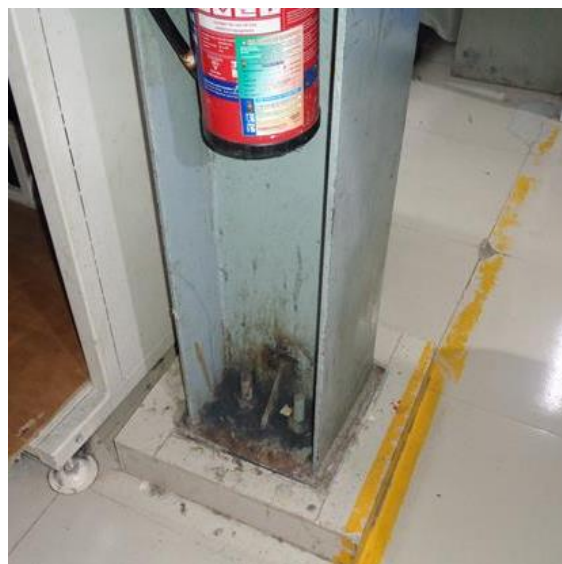
Stair(1-4) column Schedule

Least dimension of the column for stair (1-4) was found 250mm and for the stair-5 was found 300mm

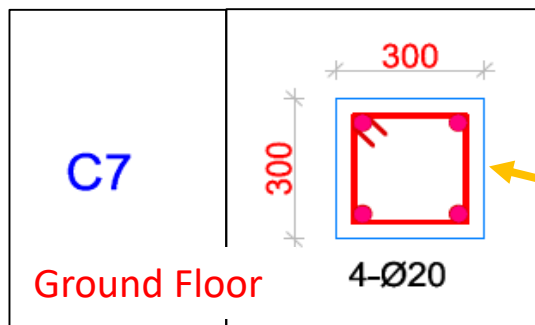
Ground Floor

Column schedule for the C7 column near stair-5

Ground floor column for the stair (1-4) was found 4.45 m (least one) in unsupported length and least dimension 250 mm in size. And the ground floor column for the near stair-5 was found 4.67 (unsupported length) and dimension 300mm. The unsupported length/width=17.52 for stair (1-4) and unsupported length/width=15.67 for the stair-5 indicate that the columns are critical for slenderness effect. So, the factory engineer is required to check and address this issue in the DEA report.

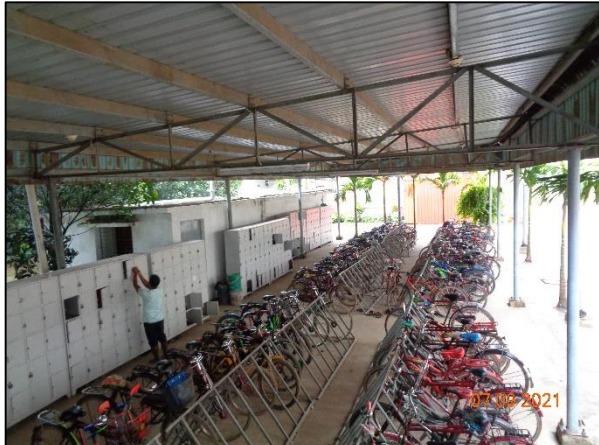
Truss roof System

Lack of lateral stability

The steel roof truss is supported by steel pipe column. No vertical & roof bracing was found. As a result, there is no apparent load path to transfer the lateral loading along the long direction. Building Engineer is required to check the lateral stability of the steel shed and check the adequacy of the connection.
