# Executive Greentex Limited

Mulaid Telihati Gilarchala, Sreepur, Gazipur.

9<sup>th</sup> and 23<sup>rd</sup> February 2021

# Observations

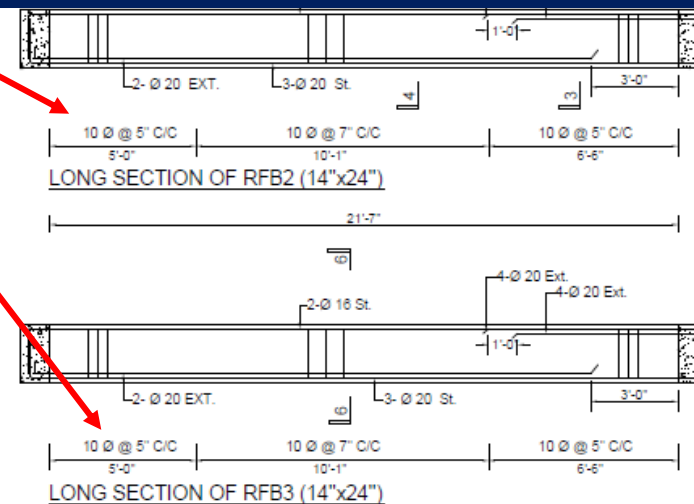
Roof beam layout

Dimension of same beam is shown differently in beam layout and beam section. For example, width of RFB-2 shown in layout but in section dimension shown for the same beam as 350mm. However, dimension of all beams was found as per section of the beam. Factory engineer is required to survey the whole structure and update the as-built drawing as per on-site condition in accordance with section 1.9.1.2 (BNBC Part-6).
