# Bangla Poshak Ltd.

Sikder Complex, Chaidana, National University, Gazipur, Bangladesh  
(23.961573, 90.380068)

29 March 2014

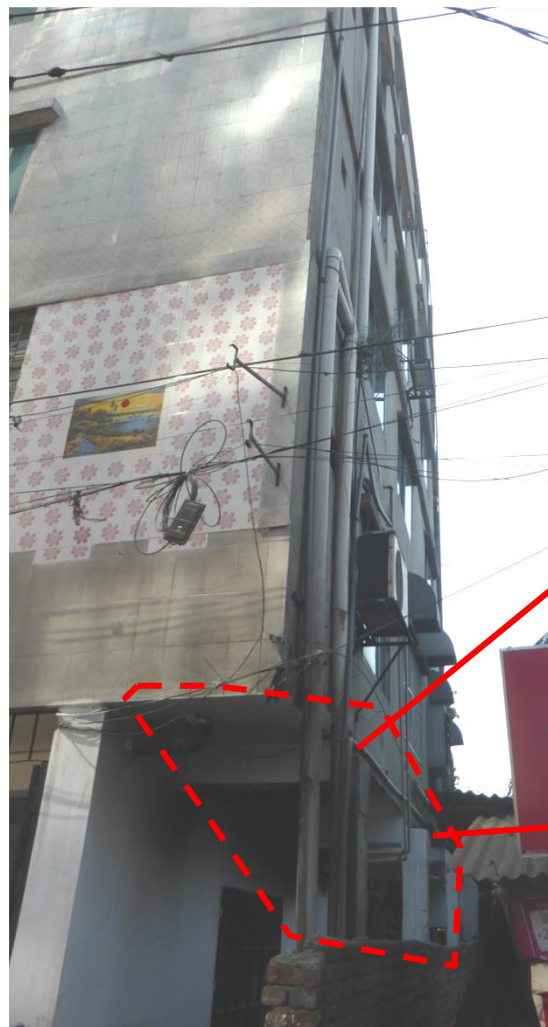
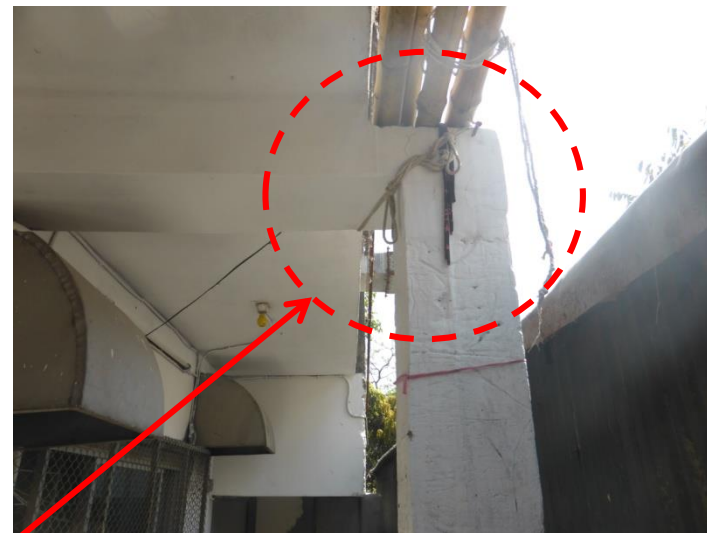
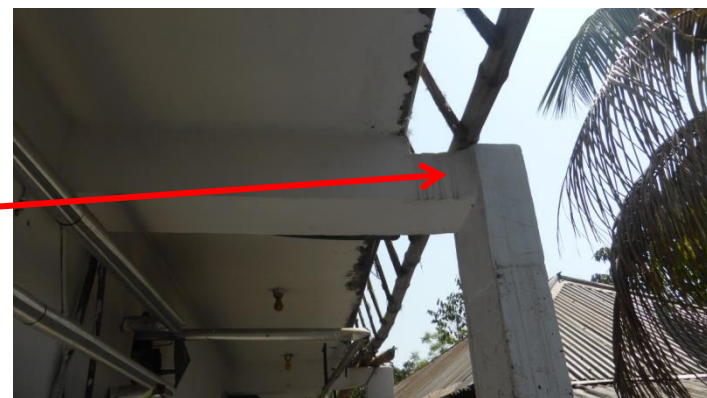
West slab cantilever.

On west facade it is unclear at ground level whether the edge is a cantilever or whether supported off an additional line of columns. Design review required.
