# Epoch Garments Ltd

Dholadia, Bhawal Rajabari-1742, Sreepur, Gazipur, Bangladesh

22 December 2019

# Observations

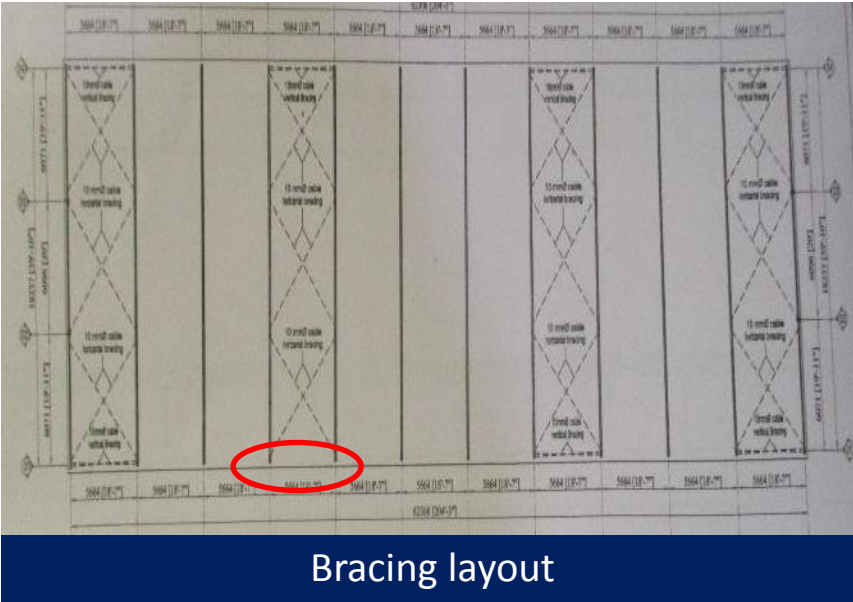
Bracing layout

## Missing bracing at sewing shed

Wall bracing was found missing at one location.

| Item No. | Observation | Recommended Action Plan | Recommended Timeline |
|---|---|---|---|
| 03 | Missing bracing at sewing shed. (Sewing shed) | Install the missing bracing. | (within 6-weeks) |
