# Fakhruddin Textiles Mills Limited (Extension Area)

Ghargharia, Master Bari, Kewa, Sreepur, Gazipur  
(24.191469, 90.435220)

25 February & 11 August 2021

# Observations

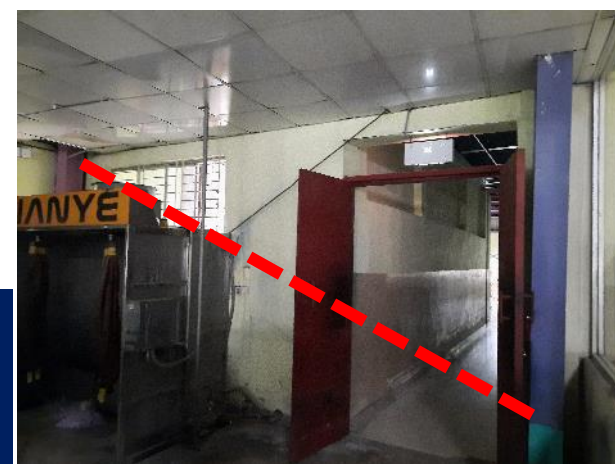
Column & Bracing Layout plan

# **Vertical bracing missing in several location**

Vertical bracing found missing in several location.  
Building engineer is required to check the lateral stability  
of the building.

| Item No. | Observation | Recommended Action Plan | Recommended Timeline |
|---|---|---|---|
| 20 | Vertical bracing missing in several location. (Shed 16- Garments Dyeing & Seamless Shed) | Building engineer is required to re-install all the missing bracing as per the design specifications. | 6-weeks |
| 21 | Vertical bracing missing in several location. (Shed 16- Garments Dyeing & Seamless Shed) | Building engineer is required to check the lateral stability of the shed. | 6-weeks |
| 22 | Vertical bracing missing in several location. (Shed 16- Garments Dyeing & Seamless Shed) | Complete implementation of any remedial works deemed necessary by the Design Report. | 6-months |
