# **M.I.T Apparel (Extension new 5 storied building)**

Pathantuly, Godnail, Siddirganj, Narayanganj.

9<sup>th</sup> June 2021

1. **Extension new 5 storied building** (five storied (G+4) reinforced concrete structure)

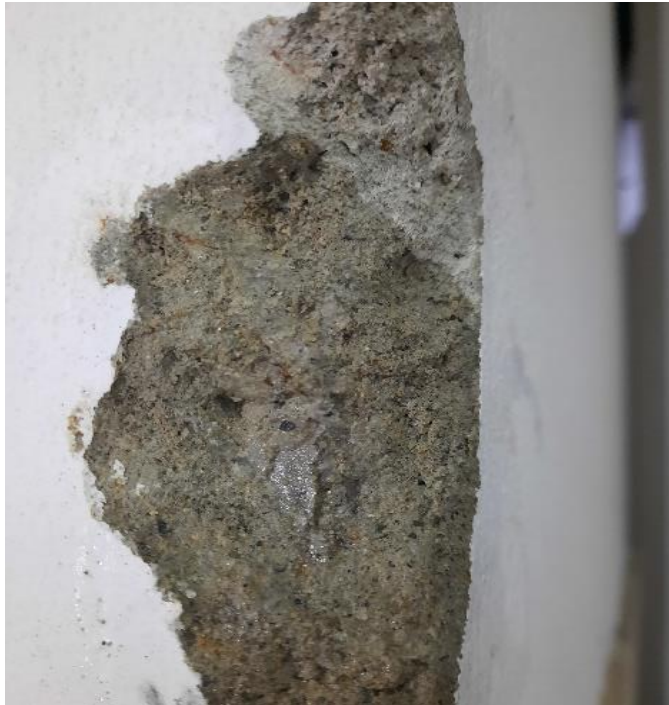
Stone Chips

| Sl. No. | Location | Sample Identification Mark | Length of Sample | | Diameter of Sample | | Average Cross Sectional Area | Ultimate Load | Crushing Strength | Type of Failure |
|---|---|---|---|---|---|---|---|---|---|---|
| 1 | Ground Floor Column, Grid-K-16 | TP-G-GF | 5.3 | 2.60 | 5.31 | 23,995 | 4520 psi (31.2 MPa) | Combined * (Stone Chips) | | |
| 2 | Ground Floor Column, Grid-K-14 | TP-2G-GF | 5.3 | 2.60 | 5.31 | 22,422 | 4290 psi (29.7 MPa) | Combined * (Stone Chips) | | |
| 3 | Ground Floor Column, Grid-M-7 | TP-3G-GF | 4.9 | 2.60 | 5.31 | 21,972 | 4140 psi (28.6 MPa) | Combined * (Stone Chips) | | |
| 4 | 3rd Floor Column, Grid-K-16 | TP-4C-3F | 5.3 | 2.60 | 5.31 | 15,778 | 2760 psi (19.2 MPa) | Combined * (Stone Chips) | | |
| 5 | 3rd Floor Column, Grid-K-14 | TP-5C-3F | 5.3 | 2.60 | 5.31 | 12,580 | 2440 psi (16.8 MPa) | Combined * (Stone Chips) | | |
| 6 | 3rd Floor Column, Grid-M-7 | TP-6C-3F | 5.3 | 2.60 | 5.31 | 10,801 | 2160 psi (15.0 MPa) | Combined * (Stone Chips) | | |

**NOTE 3** — Among the supplied samples Core No. 5 & 6 found to contain piece of reinforcement on the peripheral surface of the cores.

**COMMENT** — Please compare the results with your corresponding design values and consult with your design engineer.
