# Jinnat Knitwears Limited (Sreepur) (Extension)

Dhanua, Sreepur, Gazipur-1740.

08 January 2023

# Observations

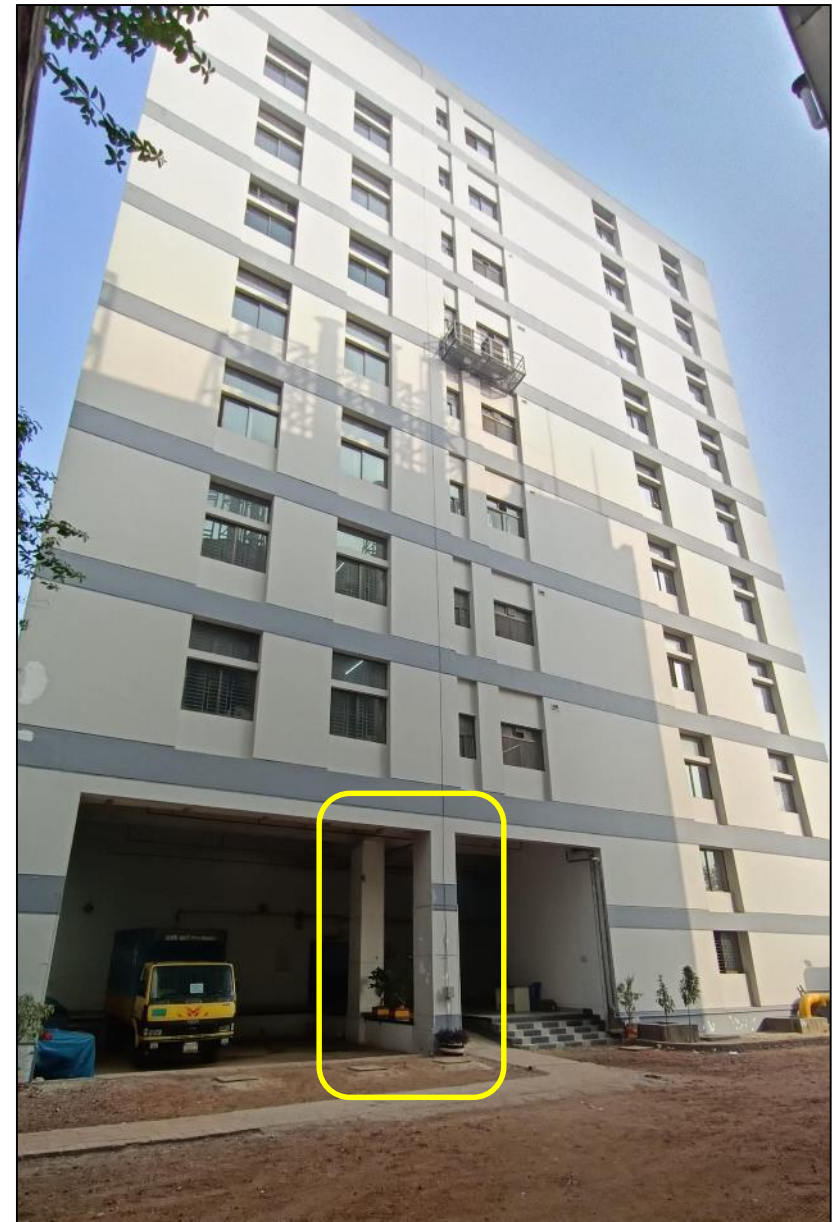
Columns on loading/unloading areas are susceptible to vehicle impact. The factory engineer is required to take necessary action to prevent the vehicle impact in the columns.
