Well Lord Knitwears Ltd.

## Preliminary Factory Safety Inspection

### Electrical Safety Assessment Report for Well Lord Knitwears Factory

Issue | May 9, 2018

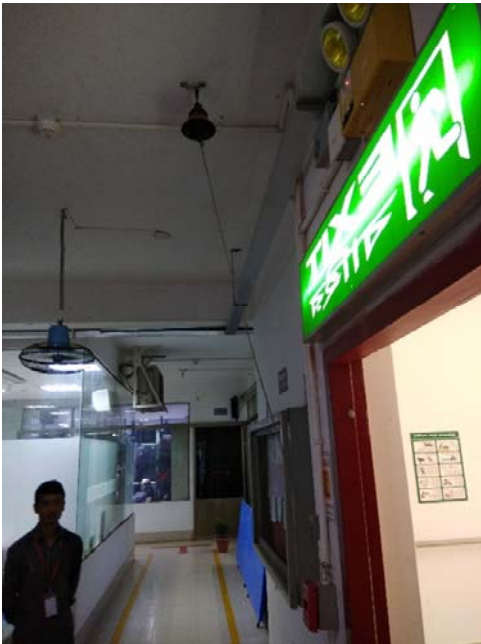
| <b>Fire Alarm</b> | <p>Alarm sounders are located over all floors</p> <p>Alarm system is activated automatically by smoke detectors, and activated manually by MCPs at exit doors in all areas.</p> <p>Fire Alarm Panel backed by in built batteries (90 mins. backup time as informed by maintenance staff) is located in fire control room in a separate ground structure in front of main production building.</p> <p>The fire alarm of Well Lord Knitwear is integrated with adjacent factory name Arabi Fashion fire alarm panel. The generators which provides power backup to fire alarm panels had manual starting.</p> <p>In addition to automatic fire alarm notification, a manual metal bell is provided at exit door. The following figure shows the manual bell arrangement.</p> <p>Figure 4 Manual bell point</p> |
