# **FIRE SAFETY INSPECTION REPORT**

**SAYEM FASHIONS LTD**  
**KAMARJURI, NATIONAL UNIVERSITY**

**ACCORD**  
on Fire and Building Safety in Bangladesh

August 24, 2014

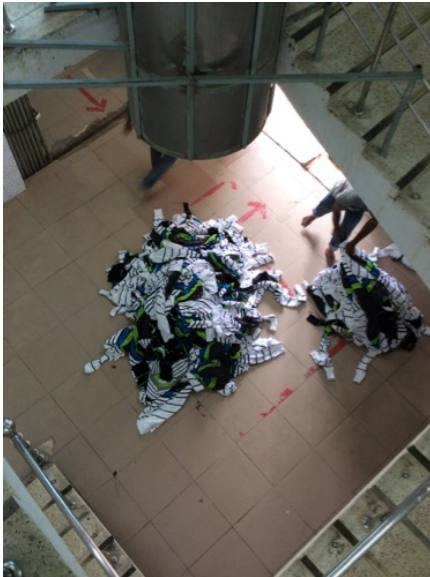
| F-14 | Egress | Building 1/2 | Remove all storage from all exit stairs and egress paths. | Immediate |
| <p>Storage was located in all exit stairs. Specifically, there was storage on all floors, in each exit stair of Building 1 (trash bins). The southwest exit stair of Building 1 (also shared with Building 2) had water sinks by floor, at the main floor landings and a garment chute from the fifth to ground floor. The southeast exit stair of Building 1 had packaged box storage on the ground floor. The Building 2 exterior exit stair had storage (garment bags) at the fourth floor landing.</p> | | | | |
