Shipra Fashion Ltd.

20 March 2023

Observations

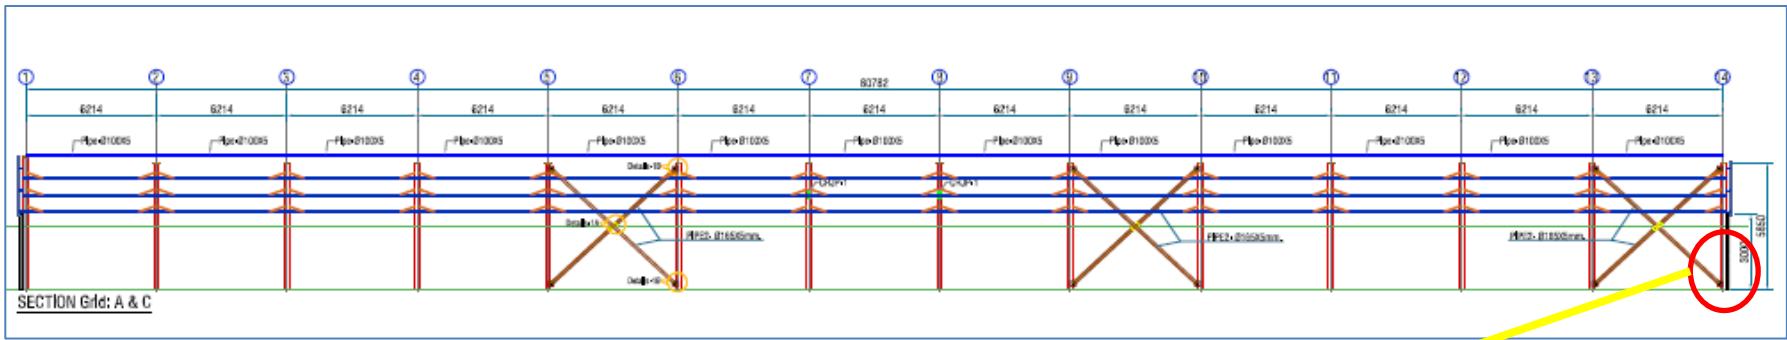
Bolt placed out gusset plate

2 out bolts are not connected with gusset plate and Long slotted holes in the connection

2 out of 4 bolts are not connected with gusset plate. Rest of 2 bolts are connected with large slotted holes which is placed along the line of action of forces. The connection may not functional due to lack of active bolts and loose connections. However, the building engineer is required check the connection type, code requirements for long slotted holes & connection design method and suggest suitable repair action accordingly.
