# Textil Fashions Ltd. (Extension)

Holding No-6/1, Plot No-168, Choydana, National University, Gazipur.

29 March 2023

# Building Information

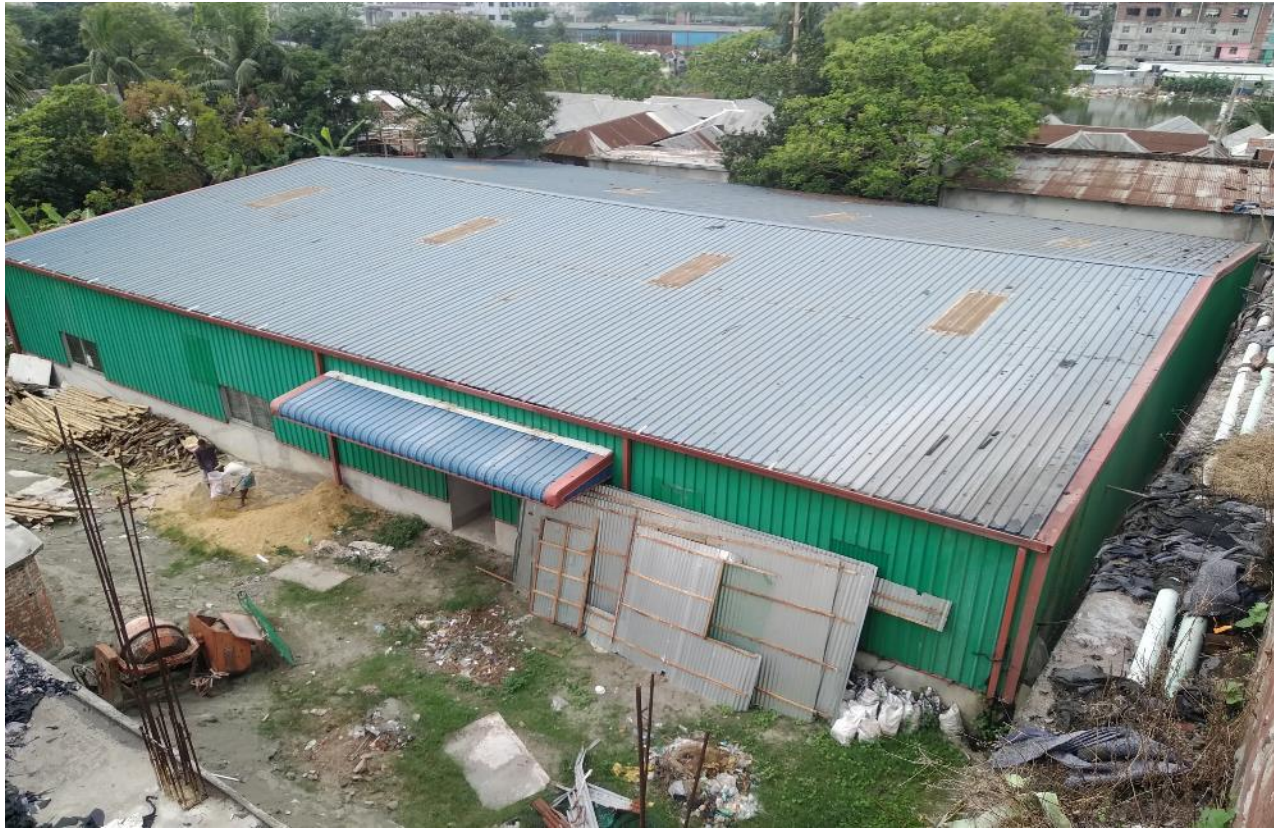
Warehouse Shed

**Missing approval drawing from local authority**

At the time of inspection, no approval drawing from local authority was available. Factory is required to seek approval from the local authority for the structure.

Item 02: Missing approval drawing from local authority
