Union Label & Accessories Ltd.

Baniarchala, Bhabanipur, Gazipur Sadar, Gazipur.

10 April 2023, 14 May 2023 & 06 June 2023

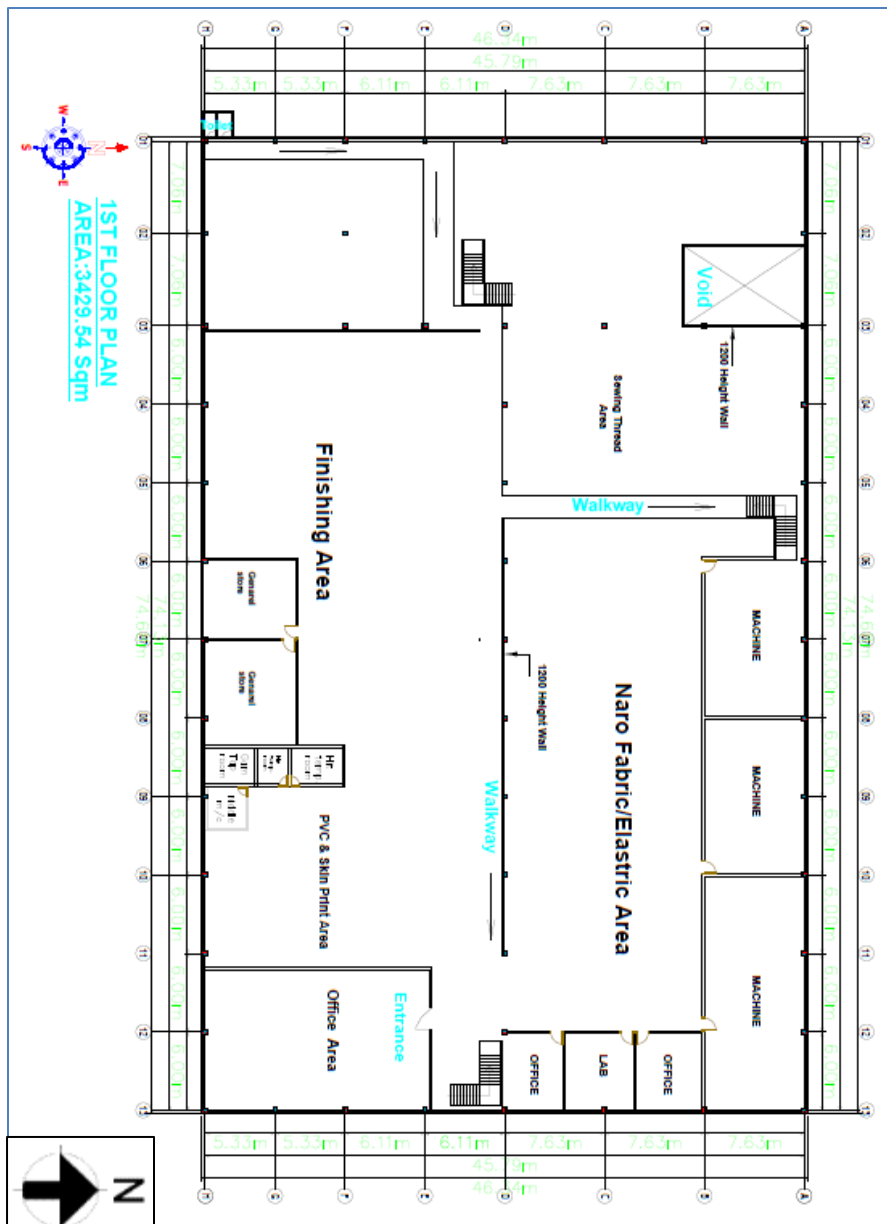
Floor Plan

Vibration observed at the first floor

During inspection, significant vibration was observed at the first floor of the Main Shed due to the spinning machine's operation. Building engineer is required to measure the vibration and to investigate whether the vibration is impacting the structure or not and to take proper measure accordingly.

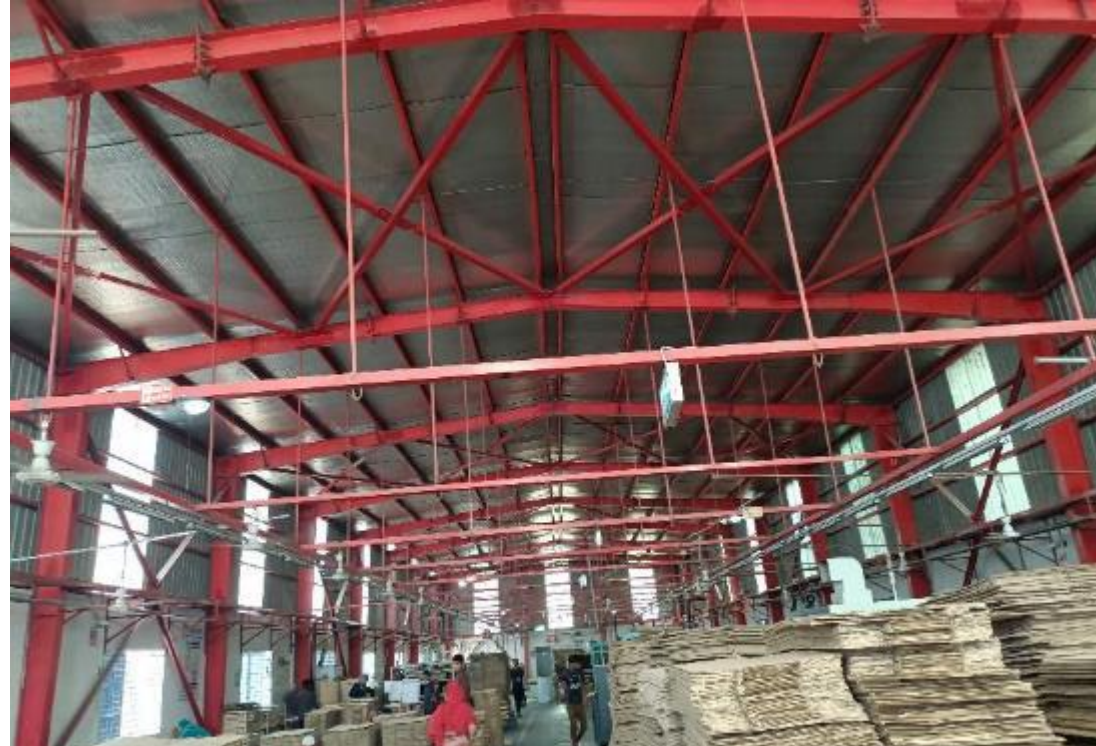
Manual Carton Shed

Moreover, in the provided design report material specification (no test report steel plate), details calculation of wind and other input values are not mentioned. Before submitting the EA, the factory is required to incorporate the all the issues in revised EA.

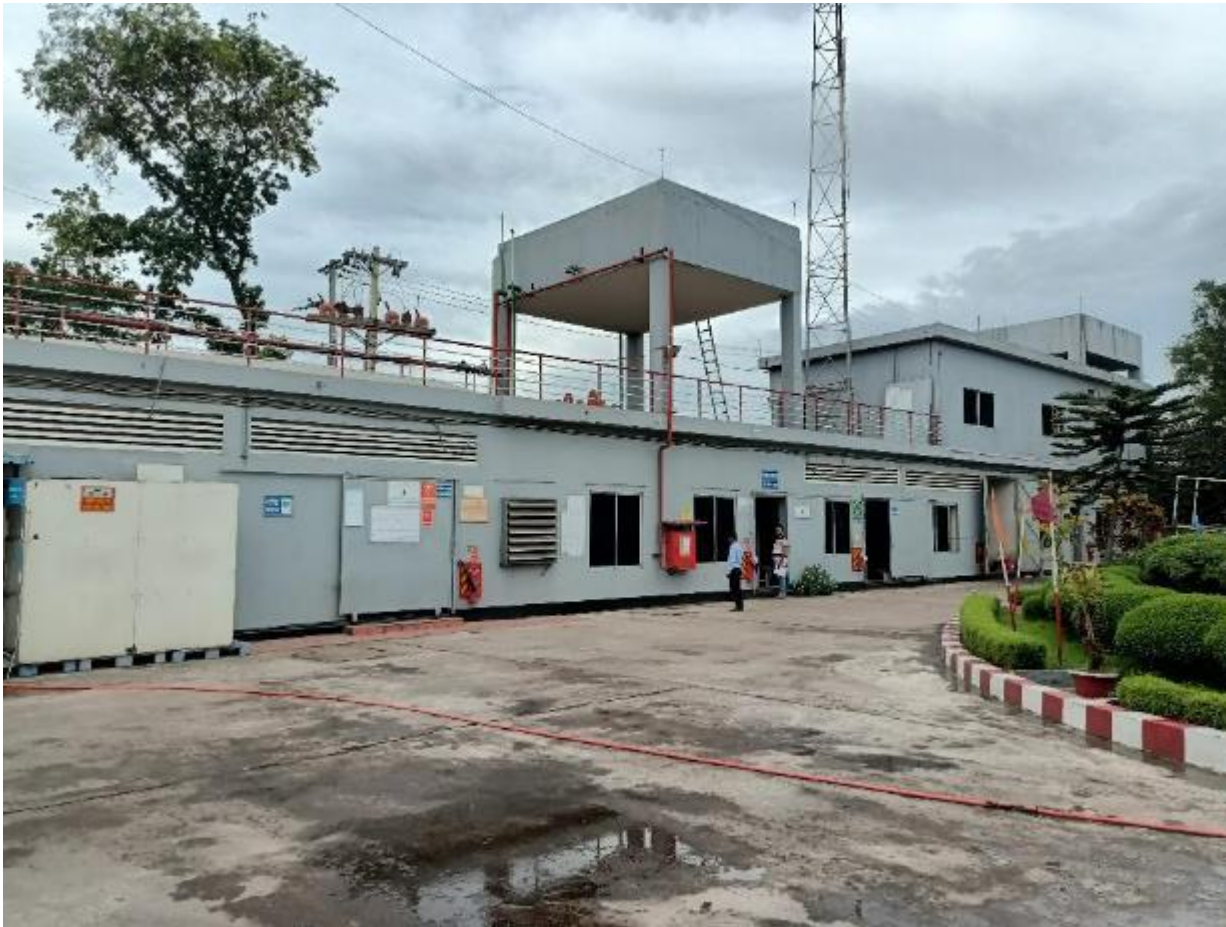
As per BNBC, every building or structure designed shall have its design documents prepared in accordance with the provision of Section 1.9.1. The design document shall include a design report, and a set of structural drawings, which shall be prepared in compliance with section 1.9.1.1 and section 1.9.1.2, part-6 of BNBC. At the time of inspection, only as-built drawings were available, but no design report was available which are required to be prepared in compliance with section 1.9.1.1 (part-6, BNBC).

No design report was available for Utility Building

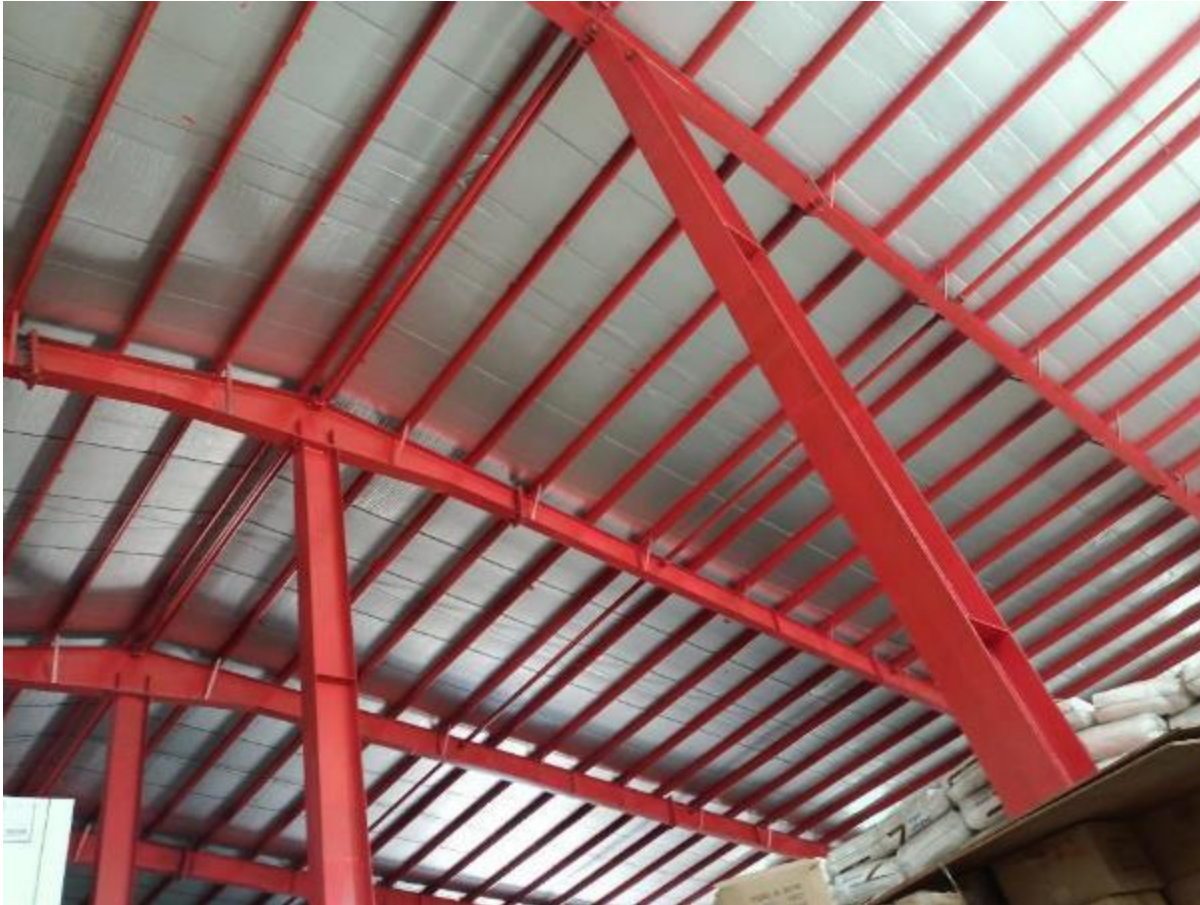
As per BNBC, every building or structure designed shall have its design documents prepared in accordance with the provision of Section 1.9.1. The design document shall include a design report, and a set of structural drawings, which shall be prepared in compliance with section 1.9.1.1 and section 1.9.1.2, part-6 of BNBC. At the time of inspection, only as-built drawings were available, but no design report was available which are required to be prepared in compliance with section 1.9.1.1 (part-6, BNBC).

No design report was available for Bonded Warehouse 3

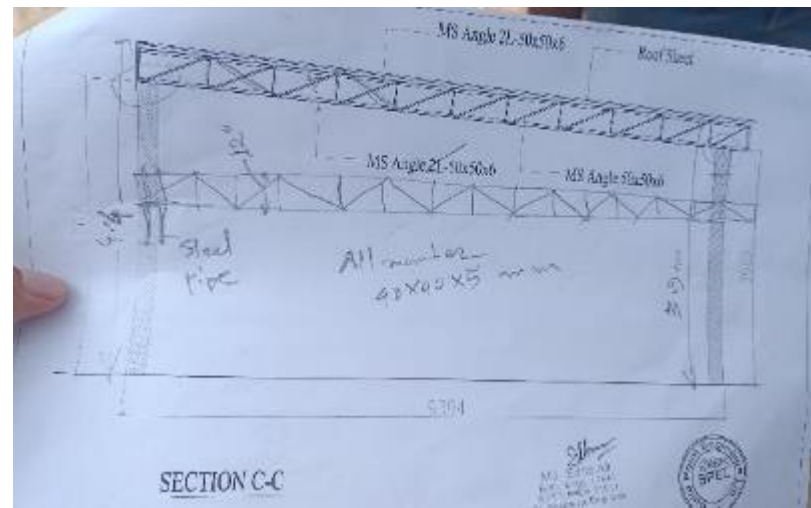
Provided sectional details

Type of truss, member details and support conditions were not matched with as-built condition. The factory engineer is required to survey the whole structure and prepare full set of as-built drawing in compliance in compliance with section 1.9.1.2, part-6 of BNBC.

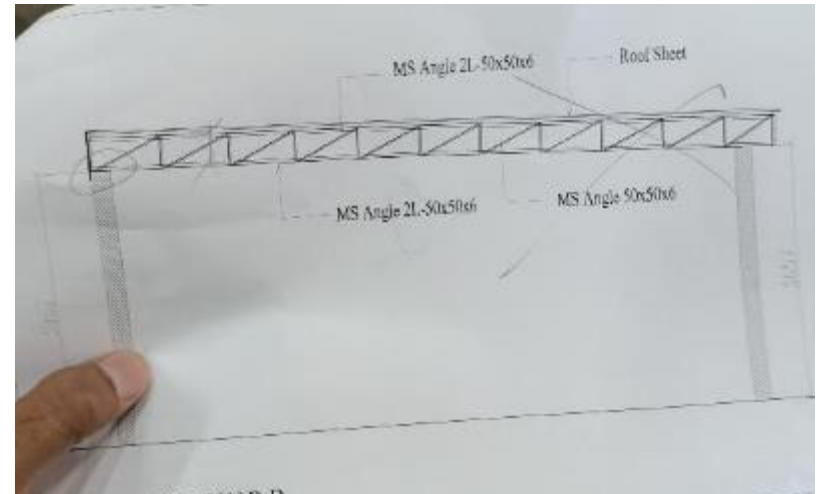
Provided sectional details

Proper as-built drawing was not available for the Poly Recycle Room. Only a section and elevation was provided for the shed but not matched with the onsite condition.

The building engineer is required to survey the whole structure and prepare full set of as-built drawing in compliance in compliance with section 1.9.1.2, part-6 of BNBC.
