# AKH ECO APPARELS LTD.

495-Balithia, Shah-Belishwer, Dhamrai, Dhaka  
(23.9166 N, 90.1136 E)  
18<sup>th</sup> October 2015

# Observations

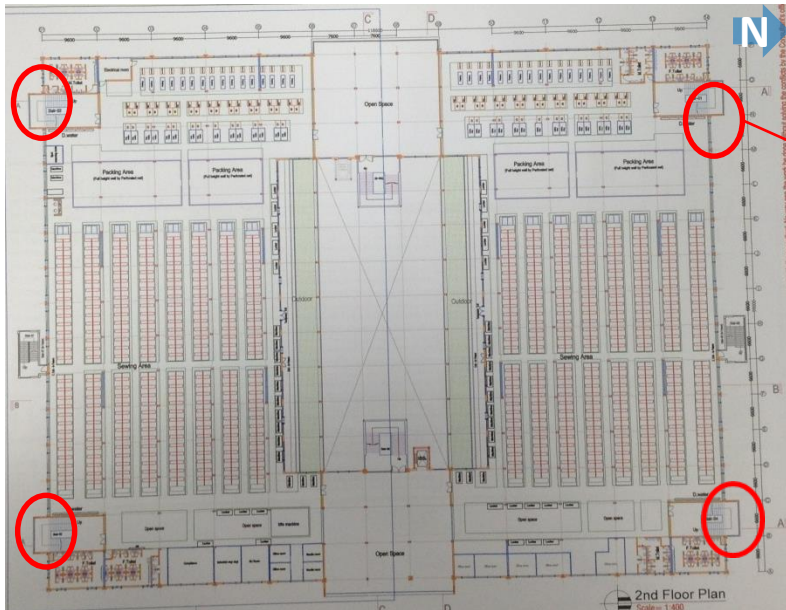
Typical floor plan

# Connection of cantilever beams at stair appear light

Connection of cantilevers at stair appear light

5 mm stiffener

Top of connection is open

Item No.	Observation	Recommended Action Plan	Recommended Timeline
1	Connection of cantilever beams at stair appear light, particularly the stiffener	Building Engineer to review design of the cantilever beam/column connection. It is also noted that the top of the cantilever connection is not fully tightened	6-weeks
2	Connection of cantilever beams at stair appear light, particularly the stiffener	Building Engineer to review design of the cantilever beam/column connection. It is also noted that the top of the cantilever connection is not fully tightened	6-months
3	Connections of cantilevers on floor plate at level 4 appear light. Note lack of deep back span beam	Building Engineer to review design of the cantilever beam/column connection. There is a lighter beam forming the back span It is also noted that the top of the cantilever connection is not fully tightened	6-weeks
4	Connections of cantilevers on floor plate at level 4 appear light. Note lack of deep back span beam	Carry out any remedial action as a result of the connection review. Alter connection to avoid gap between end plate and column flange	6-months

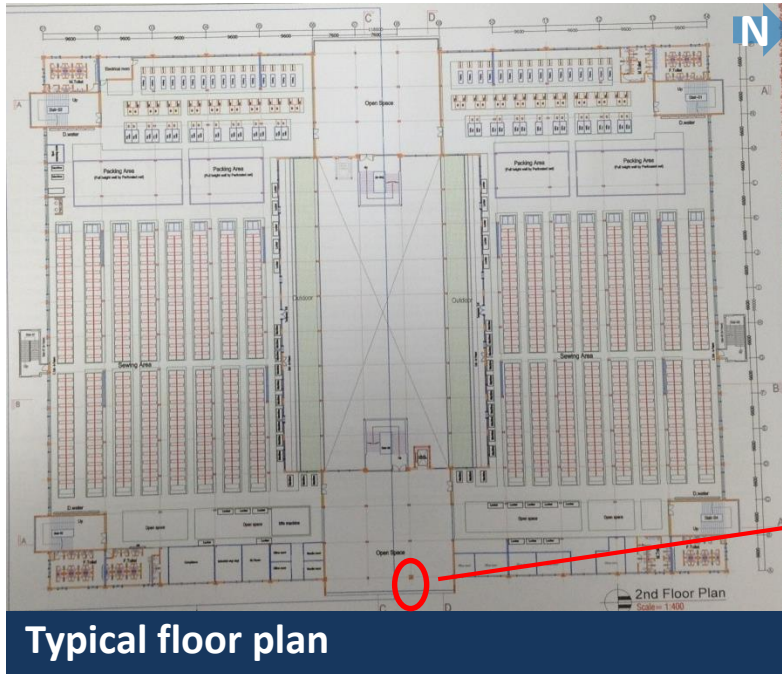
Typical floor plan

Connections of cantilevers on floor plate at  
level 4 appear light

Various depth of beam on each side of column

Connections between cantilevers on floor plate at level 2 appear light

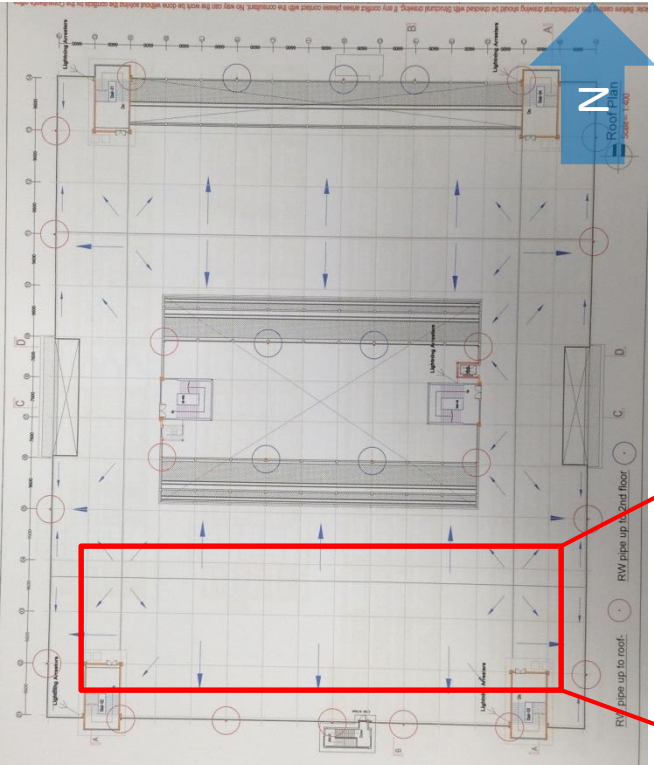
**Typical Roof Plan**

Column stubs noted on roof at southern end

**Column stubs noted on roof at southern end. Any proposed additions to the existing building structure, including additional storeys, should be reviewed by the Building Engineer**

**ITEM 4** Column stubs noted on roof at southern end.

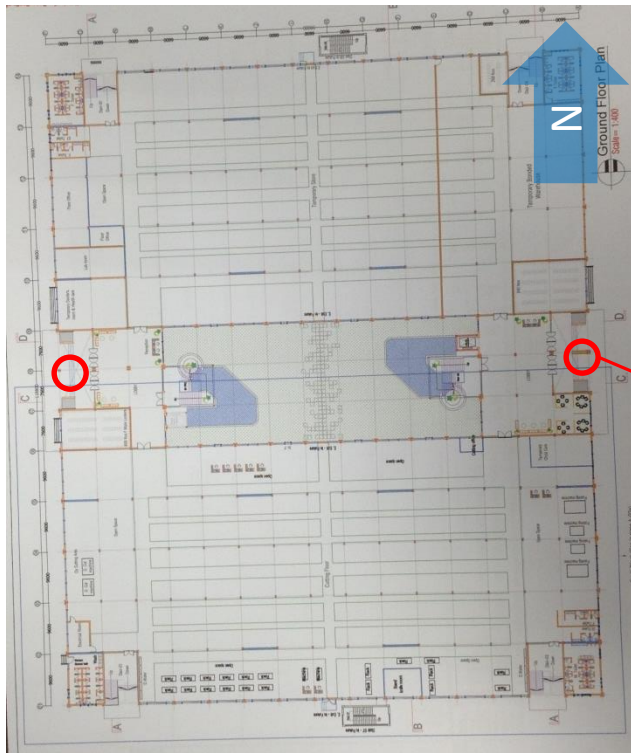
Typical Ground Floor Plan

# Loading bay column not protected from traffic collision

Loading bay column not protected from traffic collision

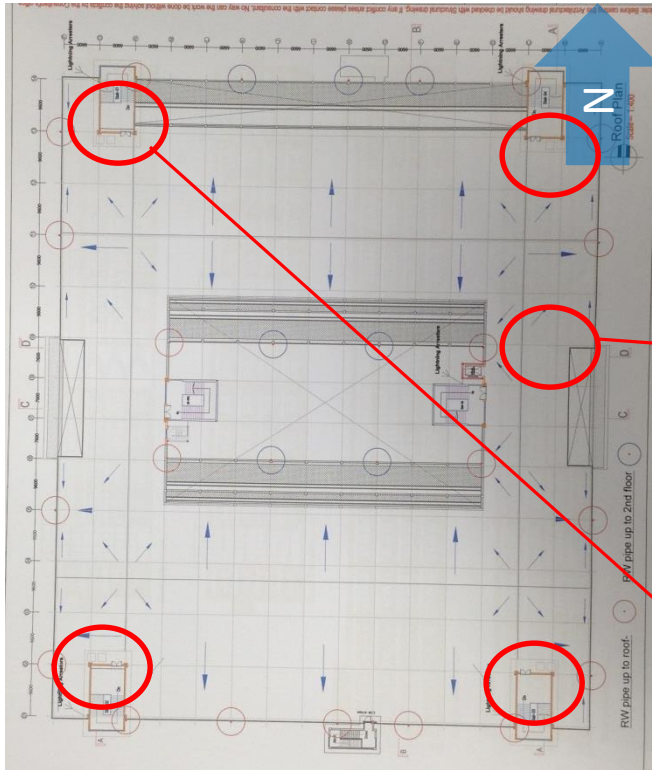
Typical Roof Plan

Rubble and water tanks noted on roof

Rubble and water tanks noted on roof.

**ITEM 6** Rubble and water tanks temporary noted on roof.

11	Rubble and water tanks temporary noted on roof.	Rubble to be removed from roof. Remove temporary tanks if required by above review	<b>6-months</b>
