# Yester Jeans Ltd (Extension Building)

Plot # 115-116, Adamjee EPZ, Siddhirganj, Narayanganj-1431.

19 June 2023

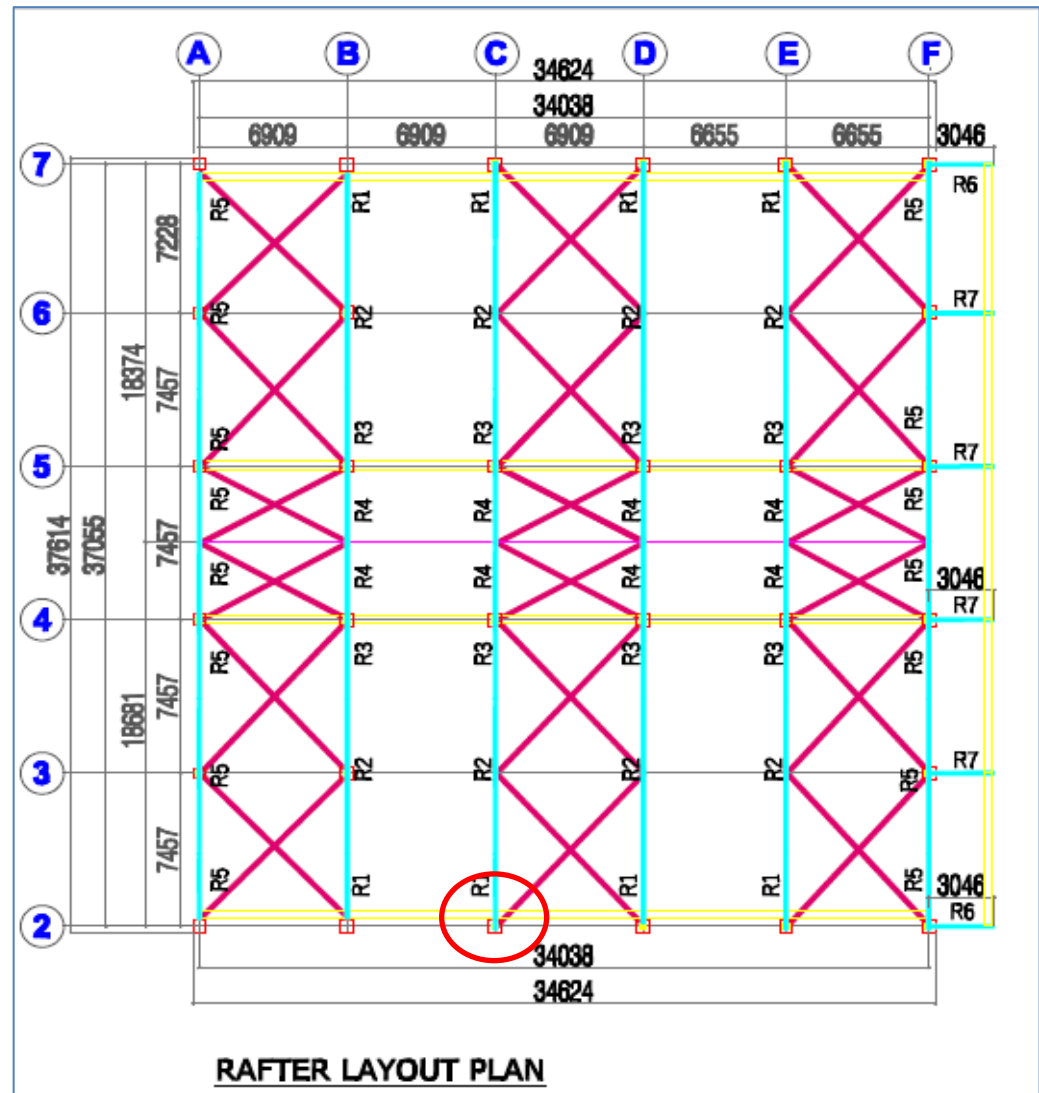
Offset strut

Lateral load transfer media (compression strut) was found offset along grid 2 at point C. Also, number of joint of rafter did not match with provided drawings. Building engineer is required to revise the drawings as per as-built condition and submit to RSC.

| Item No. | Observation | Recommended Action Plan | Recommended Timeline |
|---|---|---|---|
| 09 | Discrepancies in as built drawings. (Production Building-2 Roof Shed) | Building engineer is to survey the whole structure and update as-built drawings representing accurate site condition. | 6-weeks |

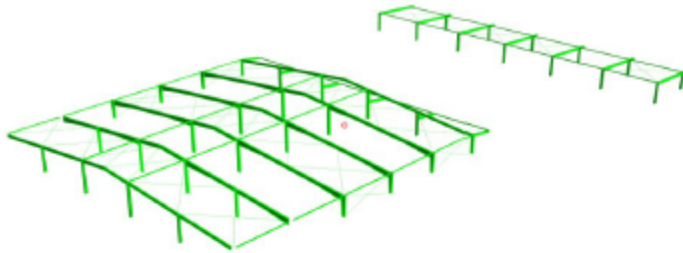
Roof top steel shed

In the design report, wind load calculation for roof shed and rafter deflection check was not found. Building engineer is required revised the design report incorporating all the missing information.

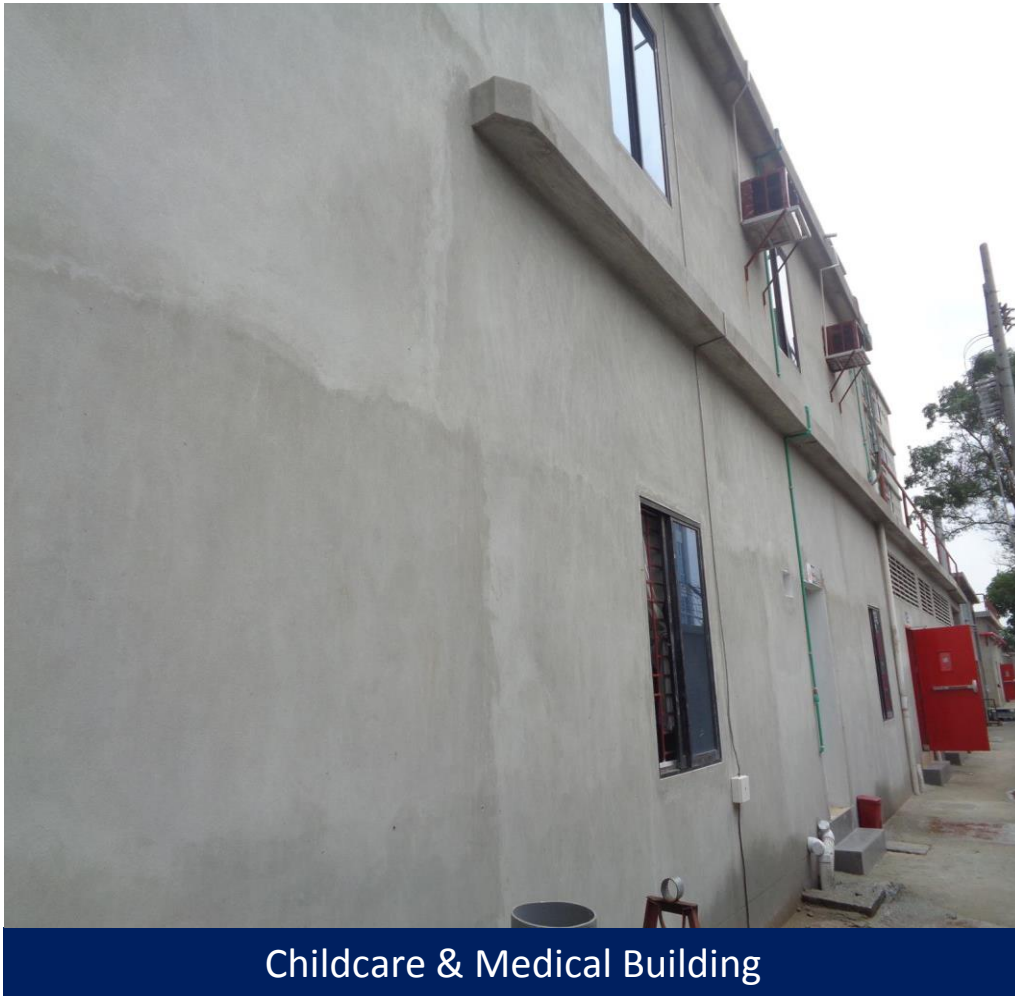
**Observations: Childcare & Medical Building**

As per BNBC, every building or structure designed shall have its design documents prepared in accordance with the provision of Section 1.9.1. The design document shall include a design report, and a set of structural drawings, which shall be prepared in compliance with section 1.9.1.1 and section 1.9.1.2 as per BNBC. At the time of inspection, design report was not available which is required to be prepared in compliance with section 1.9.1.1 (part-6, BNBC).
