# SOUTHERN CLOTHINGS LIMITED

## (Extension)

Bottola, Zirabo, Ashulia, Dhaka  
(23.907989, 90.321843)

12 June 2023

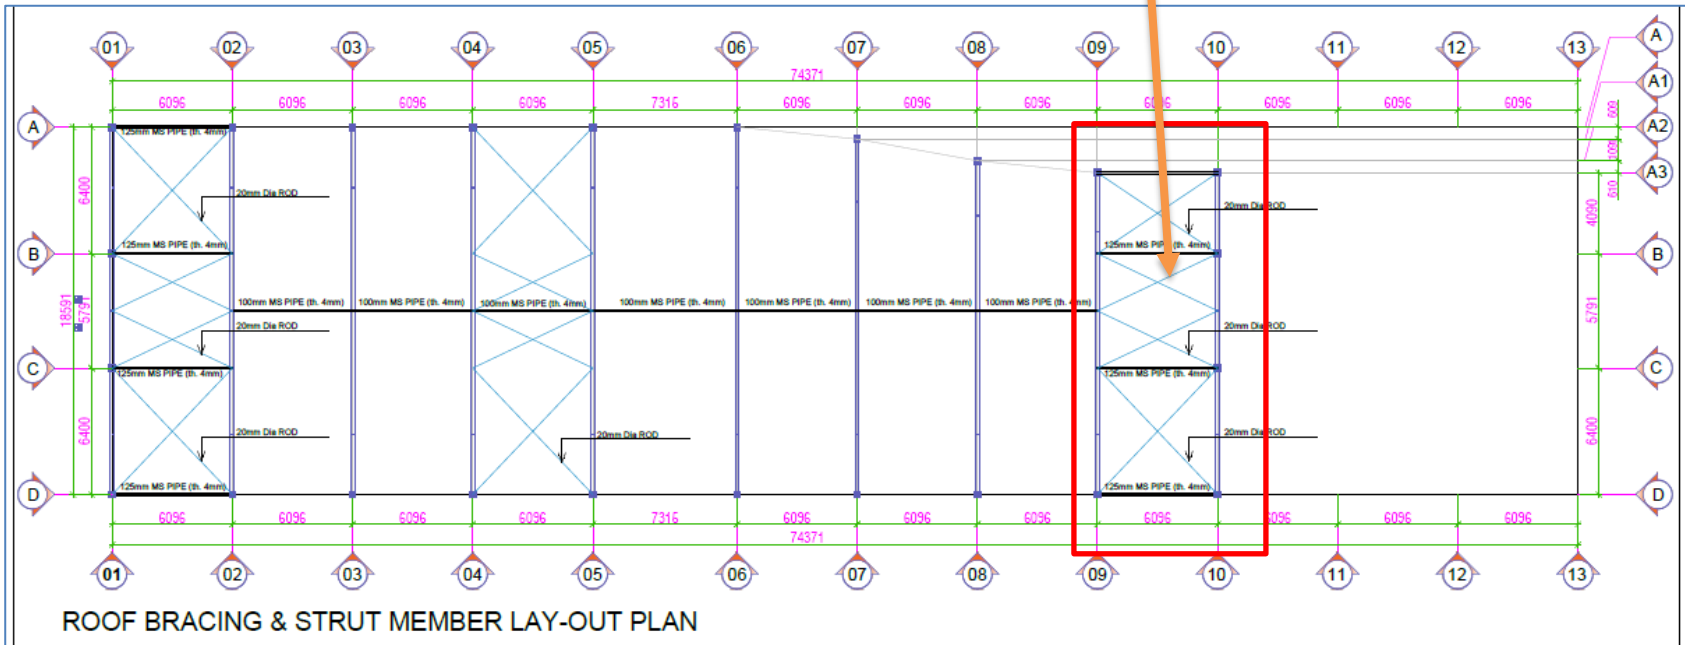
Strut and bracing

Roof bracing and compression strut layout are not matched with as-built condition. Building engineer is required to revise the structural drawings as per on site condition and submit to RSC.

| Item No. | Observation | Recommended Action Plan | Recommended Timeline |
|---|---|---|---|
| 04 | Mismatch in drawings. (Building 3) | Building engineer is to survey the whole structure and update as-built drawings representing accurate site condition. | 6-weeks |

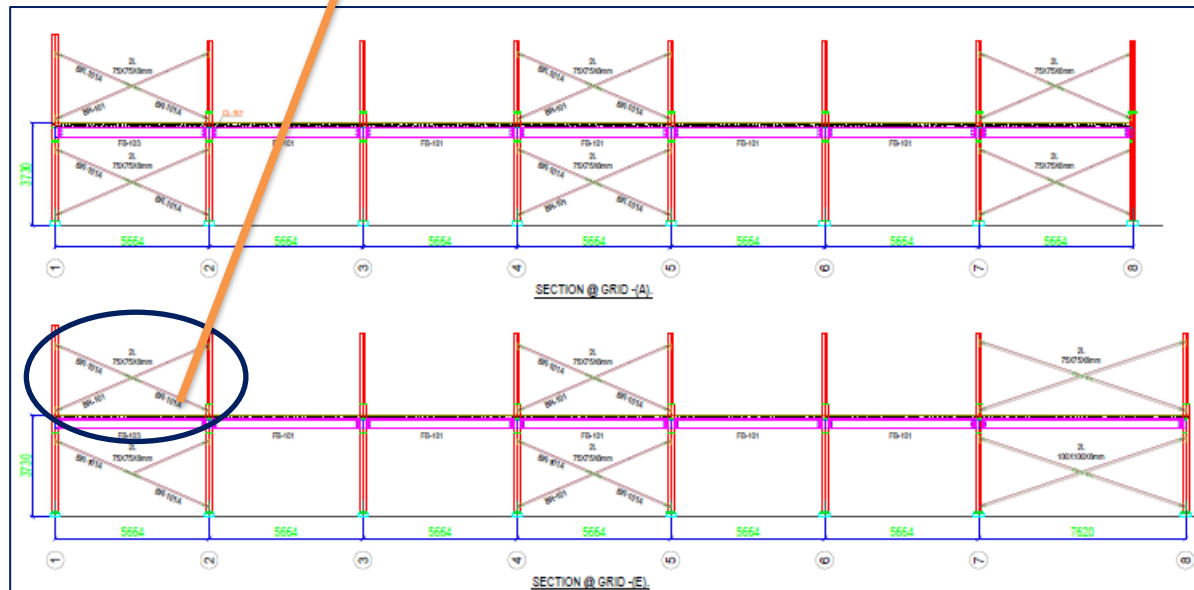
Sectional details of bracing

**Vertical bracing missing**

Missing bracing

Vertical bracings were found missing at Northwest corner of the shed due to door opening. Building engineer is required to install the missing bracing where necessary.

Item 07: Vertical bracing missing.

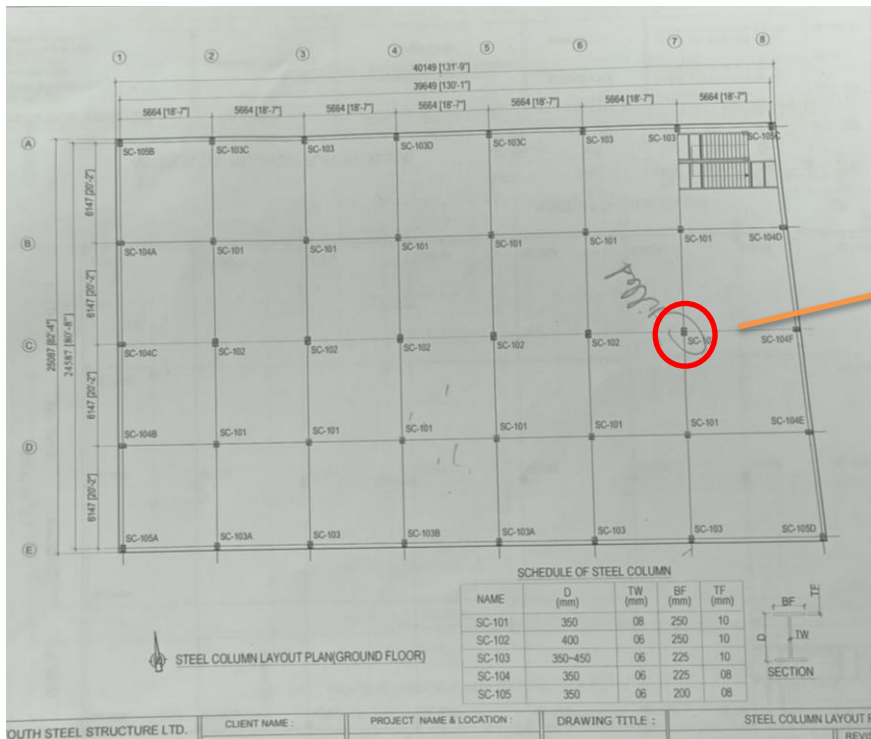
Column Layout

## **Distorted steel column**

A distorted steel column found on ground floor in parking areas. Stability for the distorted columns and related elements need to be checked. Factory Engineer to review design, loads and column stress in the area identified above.
