Max Sweater (BD) Ltd (Extension)

24,26 DIGHI BORABO,TARABO, Rupgonj, Narayangonj

22 May 2023

Building Information

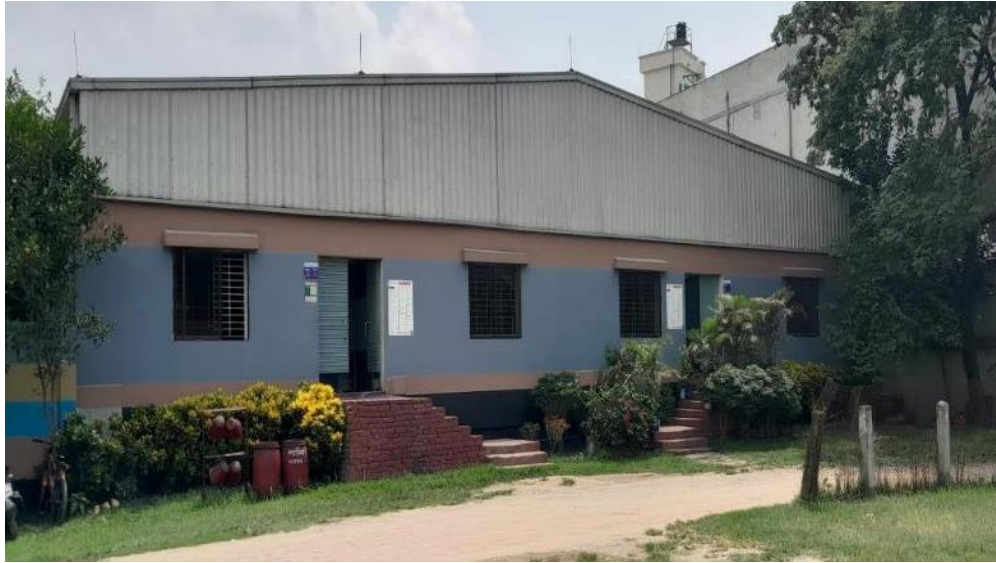
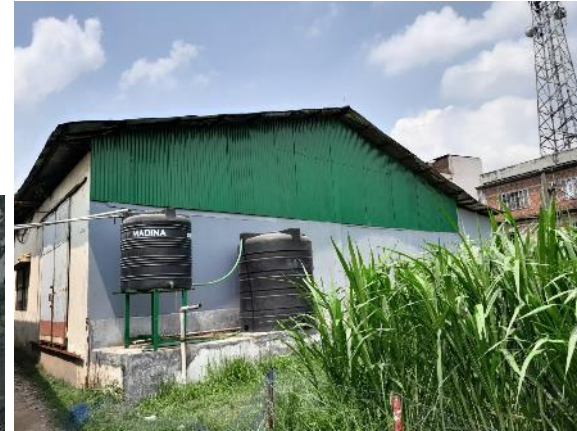
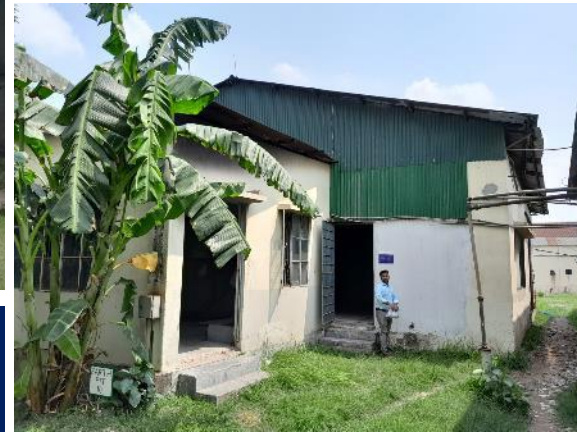
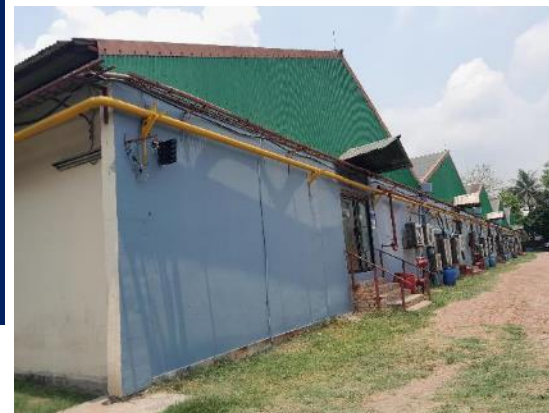
Structural design reports not available

As per BNBC, building or structure shall have its design documents prepared in accordance with the provision of Section 1.9.1. The design document shall include a design report and a set of structural drawings which shall be prepared in compliance with section 1.9.1.1 and section 1.9.1.2 as per BNBC. The design report of the mentioned structures was not found which is required to be prepared in compliance with section 1.9.1.1 (part-6, BNBC).

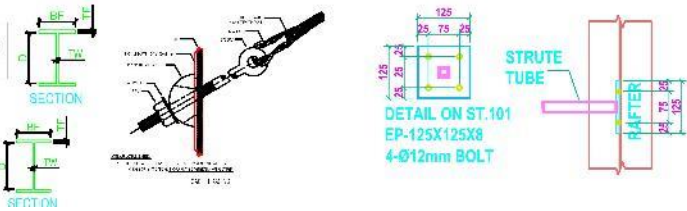
Column and truss layout plan

Apparently inadequate compression strut for long direction

Compression strut of 25X25X4 mm size apparently inadequate for taking compression load. Building engineer is required to check the capacity of compression strut.

| Item No. | Observation | Recommended Action Plan | Recommended Timeline |
|---|--|--|---|
| 10 | Apparently inadequate compression strut for long direction (Shed 10) | Building engineer is required to check the capacity of compression strut and suggest necessary remedial actions. | 6-weeks |

| Item No. | Observation | Recommended Action Plan | Recommended Timeline |
|---|--|--|---|
| 11 | Apparently inadequate compression strut for long direction (Shed 10) | Carry out remedial works where necessary. | 6-months |
