# Dewan Fashion Wears Ltd. (Relocated)

Mamun Nagor, Sarabo, Kashimpur, Gazipur.

09 July 2023

# Building Information

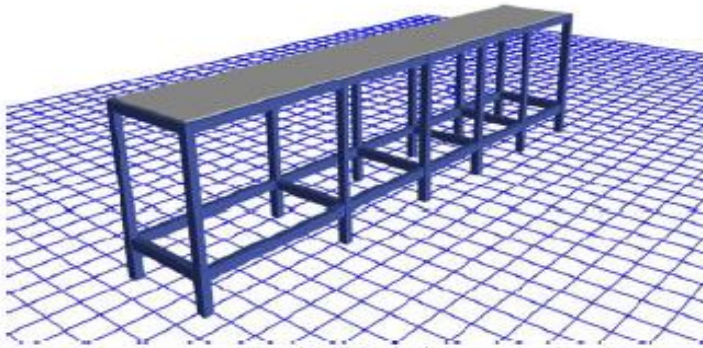
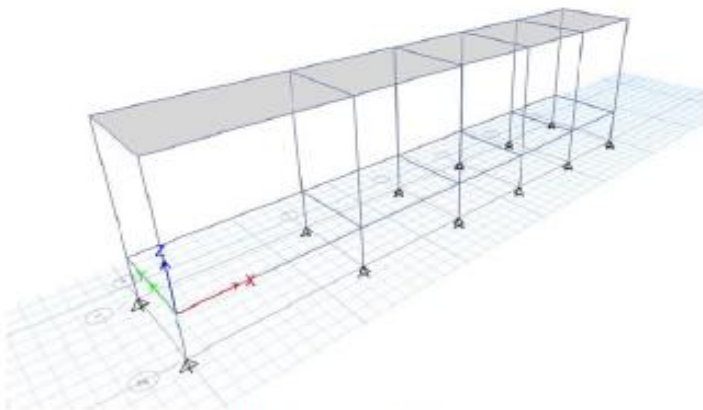
Figure 3-1: 3D Rendered view.

A set of design report was available for the Main Building following BNBC 2020. But site classification and seismic design category not determined in the design report. Also, plan & vertical irregularity check not provided in the design report.

**Additional slab portion at front not considered  
in the design report**

| Item No. | Observation | Recommended Action Plan | Recommended Timeline |
|---|---|---|---|
| 02 | Design report required to be revised. (Main Building) | Implement the recommendations of design report. | 6-months |
