# Arcorp Denim Ltd.

Holding#332 Road#2 Ward#5 Block#B  
Kumkumari, Gazipur, Ashulia, Savar, Dhaka  
23.8827N, 90.3269E

20 October 2015

# Observations

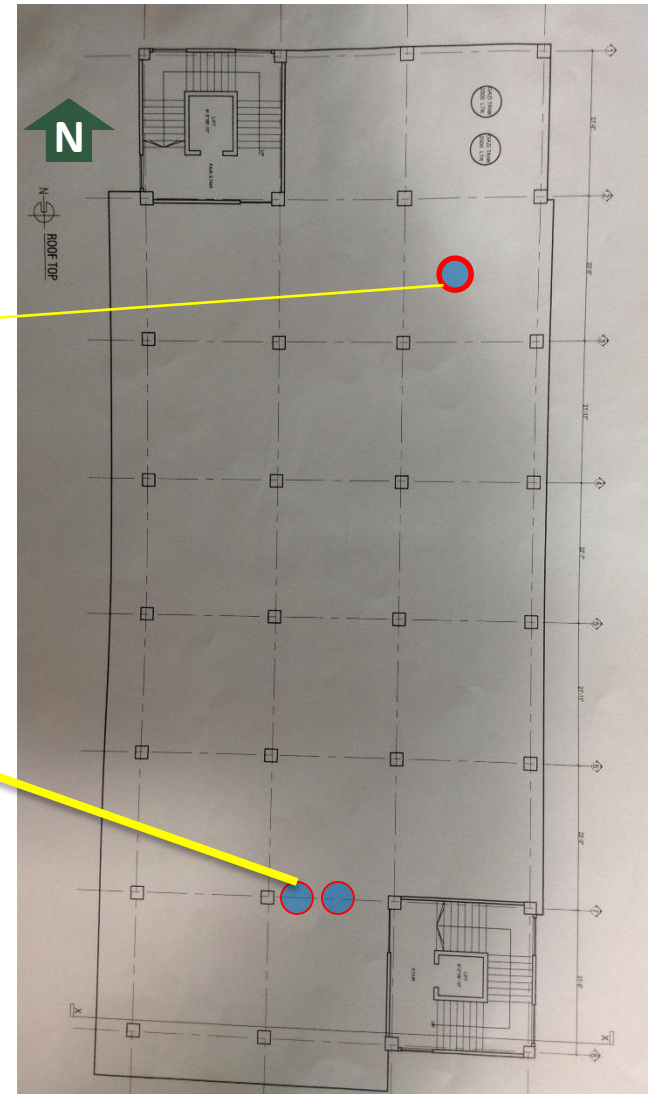
Roof plan

Water tank on roof.  
Capacity 2 x 2000L

Empty water tank –  
5000L

Item No.	Observation	Recommended Action Plan	Recommended Timeline
1	Water tanks on roof	Empty 5000 ltr. tank on the roof to be removed. The engineer to check the roof slab under the two full tanks. (2-2000ltr tanks.)	6-weeks
2	Water tanks on roof	Remove tanks if required.	6-months
3	Minor cracks on walls perpendicular to cantilever on 5th floor and cantilevers appear to have deflected	Building Engineer to check cantilever design for the wall loading and live load. Engineer to confirm likely deflection and its impact on the external wall.	6-weeks
4	Minor cracks on walls perpendicular to cantilever on 5th floor and cantilevers appear to have deflected	Restrict loading on the cantilevers to the design capacity from the engineering check.	6-months
5	Non Engineered steel roof to stair core	Engineer to review the steel roof structure to both stair cores and design a stable roof structure.	6-weeks
6	Non Engineered steel roof to stair core	Construct engineered roof to stair core	6-months

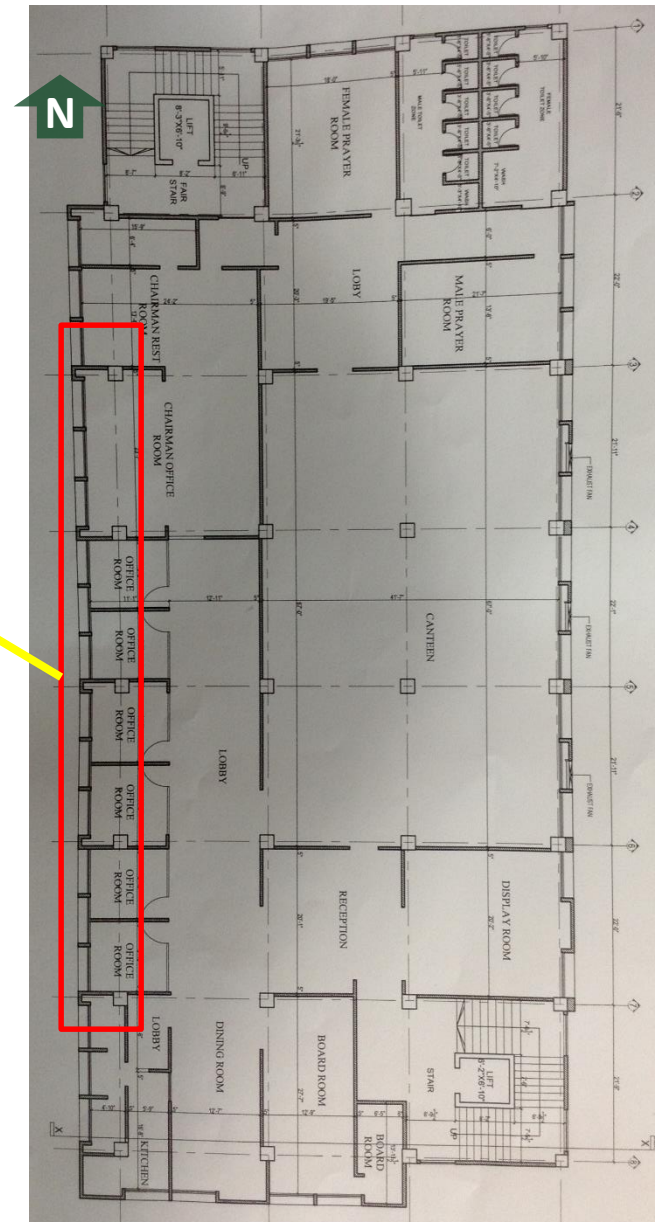
Typical 5th floor plan

Minor cracks on walls perpendicular to cantilever on 5th floor

**ITEM 2:** Minor cracks on walls perpendicular to cantilever on 5th floor and cantilevers appear to have deflected.

Building engineer to verify reason for cracking.

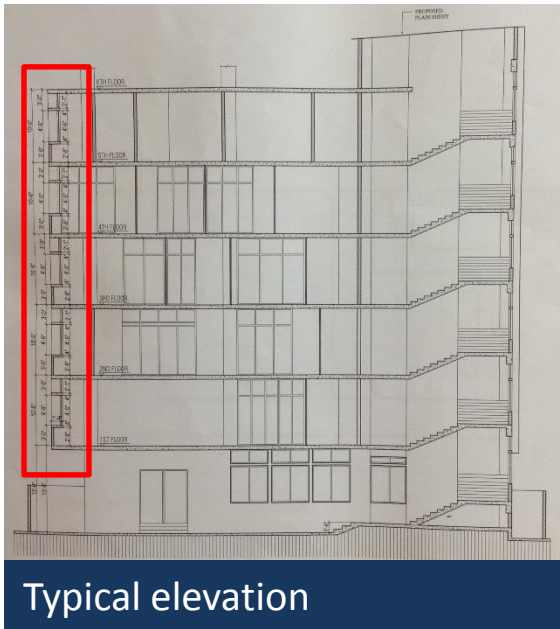
Typical elevation

Cantilevers appear to have deflected

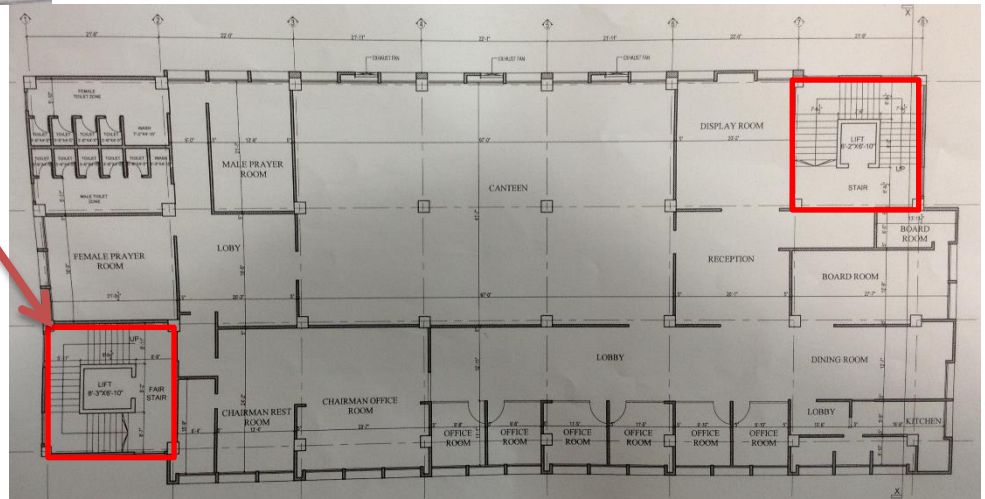
Typical roof plan

Non Engineered steel roof to stair core

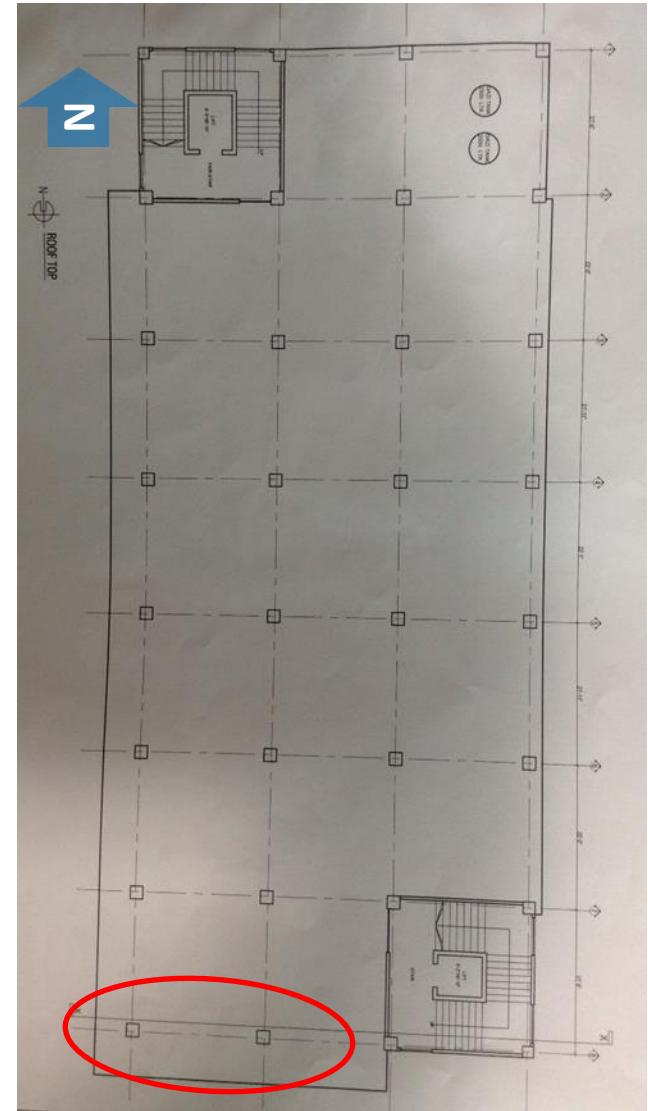
Typical ground floor layout

Columns in loading bay unprotected from traffic impact.

Item No.	Observation	Recommended Action Plan	Recommended Timeline
7	Uncontrolled loading on the floor	Limit loading on the floor plate to 2kPa	6-weeks
8	Uncontrolled loading on the floor	Produce and actively manage a loading plan for all floor plates within the factory giving consideration to floor capacity and column capacity	6-months
9	Uncontrolled loading on the floor	Continue to implement load plan.	6-months
10	Columns on loading bay unprotected from traffic impact	Engineer to review loading bay columns and their vulnerability to impact from truck. Design column protection.	6-weeks
11	Columns on loading bay unprotected from traffic impact	Implement design	6-months

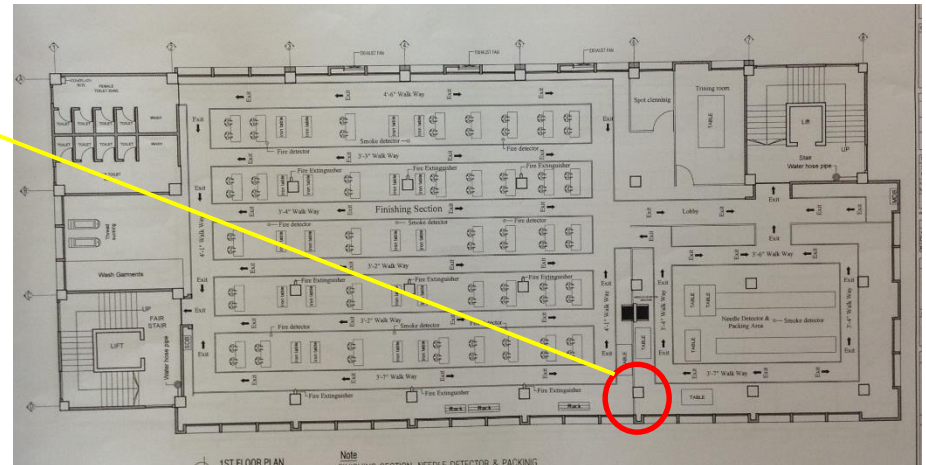
**Typical ground floor layout – tested column**

**Stone Aggregate noted in ground floor columns**
