SM Sourcing

Baimail, Konabari, Joydevpur , Gazipur

23 July 2023

Observations

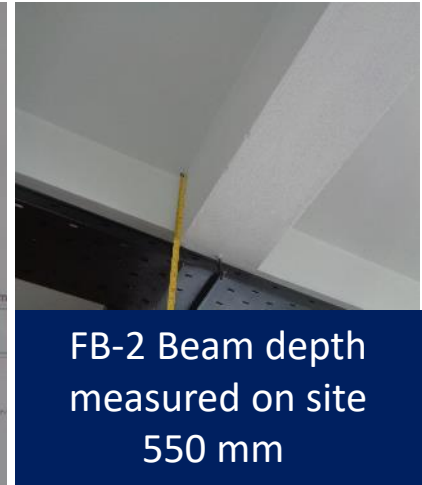
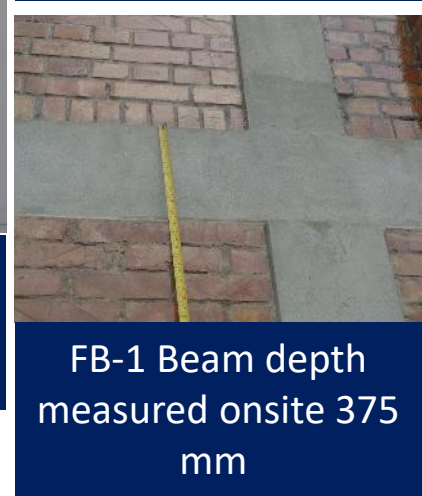
Beam depth in drawing:
 FB-1 = 500 mm
 FB-2 = 375 mm

Beam layout: Red marked beams were not found onsite. And white marked beam was found shifted.

Building engineer is required to survey the structure and prepare accurate as-built drawings and submit to the RSC for review.
