# Arunima Sportswear Ltd (Extension)

Holding-08/63/4, Road No-01, Ward-08, Block-D, Zirabo, Ashulia, Savar, Dhaka

27 August 2023

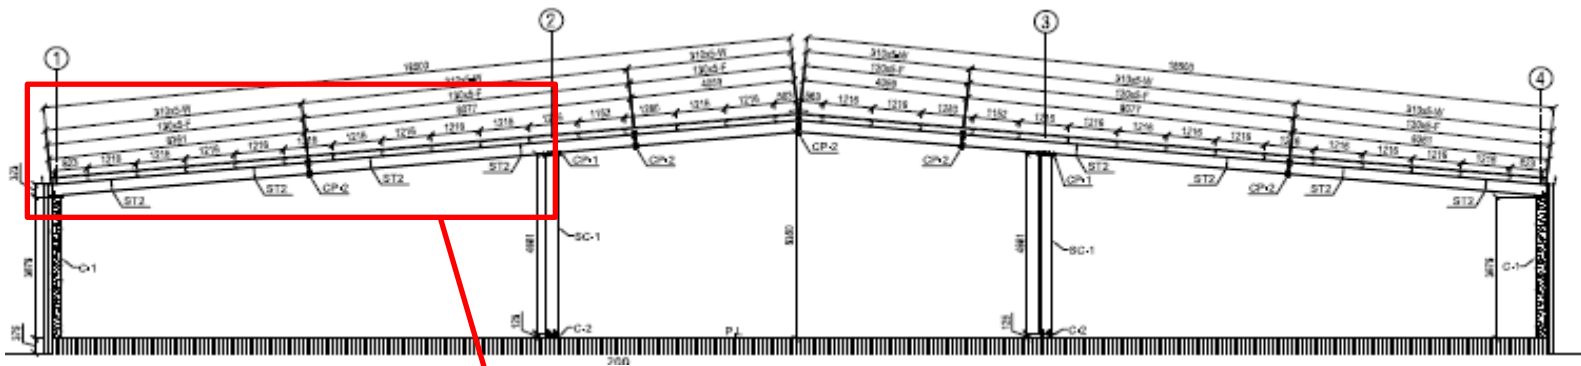
Story Displacement: The story displacement due to lateral loading are adequate.

Detail calculation and adequacy check of lateral serviceability not included in the design report. Building engineer is required to check the lateral stability of the shed.

| Item No. | Observation | Recommended Action Plan | Recommended Timeline |
|---|---|---|---|
| 06 | Inconsistencies in design report & inadequate structural members. (Block G ) | Building engineer is required to check the lateral stability of the shed. | 6-weeks |
