Mega Denim Ltd. (Extension)

88/1, B.K Bari, Taltoli, Mirjapur, Gazipur sadar, Gazipur.

10 September 2023

Observations

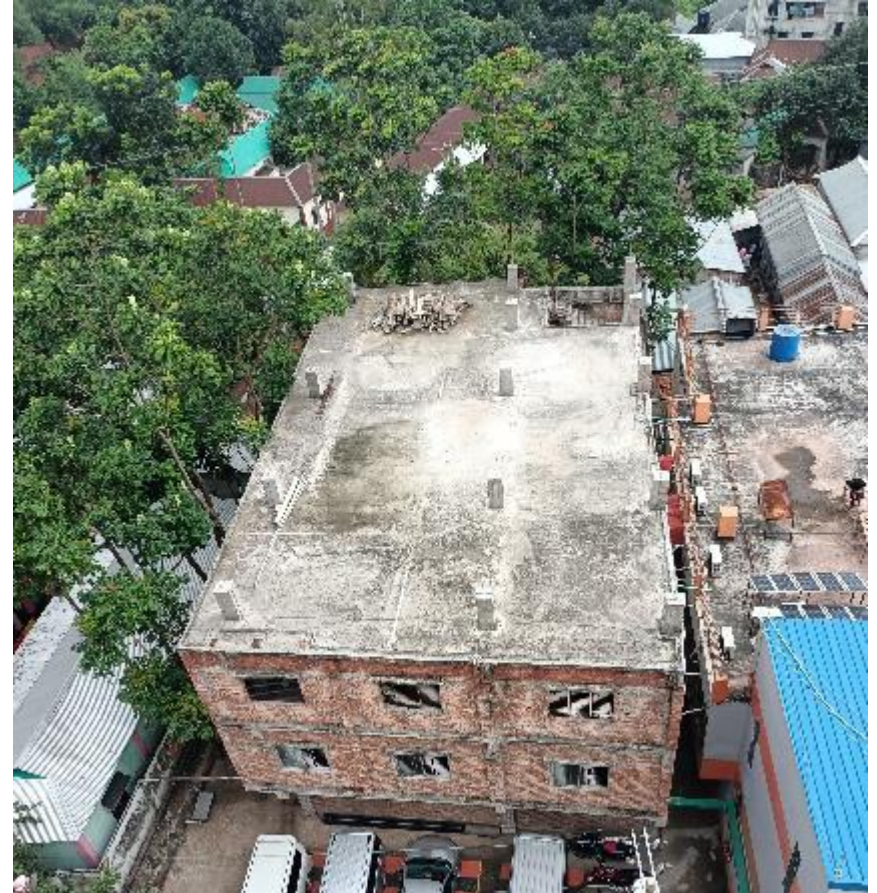
No parapet wall was found to protect falling hazards on the existing roof. Building engineer is required to provide adequate parapet wall to avoid possible falling hazard.

Item No.	Observation	Recommended Action Plan	Recommended Timeline
15	Load plan & material test not comply with BNBC requirements. (Building 3)	Implement floor load plan.	6-months
16	Lack or parapet wall on the existing roof. (Building 3)	Implement the remedial works where necessary.	6-weeks
