Green Smart Shirts Ltd (Extension)

Tapirbari, Mawna, Sreepur, Gazipur
(24.2373838, 90.4342180)
18 September 2023

Observations

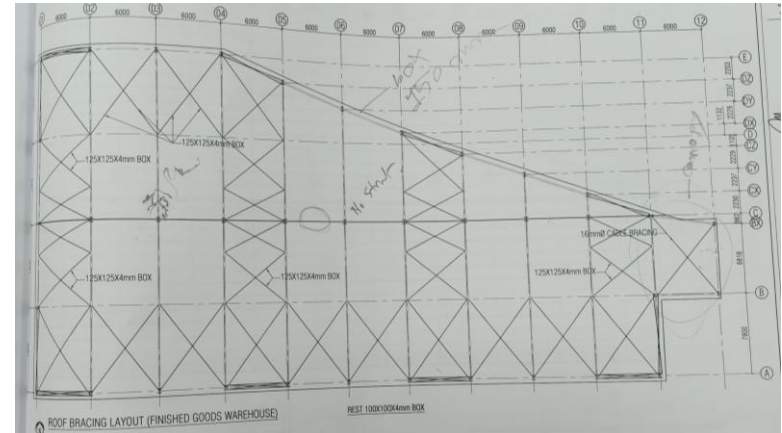
Bracings and strut layout

Incomplete lateral stability system

No compression strut was found along the ridge lines of the long direction. So lateral stability in the long direction is incomplete. The building engineer is required to check the stability system of the existing structure.

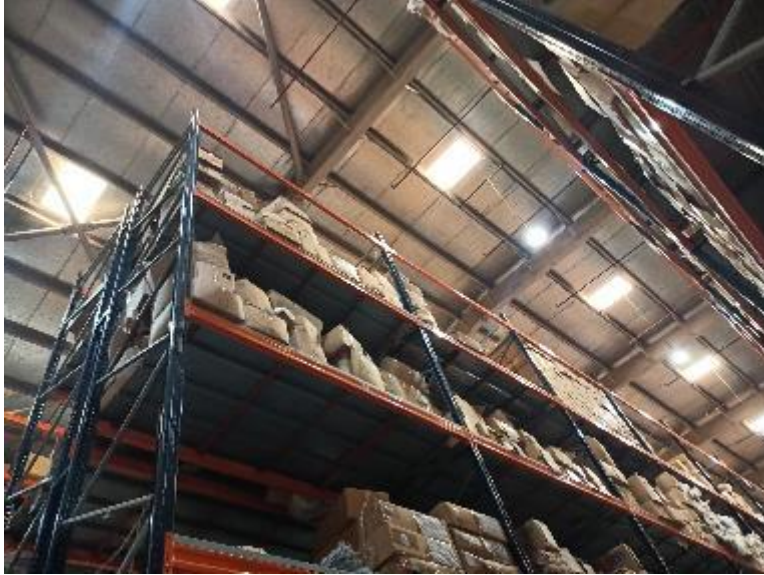
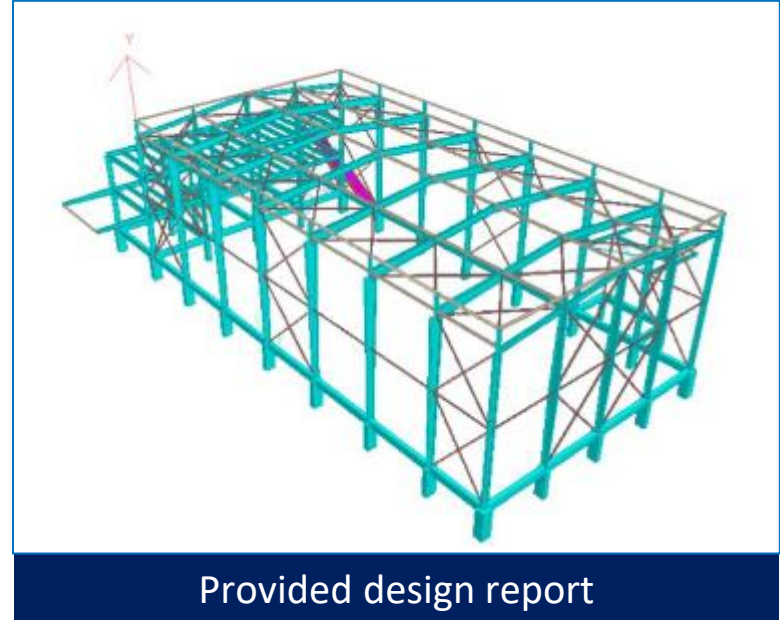
Provided design report

lateral stability system required review

No compression strut was found along the ridge of the long direction. So lateral stability in the long direction is incomplete. The building engineer is required to check the stability system of the existing structure.

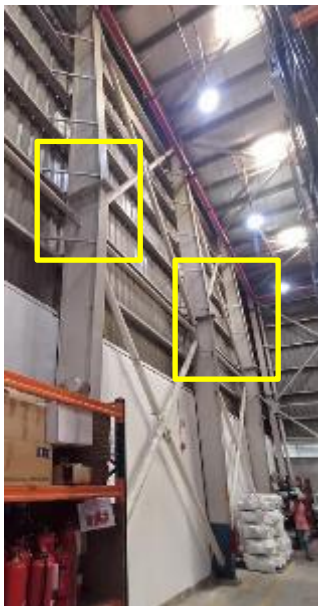
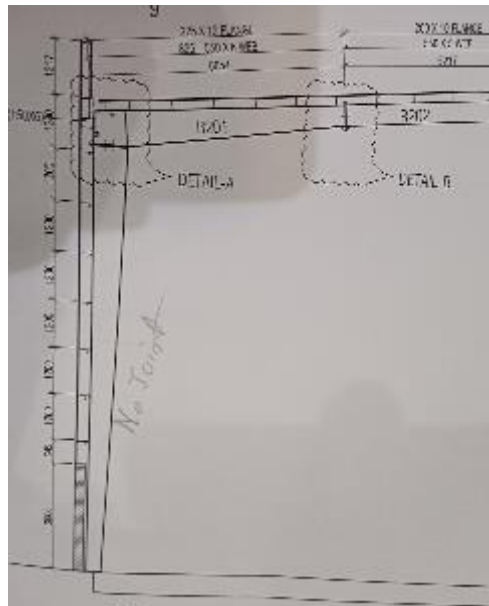
Column joint

Inconsistencies in as-built drawing

Inverted V bracing was found instead of cross bracing at grid 2. Column splice detail is not found in the provided as-built drawings. Moreover, all connection details are not found in the drawings.

Building engineer is required to revise the as-built drawing showing connection details with complete information.

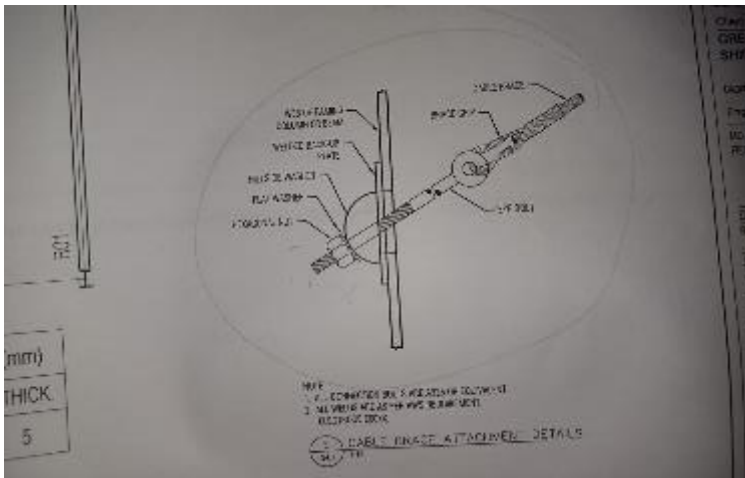
Bracings connection as per drawings

Improper bracing connection

Bracings are not connected as per drawings. Only hooks are used for connection. Building engineer is required to replace the connection as per drawings.

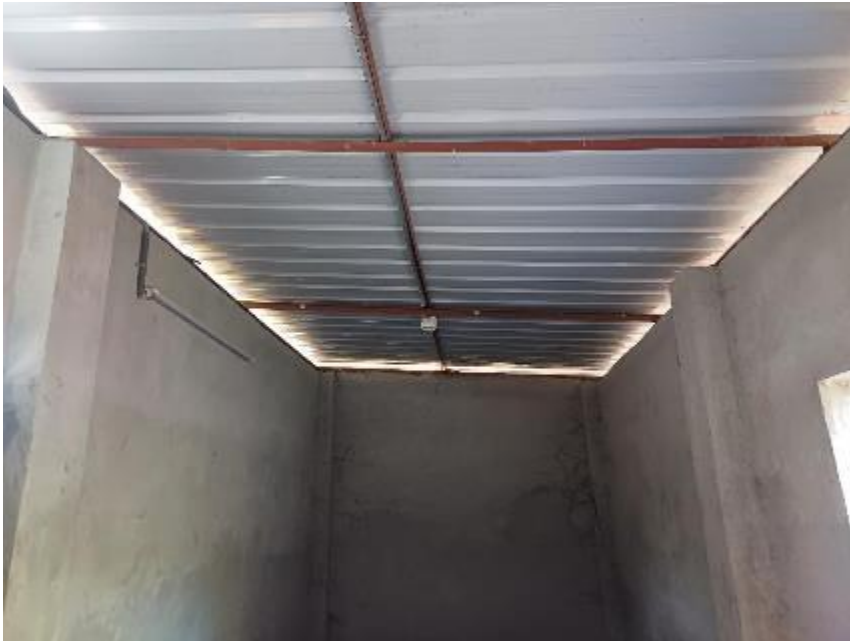
Inside of STP shed

Lack of drawings

Structural and architectural drawings were found for the STP shed. The building engineer is required to survey the whole structure and prepare a full set of as-built drawings in compliance with section 1.9.1.2, part 6 of BNBC.
