# TED Bernhardt Textile Industry Ltd.

Gazipura, Ershadnagar, Tongi, Gazipur-1704, Bangladesh

7 September 2023

# Observations

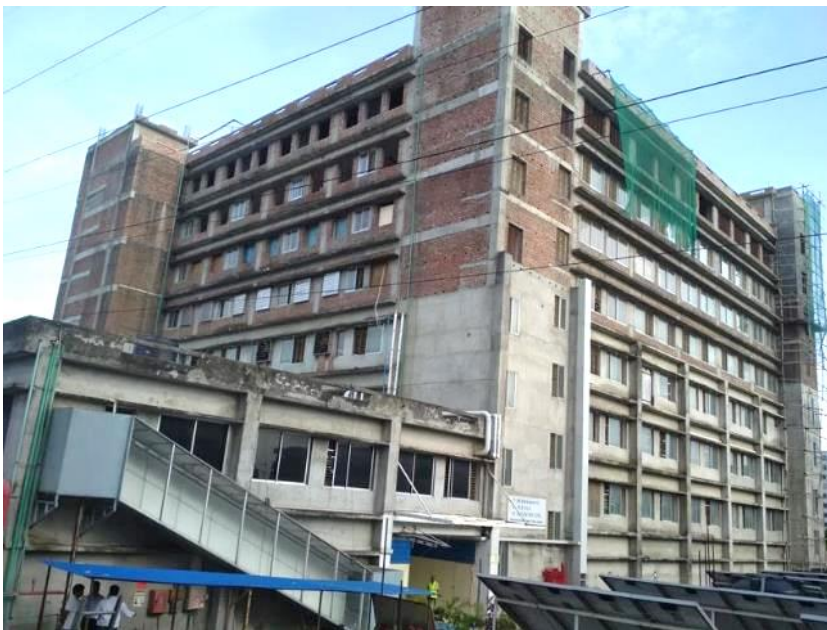
**Design report to be revised for in-situ  
material strength**

The 8 storied building was constructed in two phases. 1st phase construction period was February 2014 to March 2018 and completed till 5 storied. 2nd phase construction period was March 2020 to October 2021 and completed rest of three storied.

The factory of safety of allowable pile capacity was not clearly mentioned in the DEA report which to be incorporated.

The building engineer is required to revise the DEA as per in-situ material strength.

| Item No. | Observation | Recommended Action Plan | Recommended Timeline |
|---|---|---|---|
| 04 | Design report to be revised for in-situ material strength.<br>Building-1 (Main Building) | Determine the ultimate pile capacity from sub-soil properties and revise the foundation adequacy check accordingly. | 6-weeks |

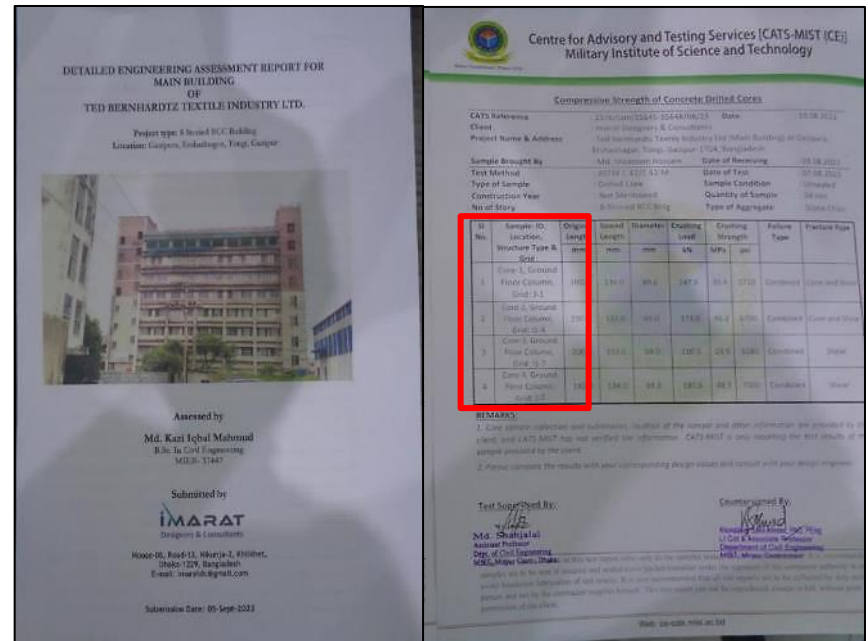
## DEA report & core test report

4 set of concrete test reports for ground column were available (1<sup>st</sup> phase). The building was constructed in two phases. As per BNBC, frequency of testing for the concrete core doesn't satisfy. So, the building engineer is required to take concrete cores from the 2<sup>nd</sup> phase construction to confirm in-situ material strength.

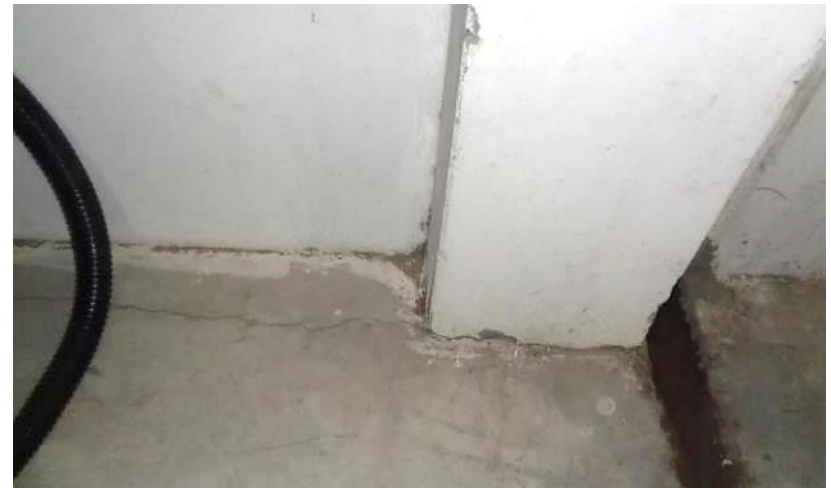
## **Crack in brick wall and ground floor**

Crack in brick walls & floors

The building engineer is required to investigate the reason of crack and prepare an investigation report with proper remedial methodology.

| Item No. | Observation | Recommended Action Plan | Recommended Timeline |
|---|---|---|---|
| 15 | Crack in brick wall and ground floor. Building-3 (Childcare, Medical & Fire Control Building) | The building engineer is required to investigate the reason of crack and prepare an investigation report with proper remedial methodology. | 6-weeks |
| 16 | Crack in brick wall and ground floor. Building-3 (Childcare, Medical & Fire Control Building) | Carry out suggested remedial works. | 6-months |
