# Fakir Knitwears Ltd. (Extension)

Kayempur, Fatullah, Narayanganj

22 August 2023

# Observations

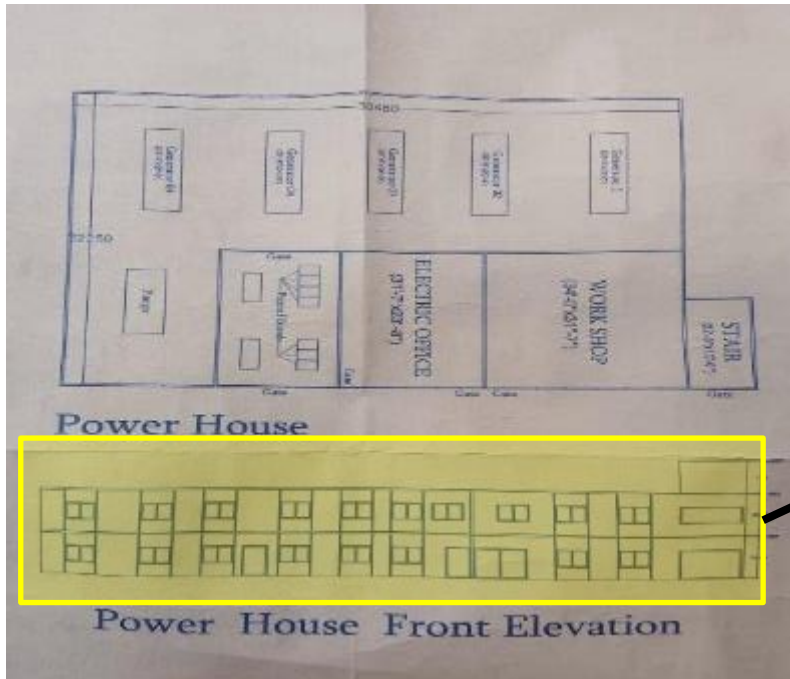
Building Permit drawing: Proposed 2 storey

Factory had a building permit drawing for proposed 2 storied Powerhouse Building (Building-4). However, the building was found as three storied. Also, the existing building plan and column layout doesn't reflect the permit drawing. The factory is required to collect revised building permit drawing for the structure from the local authority.

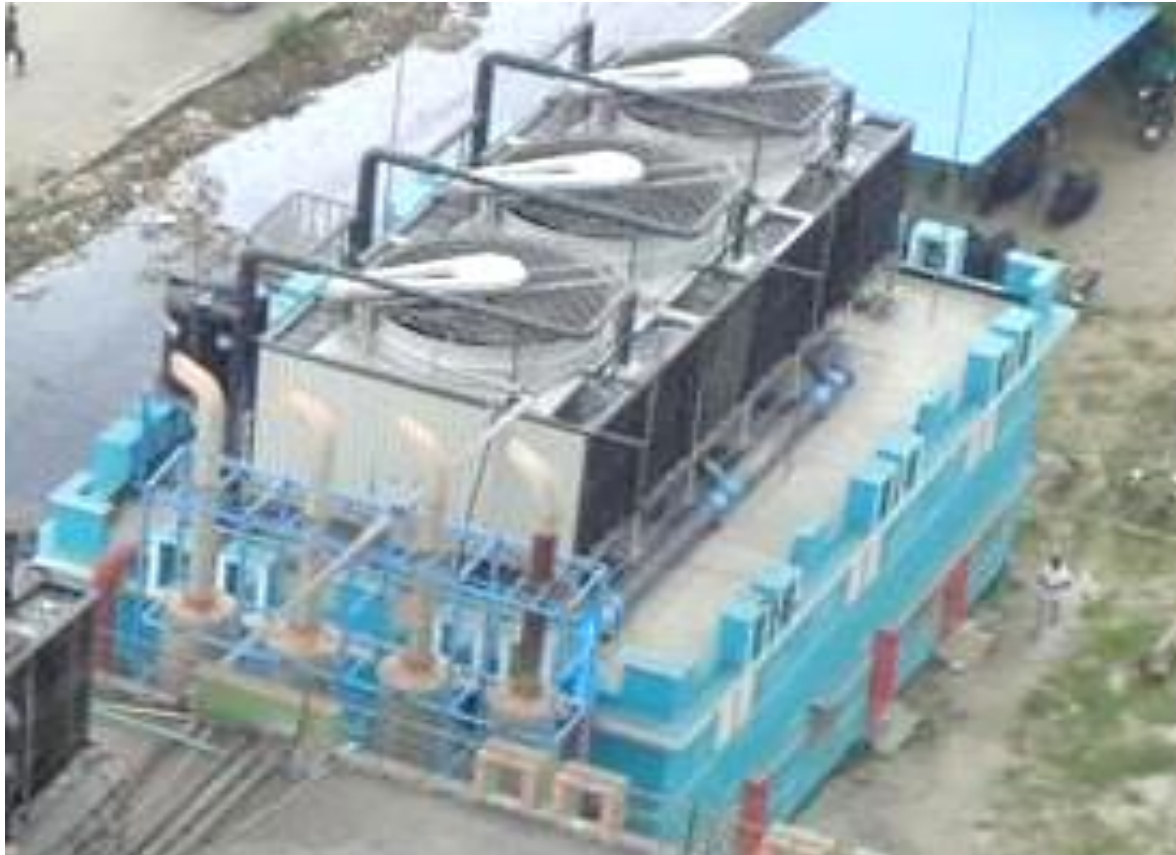
Heavy loading on roof

Building engineer is required to produce a floor load plan based on floor and column capacity of the building.

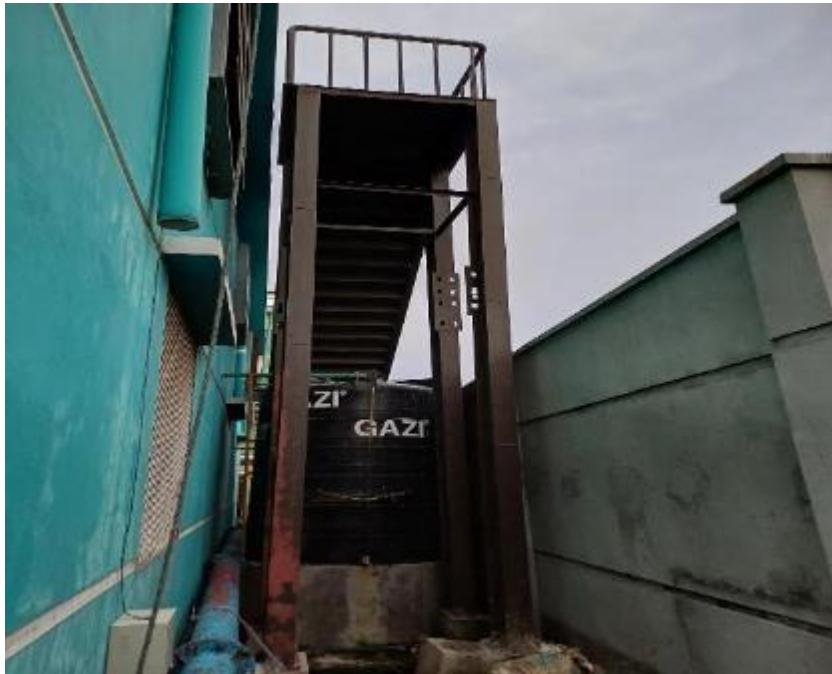
No vertical bracing provide for the stair

The steel stair was appeared to be unstable due to lack of vertical bracing. The building engineer is required to check the lateral stability of the steel stair and suggest remediation if required.

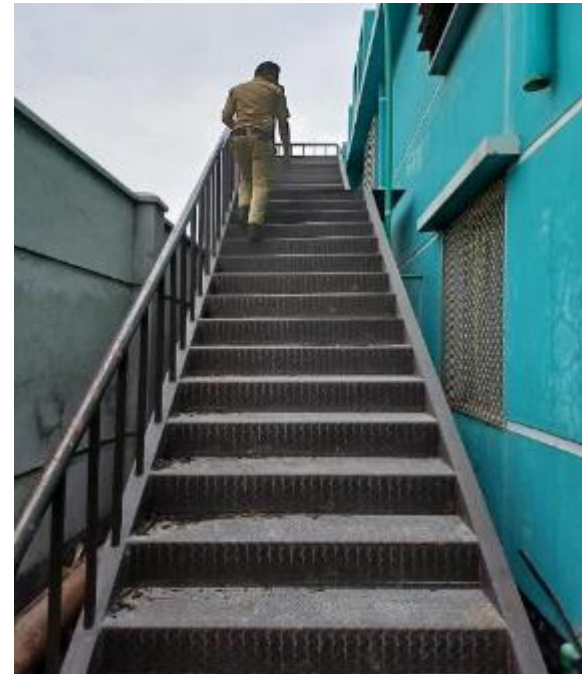
Long stringer beam

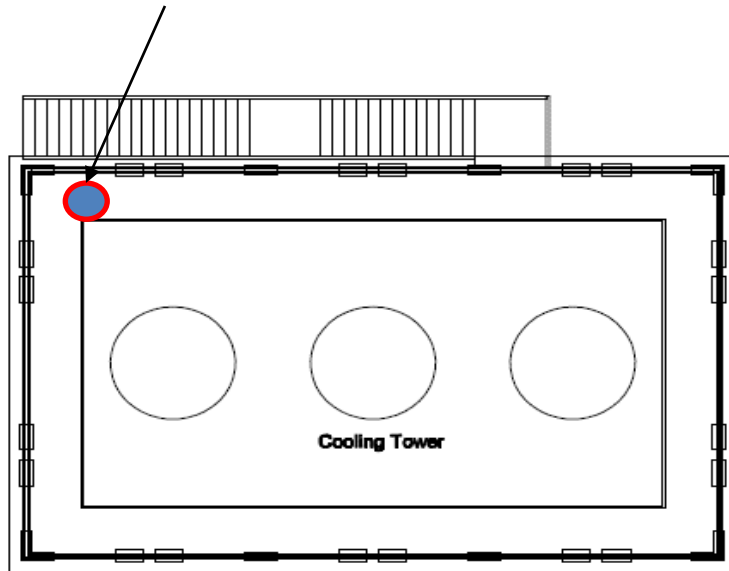
Roof Top Plan

Roof layout plan: Plastic water tank not shown

Plastic water tank was not shown in architectural drawing. Building engineer is required to revise the drawings as per site condition.

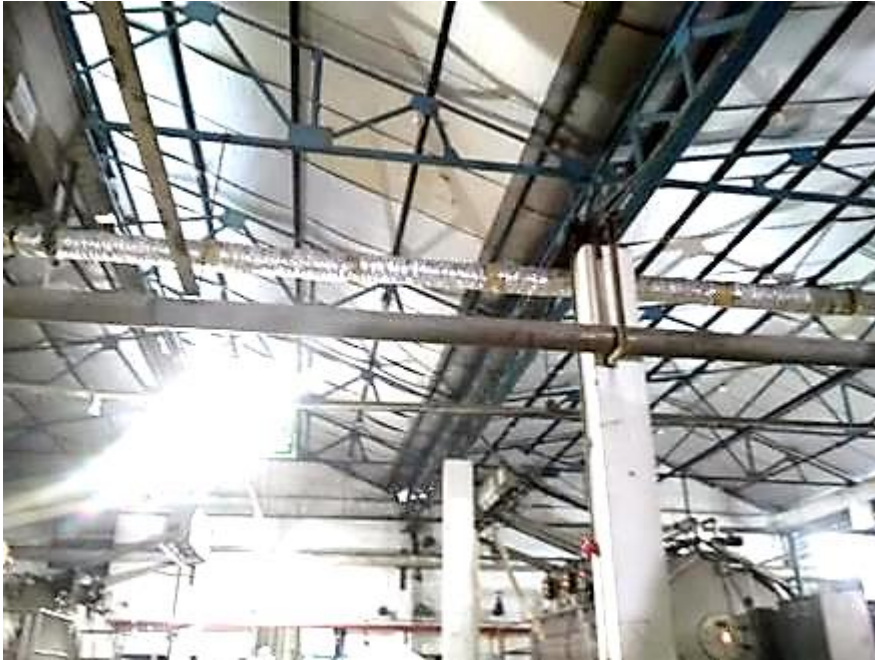
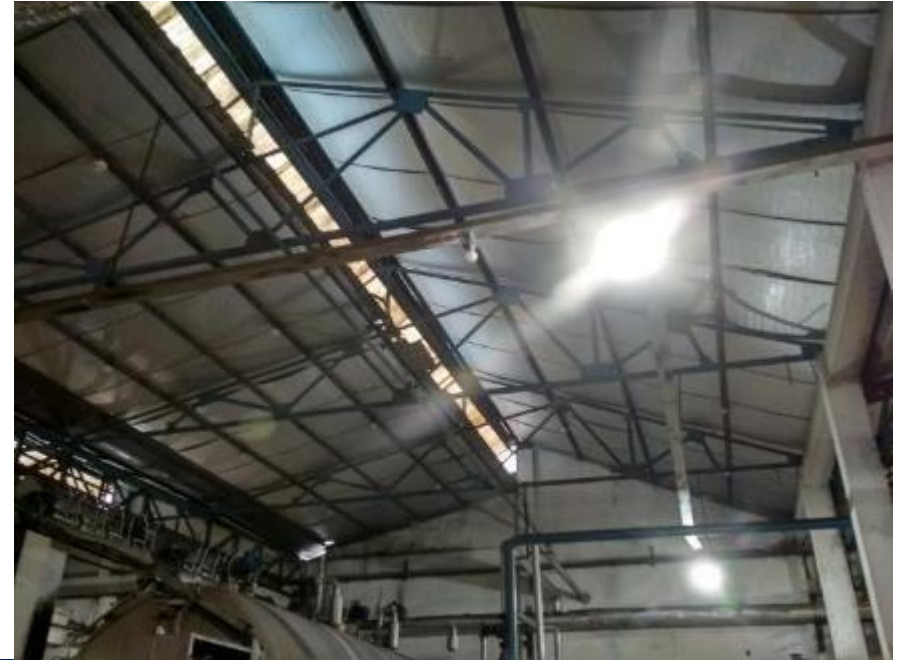
No bracing system/compression member is provided

No bracing/compression member is provided for the shed therefore the lateral stability system is absent for the structure. Building engineer is required to check the lateral stability of the shed as part of EA and suggest proper remedial work.

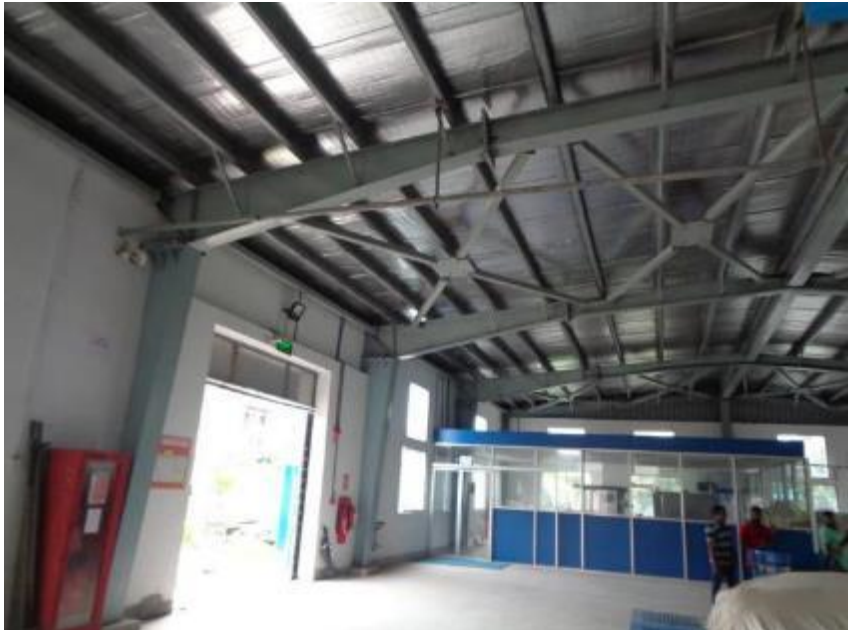
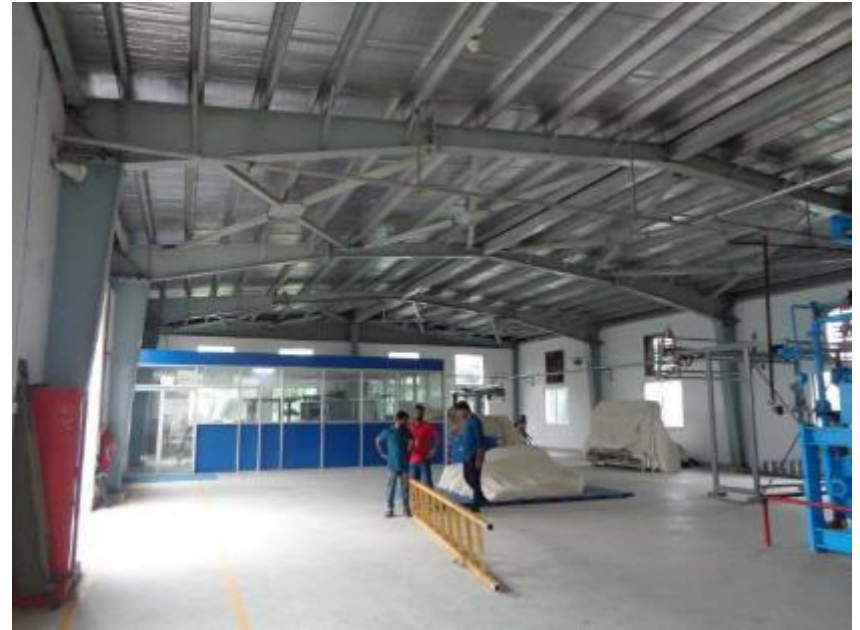
Lack of vertical load resisting system (bracing)

No vertical load resisting system (bracing) is provided for the shed therefore the lateral stability system is incomplete for the structure. As part of EA, the building engineer is required to check the lateral stability system of the shed and suggest proper alternatives.

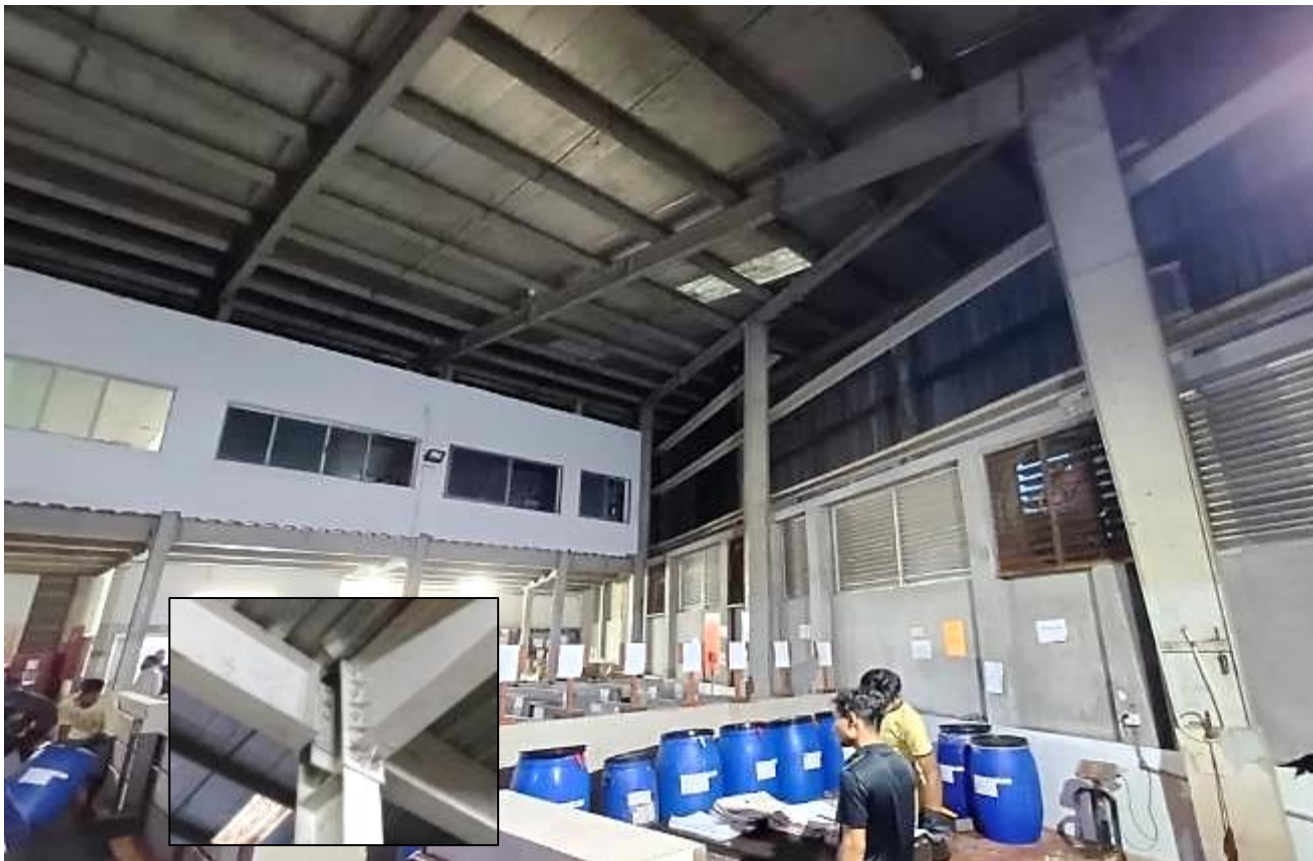
Absence of lateral load transfer media along transverse direction of rafter

Bracing & compression strut was not provided to resist the lateral load. Also, in mezzanine floor moment connection is provided in one direction only. The building engineer is required to carryout the lateral stability of the structure as part of (EA) and suggest proper remedial actions accordingly.

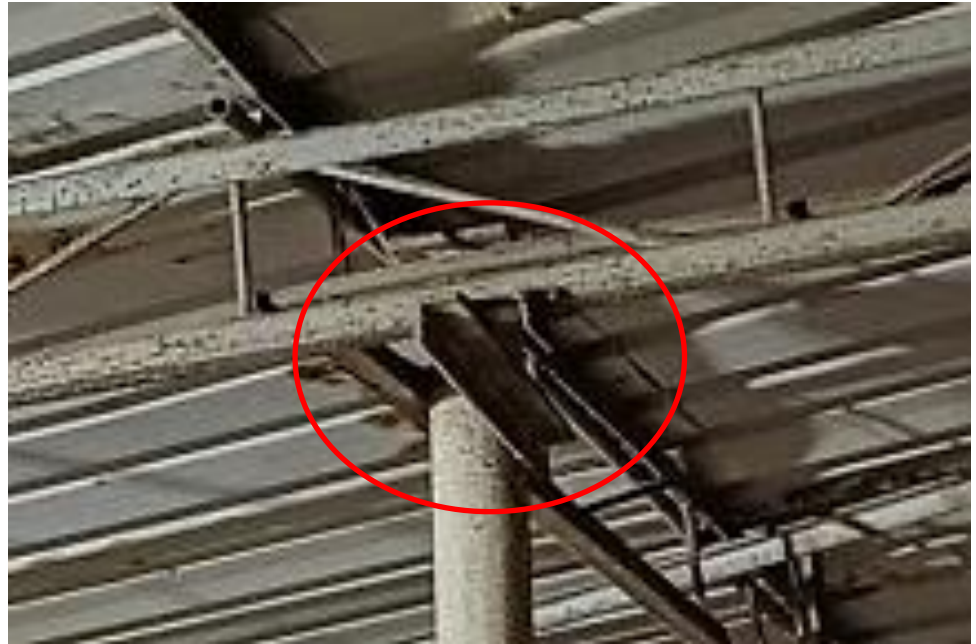
Poor connection of truss to steel pipe

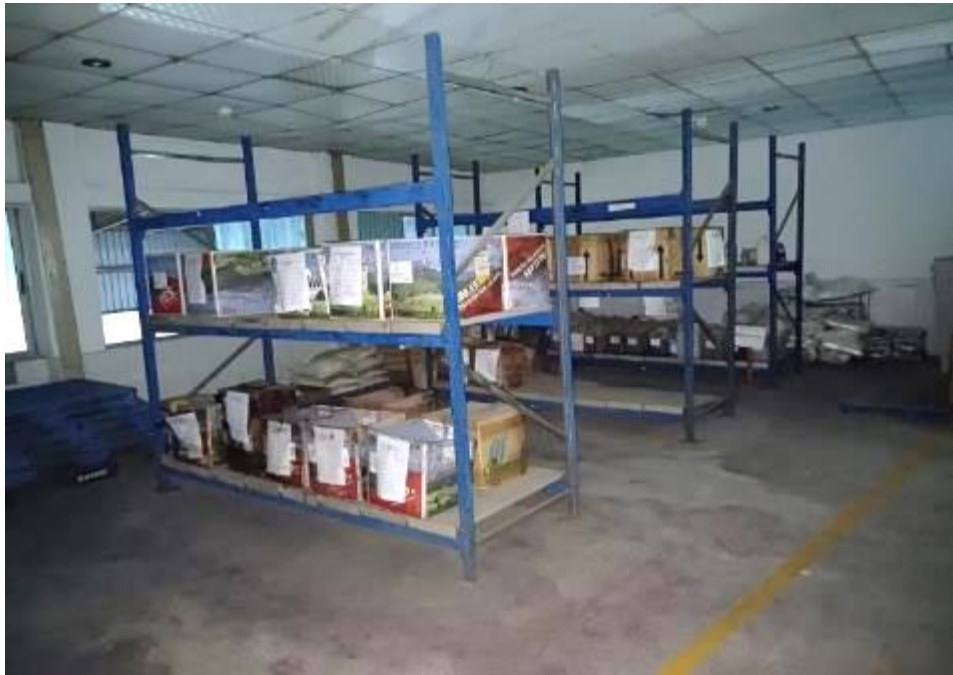
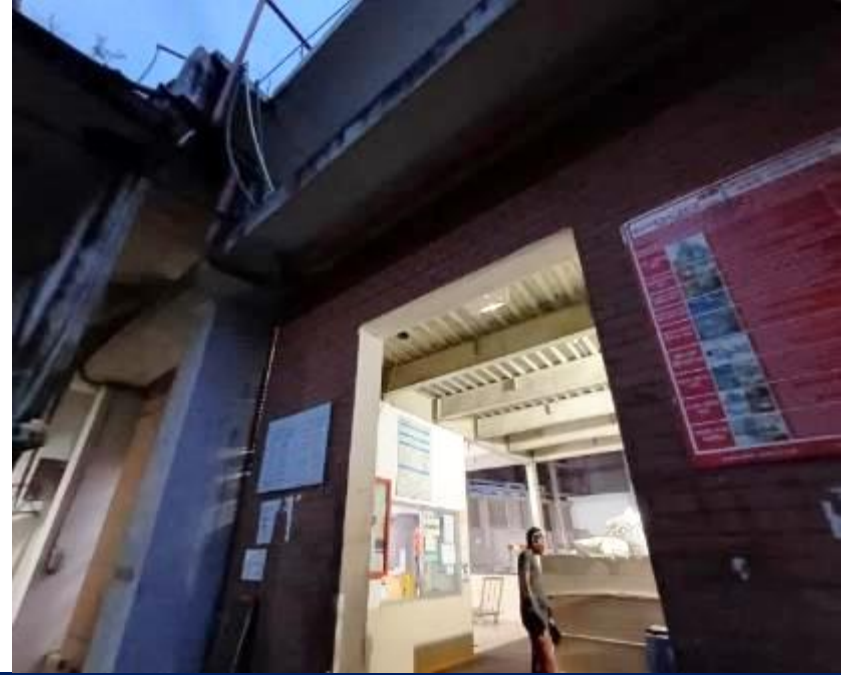
Mezzanine floor

There was no floor load plan for mezzanine floor. The building engineer is required to survey the occupancy produce floor load plan accordingly.

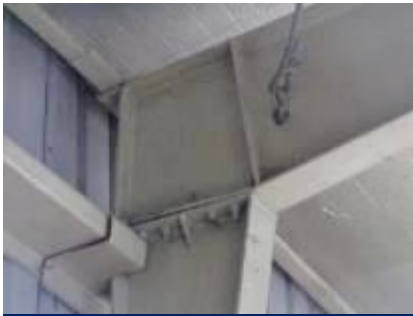
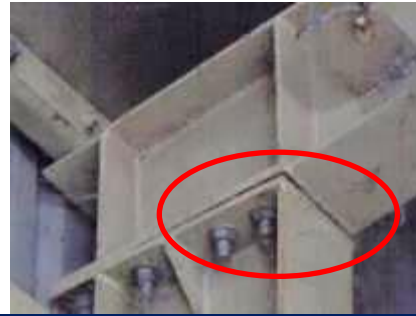
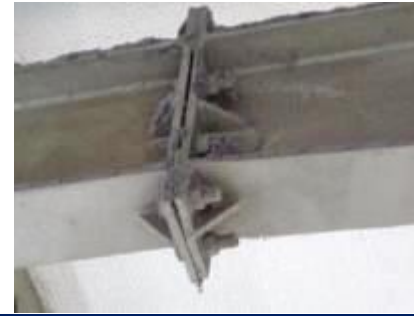
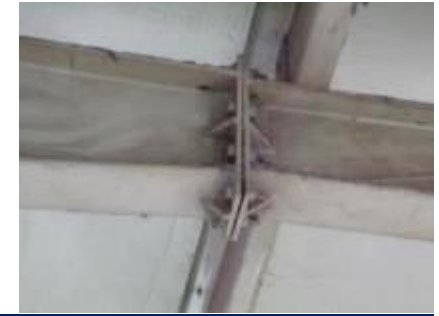
Gap between connection plates

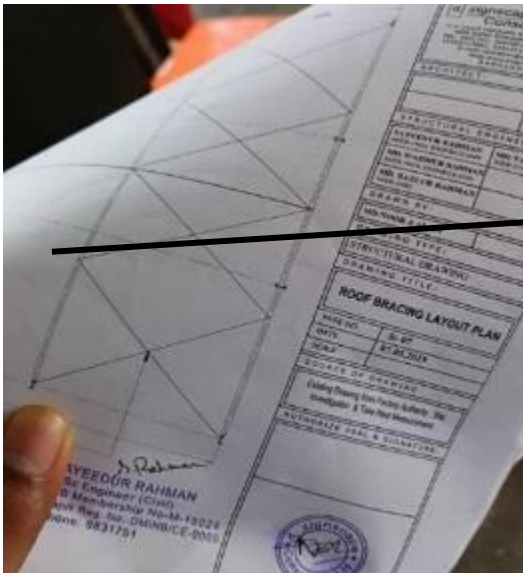
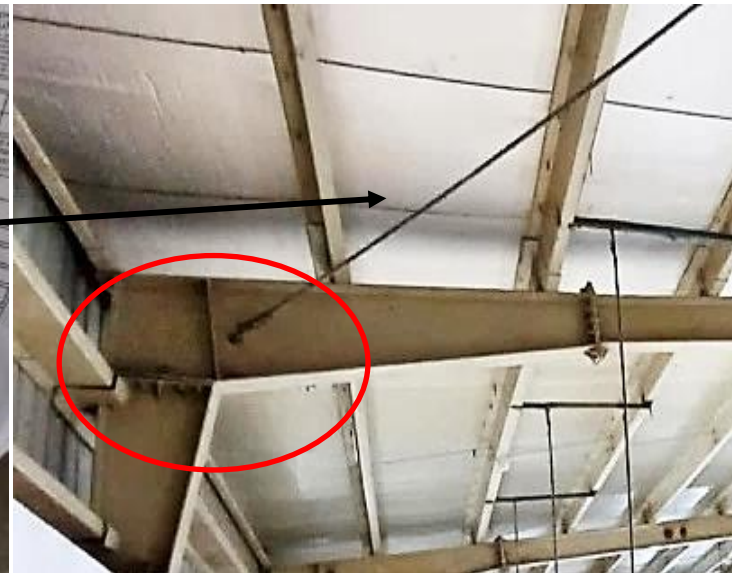
Bracings were connected apart from column-rafter joint
