# Ananta Huaxiang Ltd. (Extension)

222-223, H1, H2, H3, H4, Aepz, Narayanganj.  
(23.677063, 90.523734)  
13 September 2023

# Building Information

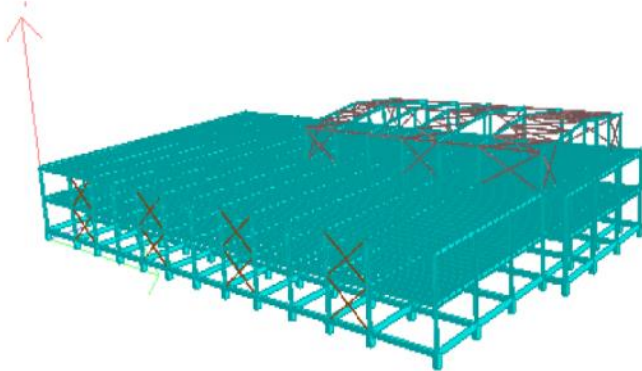
Fig: 3d Rendering View of shed.

Prayer room, RO room and walkway not considered in analysis model

Load of Prayer room, RO room and walkway not considered in analysis model. Building engineer is required to update the analysis model as per onsite condition and update the design report accordingly.

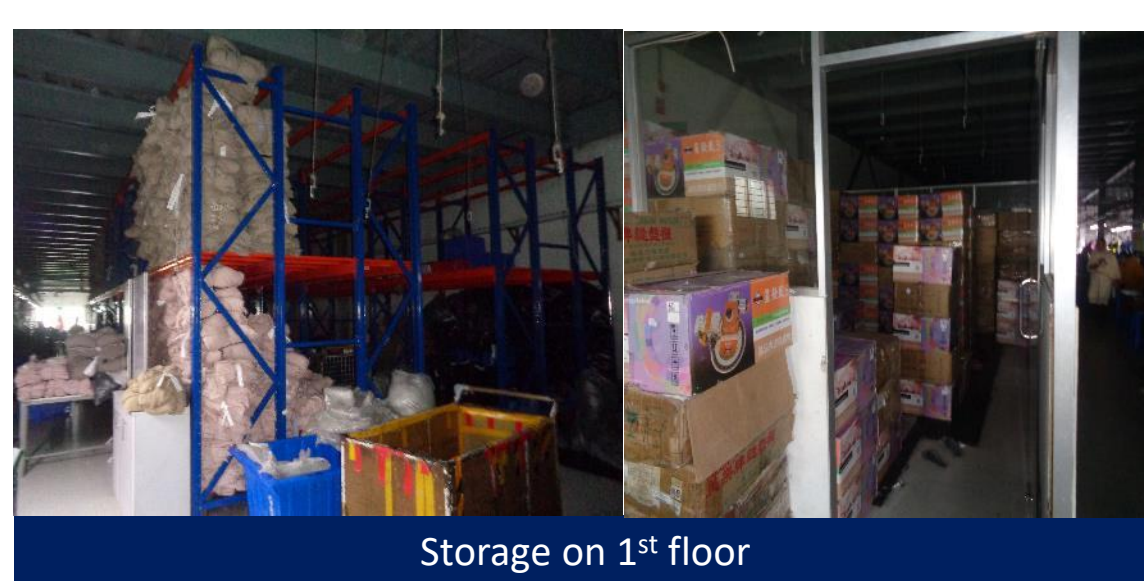
Live load on typical floor is considered as 3 kPa in prepared load plan. As per BNBC- Part 6, live load for light storage areas is required to be considered minimum 6 kPa. However, the Building engineer is required to revise the load plan as per BNBC requirement and check the design accordingly.
