# International Classic Composite Ltd. (9353)

Naojur, Kodda, Joydebpur, Gazipur, Bangladesh

08.MARCH.2014

## Site Observations

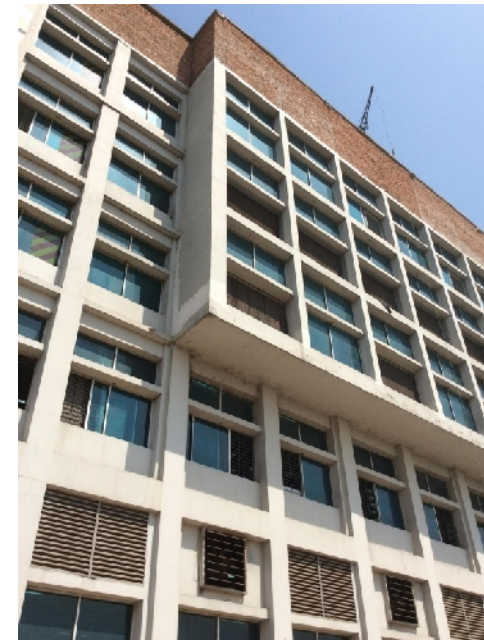
Concerns on the stability system for lateral loading and seismic loading. Façade brickwork with little capacity; lack of moment capacity in connection between columns and beams.

Further detail engineering assessment is required whether such system can resist the lateral load from wind & earthquake

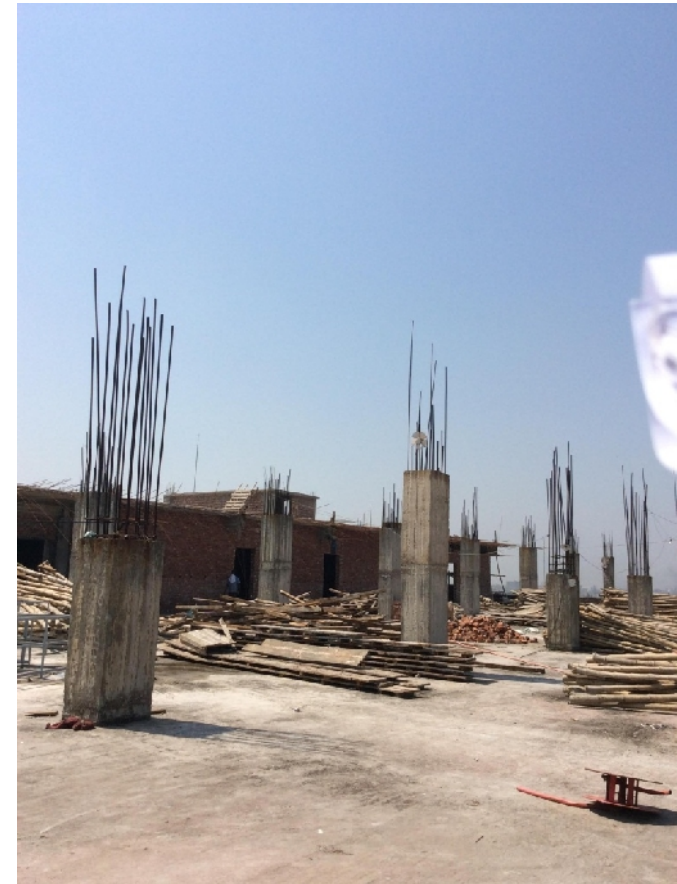
There is no evidence of water ingress at the roof level, however, it should be considered as an on-going action to apply waterproofing measures during construction, while the 6th floor acts as a roof level.
