# Impress Printing & Embroidery

5 October 2023

# Observations

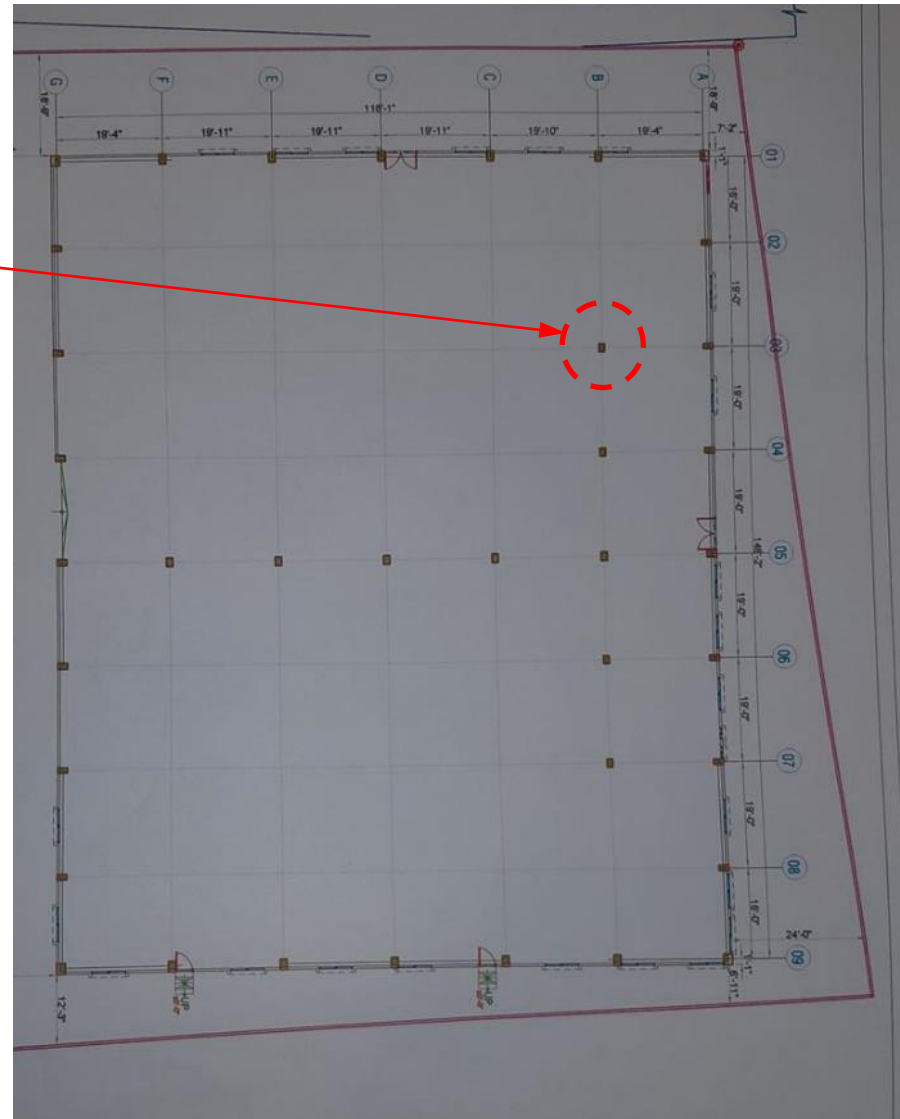
Distorted steel beam-column joint

Steel column of mezzanine floor at south-east corner is distorted. The connection between that column and steel beam also seems inadequate. The building engineer is required to investigate the reason of such distortion and take necessary action for remedial procedure.
