# MEEK KNIT LIMITED

Vogra , National University , Joydebpur,Gazipur  
(23.58530N ,90.22504E)

28<sup>th</sup> October 2015

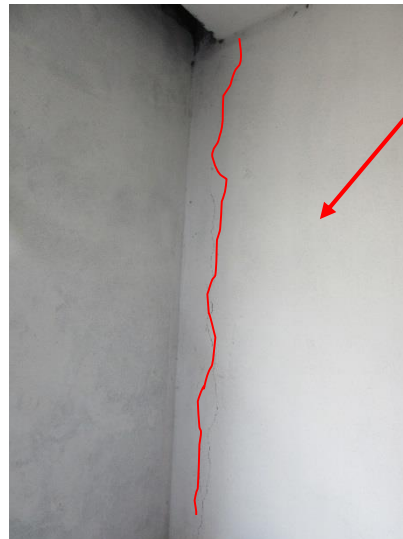
North staircase. 1st Floor

# Facade breakouts

Item No.	Observation	Recommended Action Plan	Recommended Timeline
5	Uncontrolled storage areas	The quantity of the stored materials must be reduced to the level specified by the original designer	6-weeks
6	Uncontrolled storage areas	Building Engineer to provide Load Plans for each level	6-weeks
7	Uncontrolled storage areas	Reduce loading to the recommendations of the loading plans	6-months
8	Façade breakouts	Repair the cracks	6-months
