# Fakir Fashion Ltd.(Extension)

Dohargaon, Baliapara, Rupgonj.

21<sup>st</sup> June 2017

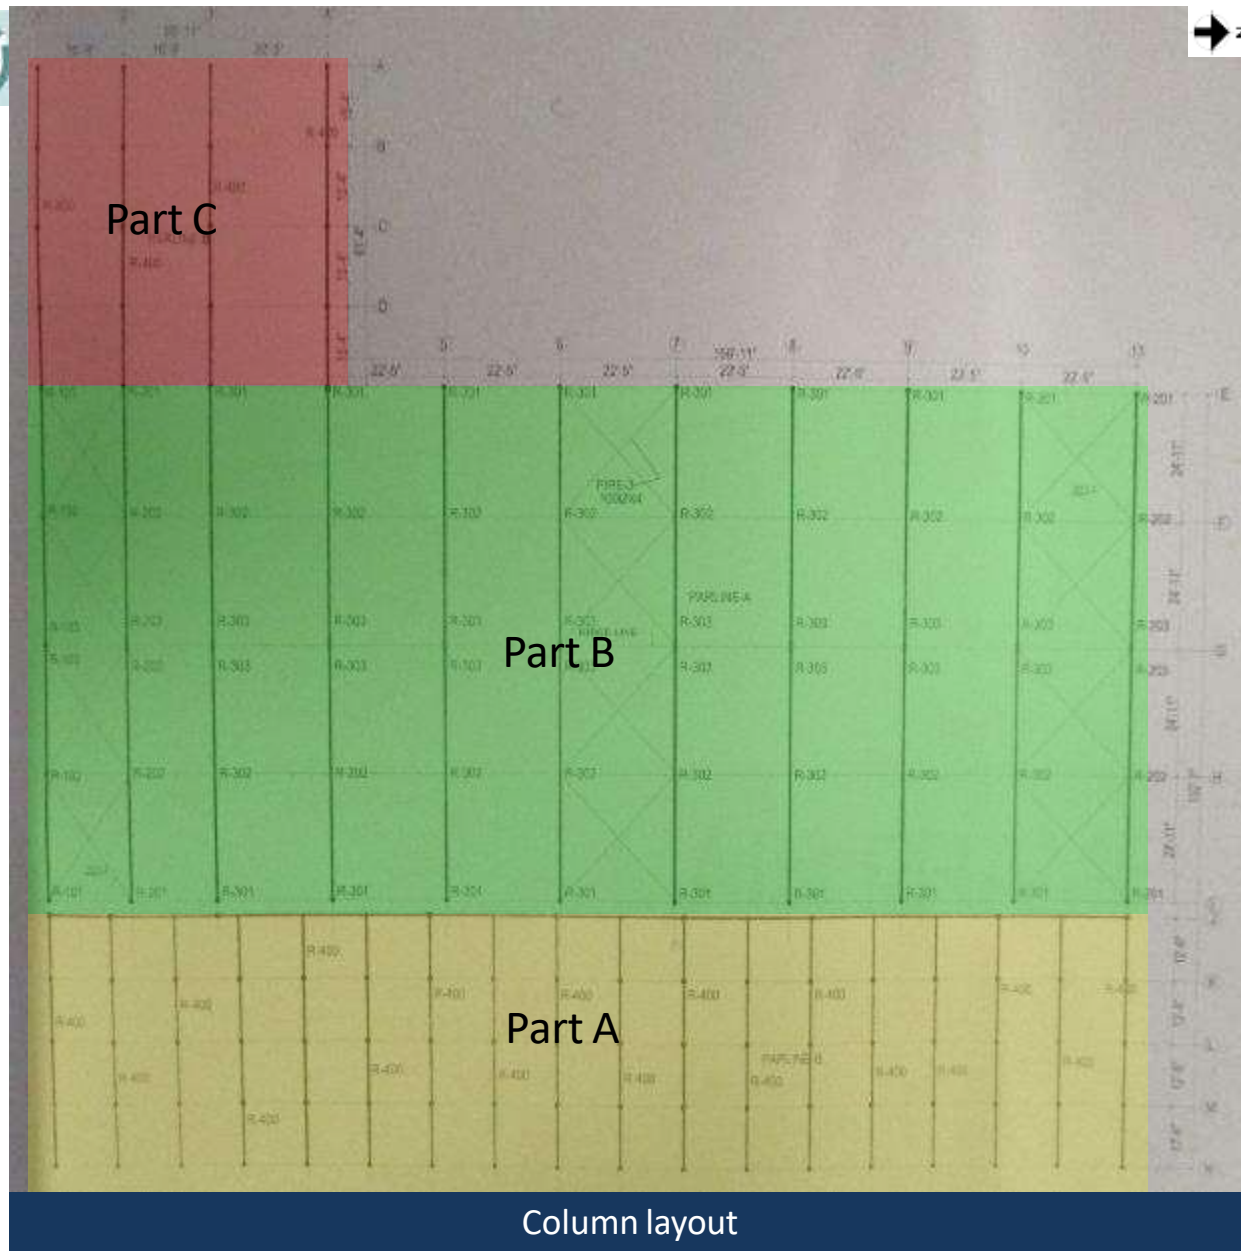
Column layout of Part A

In the marked zone, two steel pipe columns had found instead of three steel pipe columns. Factory is required to update the as-built drawing and assess the stability against vertical and horizontal load.

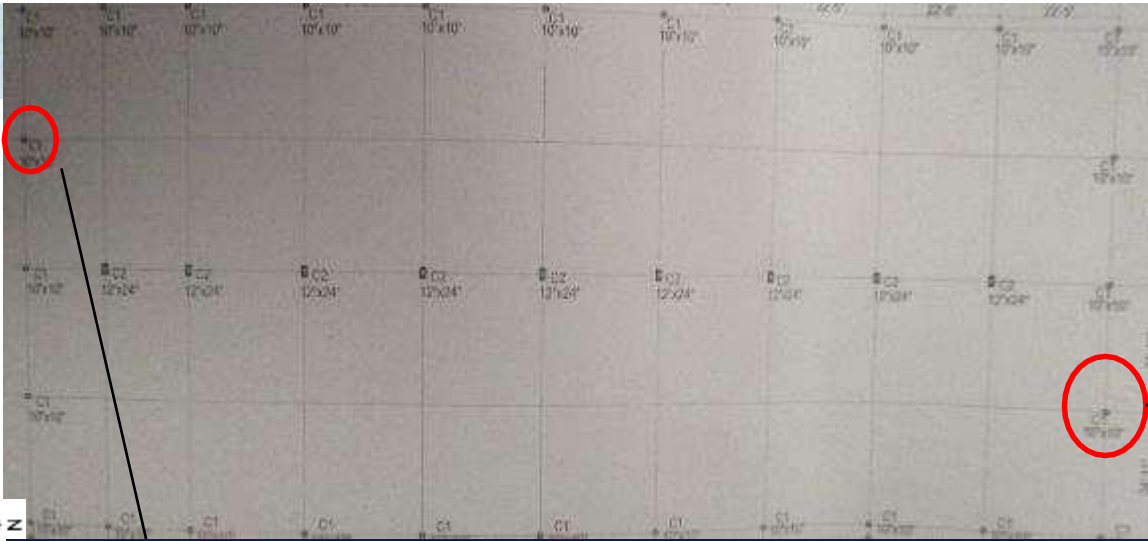
Column layout of the Part B

On the end bay, some portion of the top of RCC column was found broken. The factory engineer is required to assess the capacity of the column and rafter against vertical and lateral load as rafter not properly rested on column.

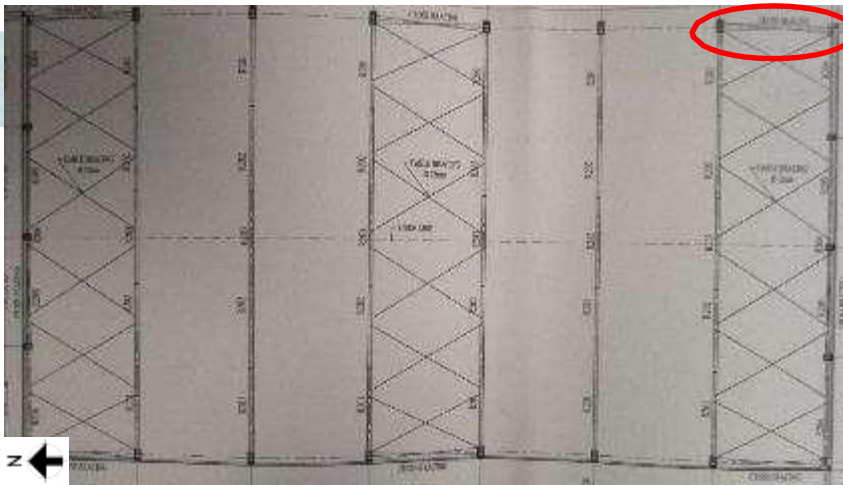
Bracing layout in provided drawing

No vertical bracing was observed on east side

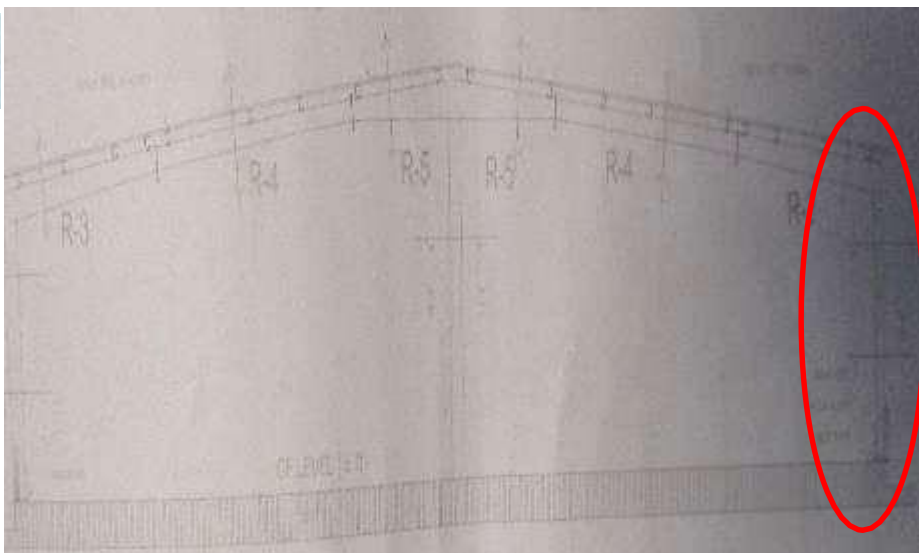
Portal frame in provided drawing

Edge columns were found tapered whereas in provided drawing, those column were shown as straight section.

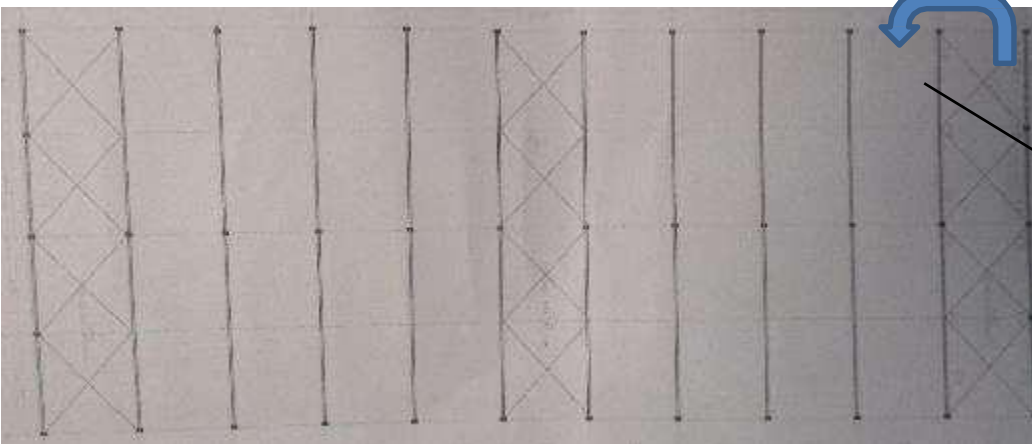
Roof bracing layout in provided drawing

Roof bracing were found installed different location and not as per provided drawing.

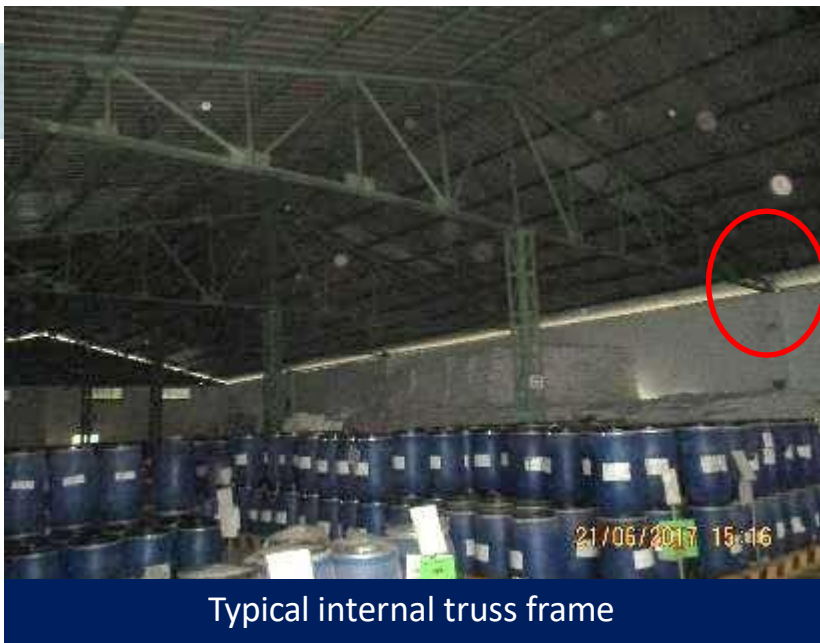
Typical internal truss frame

Section of steel truss frame was not present in provided drawing. Also, no joint detail and column section was observed in the drawing. Factory is required to update as-built drawing and check the capacity against lateral and vertical load.

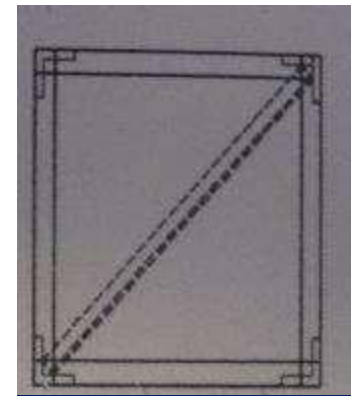
Cross section of  
steel column in  
provided drawing

Cross section of steel  
column on site which is  
different than provided  
drawing
