Union Sportswear Ltd. (Extension)

116, Pagar-Morkon Link Road, Pagar, Gazipur
Geographic Coordinates: 23.898500, 90.421014
17 October 2023

Executive Summary

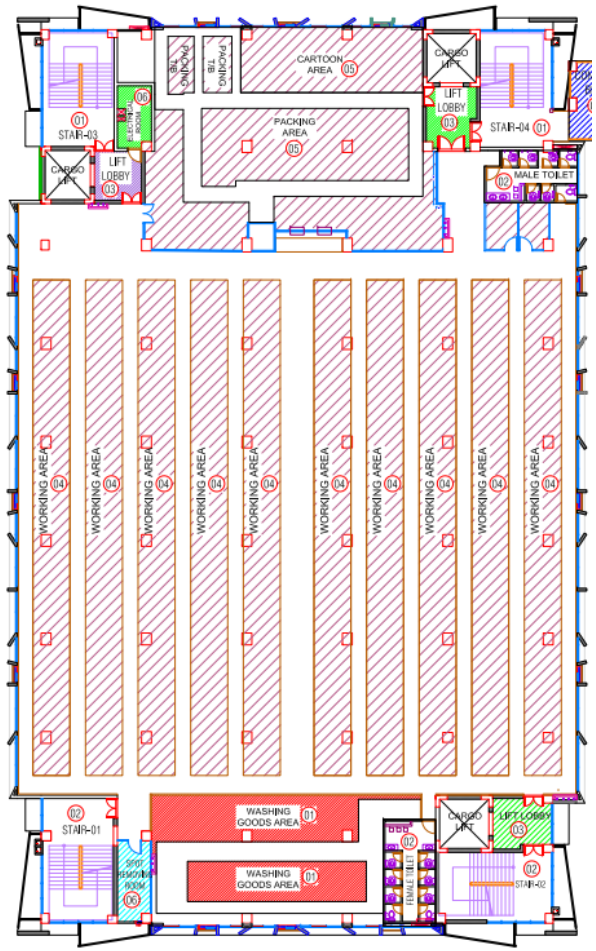
Live load table
(BNBC 2020)

Storage live load not comply with BNBC

Occupancy or Use	Uniform kN/m ²	Concentrated kN
Storage areas above ceilings	1.00	--
Storage warehouses (shall be designed for heavier loads if required for anticipated storage)		
Light	6.00	--
Heavy	12.00	--
Stores		
Retail		
First floor	4.80	4.50
Upper floors	3.60	4.50
Wholesale, all floors	6.00	4.50
Vehicle barriers	See Sec 2.3.11	
Walkways and elevated platforms (other than exit ways)	2.90	--
Yards and terraces, pedestrian	4.80	--

Live load on 4th floor and 8th floor are considered as 5 kPa in prepared load plan. As per BNBC-2020, live load for light storage areas is required to be considered minimum 6 kPa. However, the building engineer is required to revise the live load plan as per BNBC requirement and check the design accordingly.
