# Reedisha Knitex Ltd (Extension)

Dhanua, Nayanpor, Sreepur, Gazipur

5 December 2023

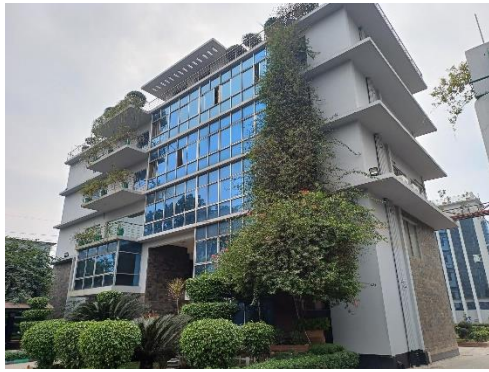
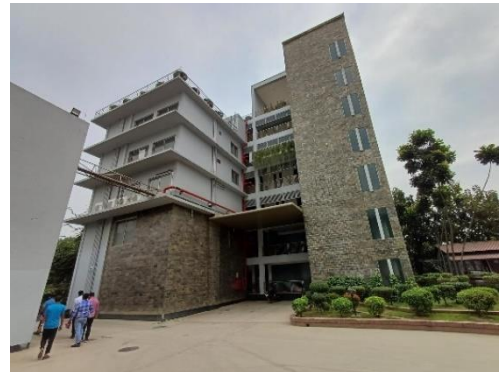
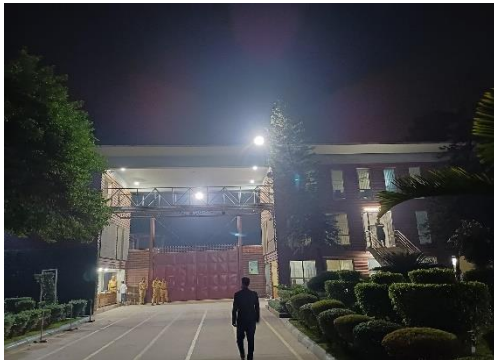
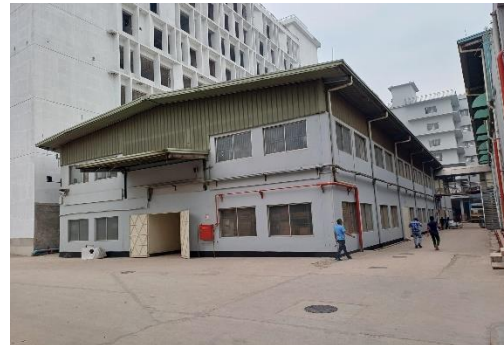
**Observation-9:** Lack of design documents (Old Admin Building, New Admin Building, General Store Shed, Main Gate Building).

**Description:** As per BNBC, every building or structure designed shall have its design documents prepared following the provision of Section 1.9.1. During inspection, the design report and load plan were not available on site.

The building engineer is required to prepare a set of design documents including live load plan and a design report based on in-situ material strength and software-based analysis which shall be prepared in compliance with section 1.9.1, part-6 of BNBC.

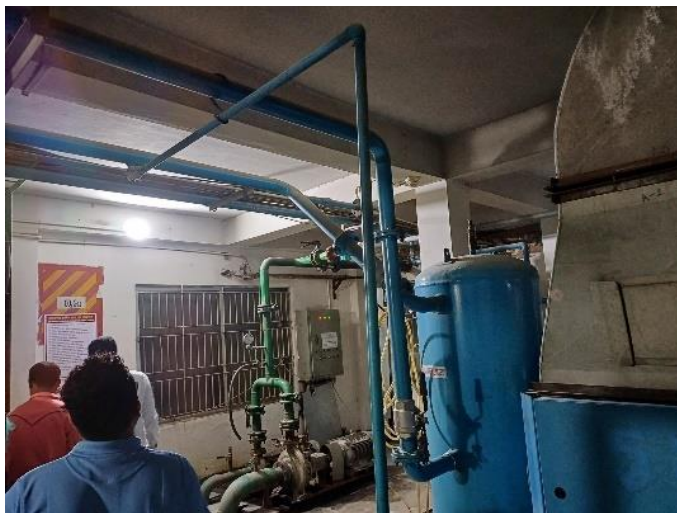
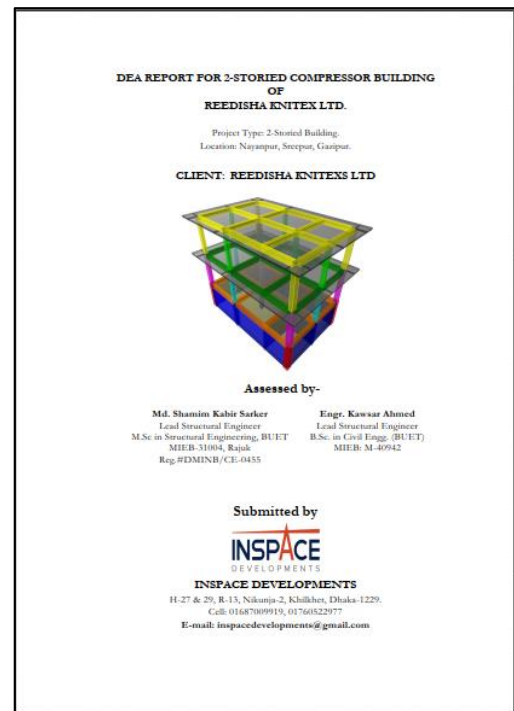
**Observation-12:** Design report needs to be reviewed (Compressor Building).

**Description:** Design report needs to be reviewed in-depth by RSC for lateral forces. The building engineer is required to submit the design report and necessary documents to RSC for review.

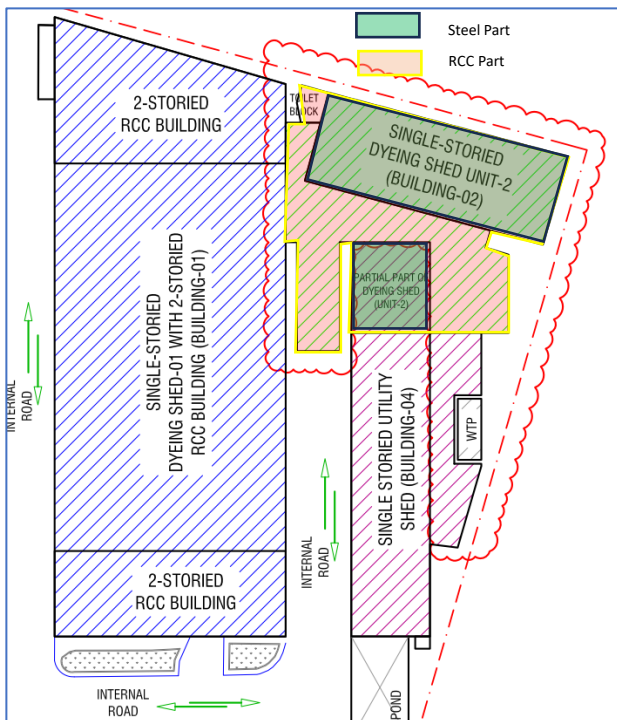
Dyeing Shed-2 (full layout)

**Observation-16:** Lack of design report. (Dyeing Shed-2)

**Description:** As per BNBC, every building or structure designed shall have its design documents prepared in accordance with the provision of Section 1.9.1. The design document shall include a design report, and a set of structural drawings, which shall be prepared in compliance with section 1.9.1.1 and section 1.9.1.2, part-6 of BNBC. At the time of inspection, only as-built drawing and geotechnical report were available, but no design report & load plan were available which are required to be prepared in compliance with section 1.9.1.1 (part-6, BNBC).

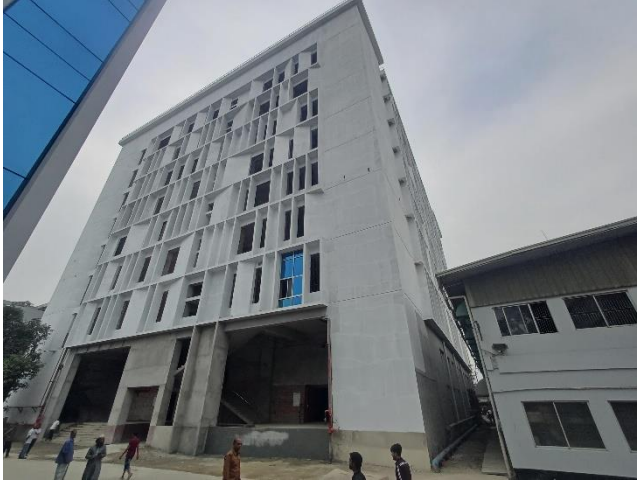
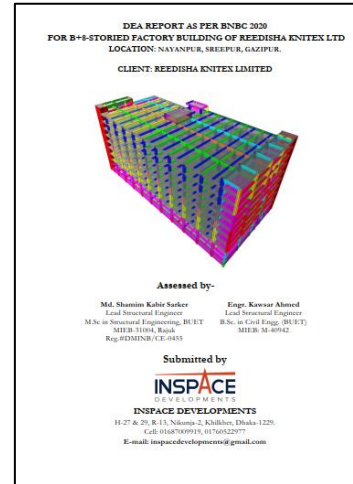
B+ 8 Storied Building

**Observation-19:** Design report needs to be reviewed

**Description:** Design report needs to be reviewed in-depth by RSC for lateral forces. The Building engineer is required to submit the design report and necessary documents to RSC for review.

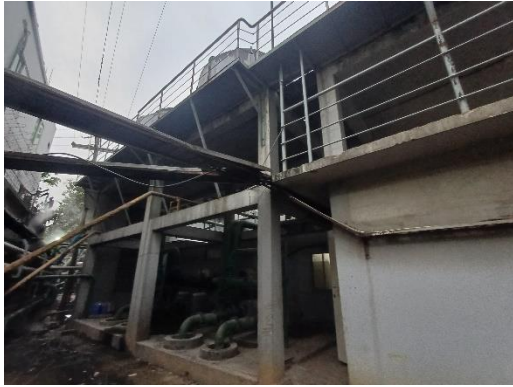
Cooling Tower

**Observation-21: Lack of drawings design. (Cooling Tower)**

**Description:** As per BNBC, every building or structure designed shall have its design documents prepared in accordance with the provision of Section 1.9.1. The design document shall include a design report, and a set of structural drawings, which shall be prepared in compliance with section 1.9.1.1 and section 1.9.1.2, part-6 of BNBC. At the time of inspection, as-built drawings, design report & load plan were not available which are required to be prepared in compliance with section 1.9.1.1 (part-6, BNBC) and submit to RSC for detail review for lateral forces.
