# Advanced Composite Textile Ltd

Kashor, Masterbari, Bhaluka, Mymensingh, Bangladesh  
(24.302157N, 90.363604E)

24<sup>th</sup> October 2015

# Observations

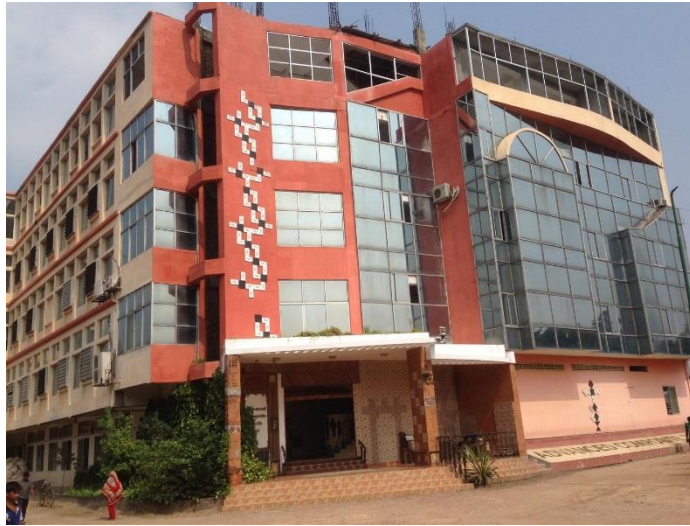
# High stress levels in columns (BLG 1 and BLG 2)

Outline calculations indicate some columns are highly stressed under their current loading conditions particularly in the areas highlighted.
