# KAS Group Knitwear Ltd.

Bypass Road, Peyarabagan, Joydevpur, Gazipur  
(23.977060 N, 90.376332 E)

1<sup>st</sup> November 2015

# Observations

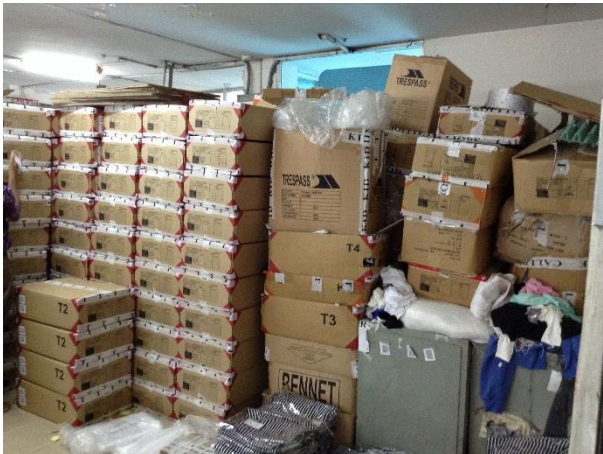
Stacked cardboard and packed finished goods stored at 1st and 3rd floors.

Vibration on 1st floor was noticeable when packing process is ongoing.

Note flat slab at 2nd Floor: punching shear failure is a concern. Excessive storage must be prevented.

Building Engineer to create controlled loading plans for all floors which will designate where storage can be placed.

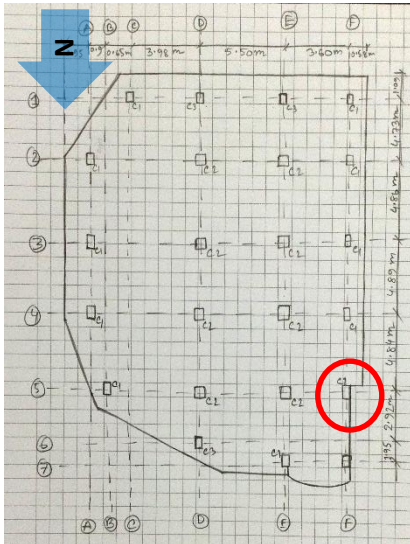
A significant portion of column has been removed, possibly cutting rebar.

| Item No. | Observation | Recommended Action Plan | Recommended Timeline |
|---|---|---|---|
| 5 | Damage on columns due to service pipes. | Engineer to inspect penetration through altered column and check column capacity. Relocate services and repair column with high-strength mortar. | 6-weeks |

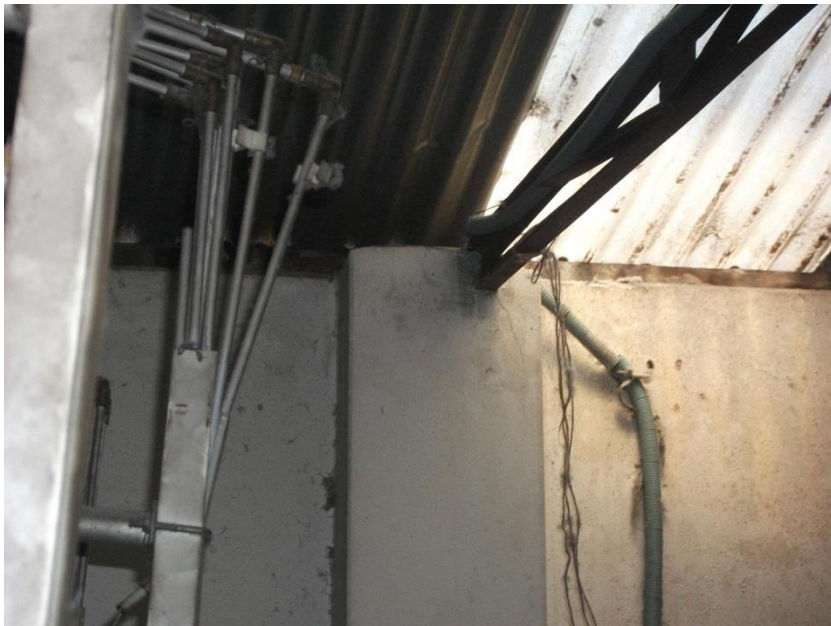
Non-engineered steel truss system with lack of proper supports at columns/brick walls without any stability bracing. Unlikely to resist any strong wind action.
