# Mega Yarn Dyeing Mills Ltd (Extension 2)

18 December 2023

## 2. Observations:

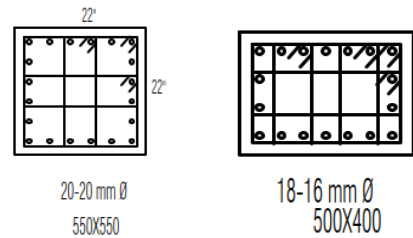
On-site rebar of column (Grid D-10)

**Description:** During the inspection, mismatches were found in the as-built drawings. In the roof, a cooling tower was found on-site but in the architectural drawing, no cooling tower is shown. The floor height doesn't match the on-site condition. In structural drawing, each floor beam size is shown 300(w)X375(d/s) in the drawing; but during inspection, floor beam size was found 300(w)X300(d/s), 300(w)X400(d/s) and 300(w)X475(d/s). Grid distance at GL 13-14 & 14-15 doesn't match with drawing. During inspection, 16nos. rebar was found instead of 20nos. rebar in the C6 column and 12nos. rebar was found instead of 18 nos. rebar in the C12 column on the 6<sup>th</sup> floor. As-built structural drawings of the ETP Office Room, Filter Press M/C Room and Compressor Room were not found on-site.
