# DANYS KNITWEAR LTD.

Surabari, Kashimpur, Gazipur sadar, Gazipur.

27<sup>th</sup> October 2015

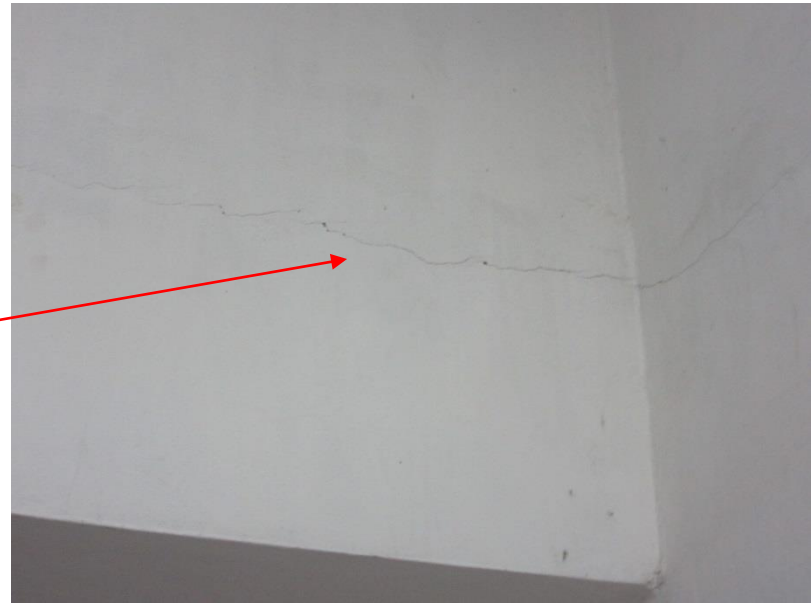
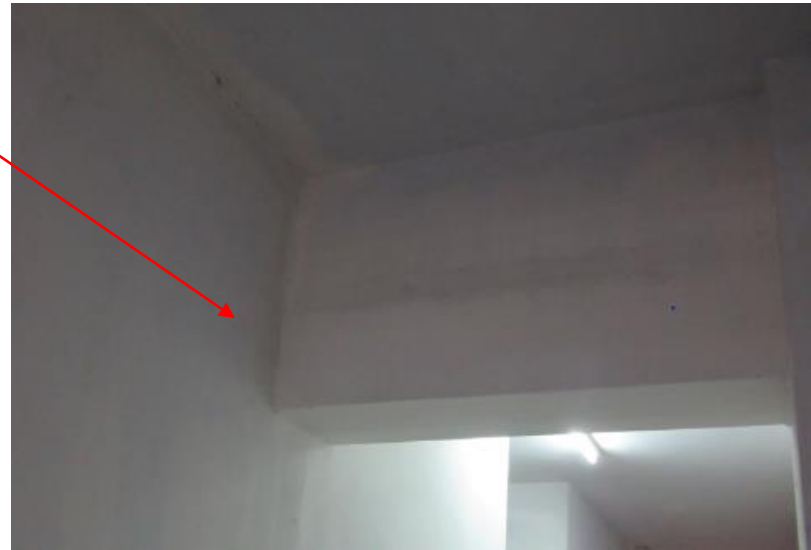
2nd Floor. Horizontal crack on the beam

| Item No. | Observation | Recommended Action Plan | Recommended Timeline |
|---|---|---|---|
| 4 | Cracks on the beams and partition walls | Remove the plaster and engage an Building Engineer to investigate the cracks on the beam | 6-weeks |
