# DYNAMIC SWEATER IND. LTD

10, Ganda, Savar, Dhaka  
(23.827699N, 90.260594E)

1<sup>st</sup> November 2015

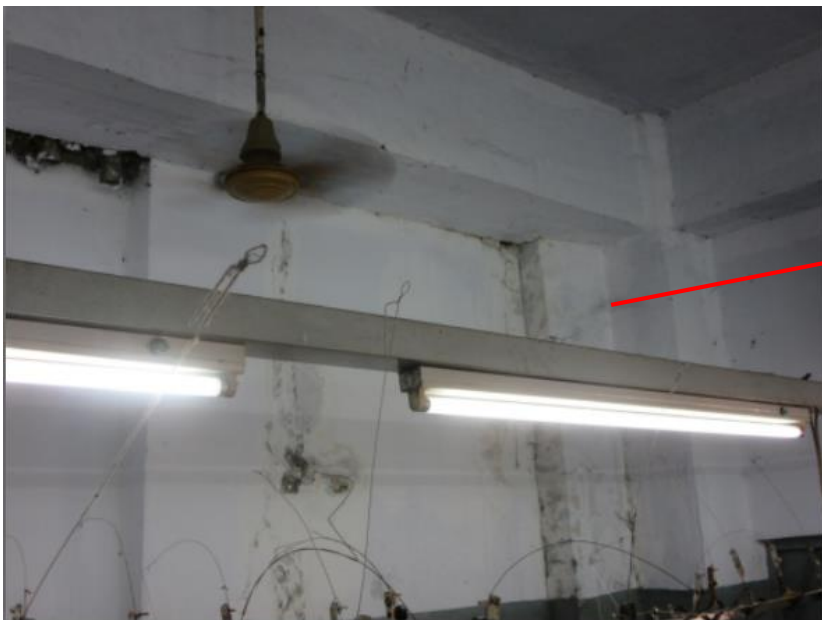
**Wet surfaces underneath the water tanks**

| Item No. | Observation | Recommended Action Plan | Recommended Timeline |
|---|---|---|---|
| 6 | Wet surface, leakage on the walls below water tanks | Building Engineer to check the cause of the water leak and it should be repaired | 6-months |

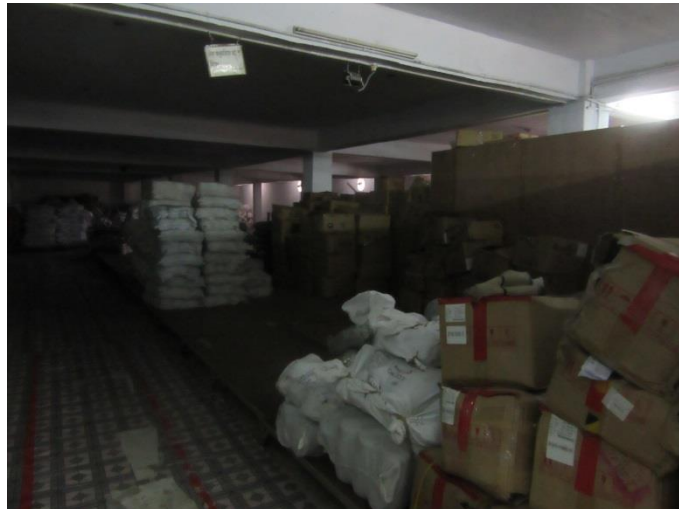
# Overloaded storage areas

**Storage material on 1st floor**

| Item No. | Observation | Recommended Action Plan | Recommended Timeline |
|---|---|---|---|
| 8 | Overloaded Storage Areas | Reduce loading to the recommendations of the loading plans | 6-months |
